Nambucca Valley River and Catchment Management Study

Technical Report F River Management and Rehabilitation

December 1999

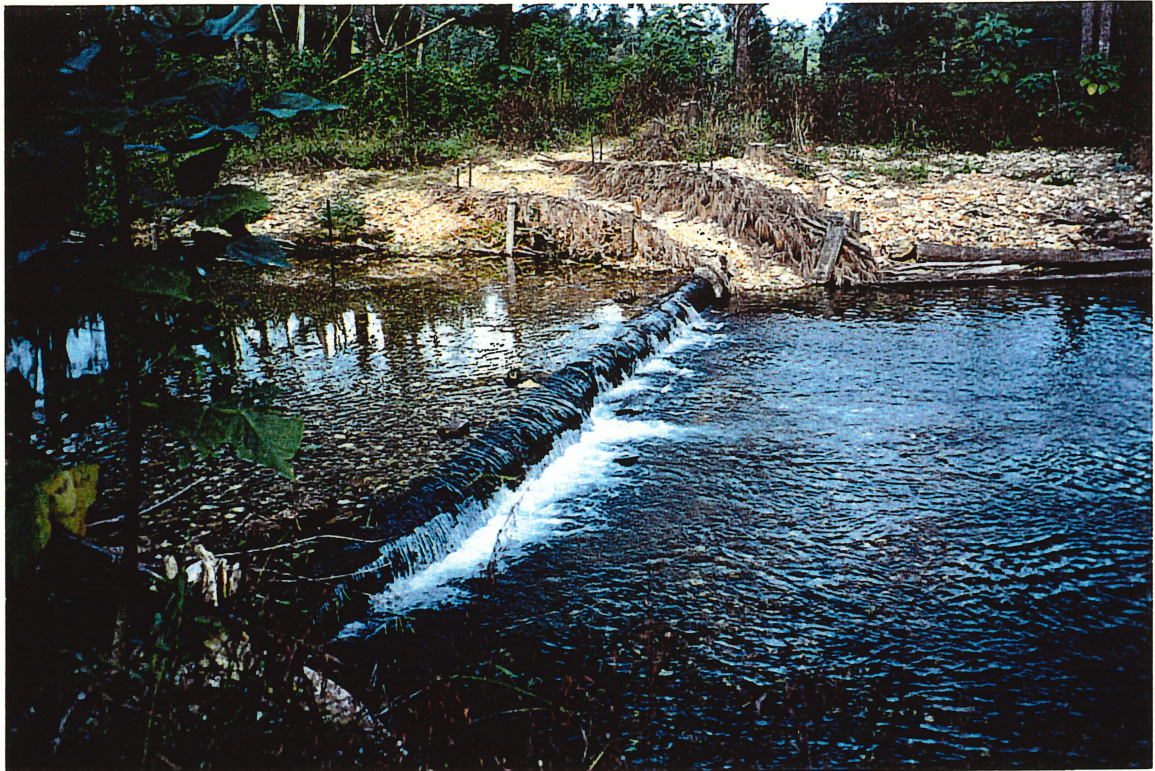
A major problem with log sills is that they can be outflanked by the flow. Plate 3.1 shows a straight log sill working on Taylors Arm. The success of this sill is, in part, due to the protection given by a 'splash log' placed on the downstream side of the main log, and to the placement of brush groynes along the banks at the outer ends of the log. These brush groynes help to prevent the sill being outflanked by flow in times of flood. Continual maintenance of the sills and brush groynes by property owners greatly contributes to their success. Plate 3.2 shows a V-notch sill on Missabotti Creek where a pool has been scoured on the downstream side. This sill has not been outflanked due to the fact that the logs have been embedded into a cohesive and vegetated bank of soil in contrast to those where the banks consist of gravel. The narrowness of the channel here and the decreased chance of outflanking has helped the sill to remain intact. However, as the geotextile continues to breakdown, the structure will surely be undercut.

Plate 3.1: Straight log sill on Taylors Arm (downstream of T3). June 1997.

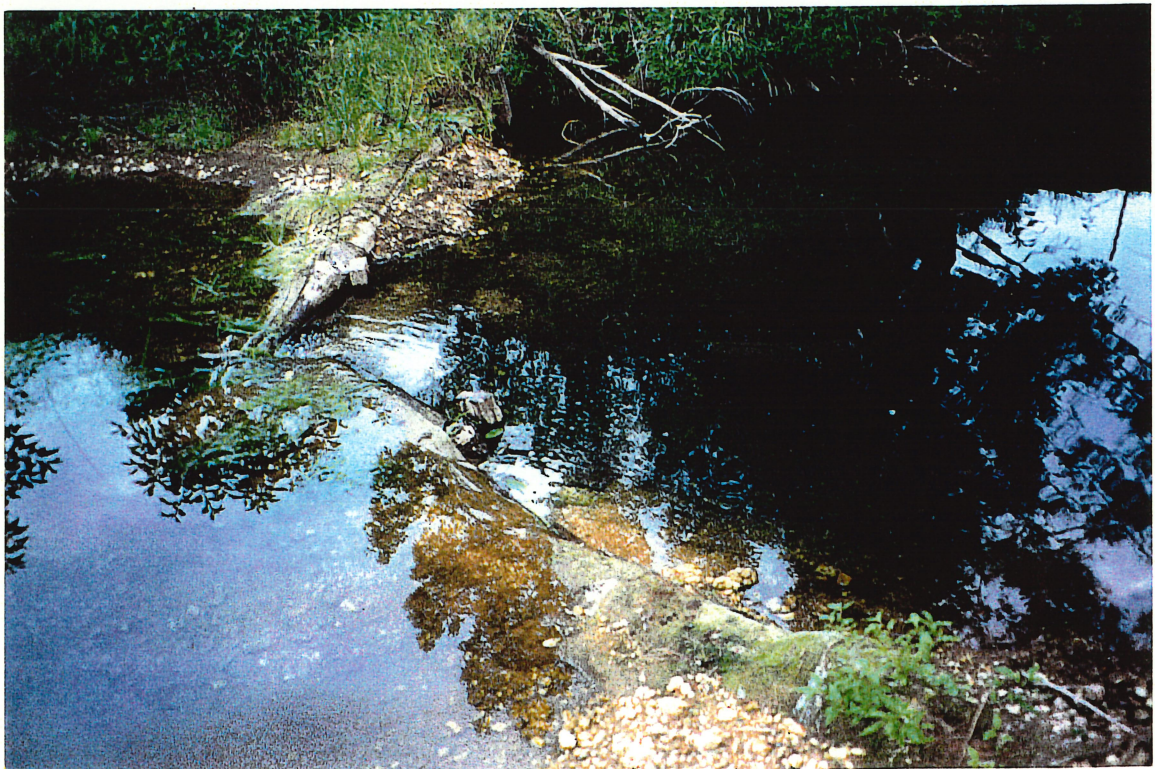
Plate 3.2: V-notch log sill on Missabotti Creek (downstream of M3). June 1997.

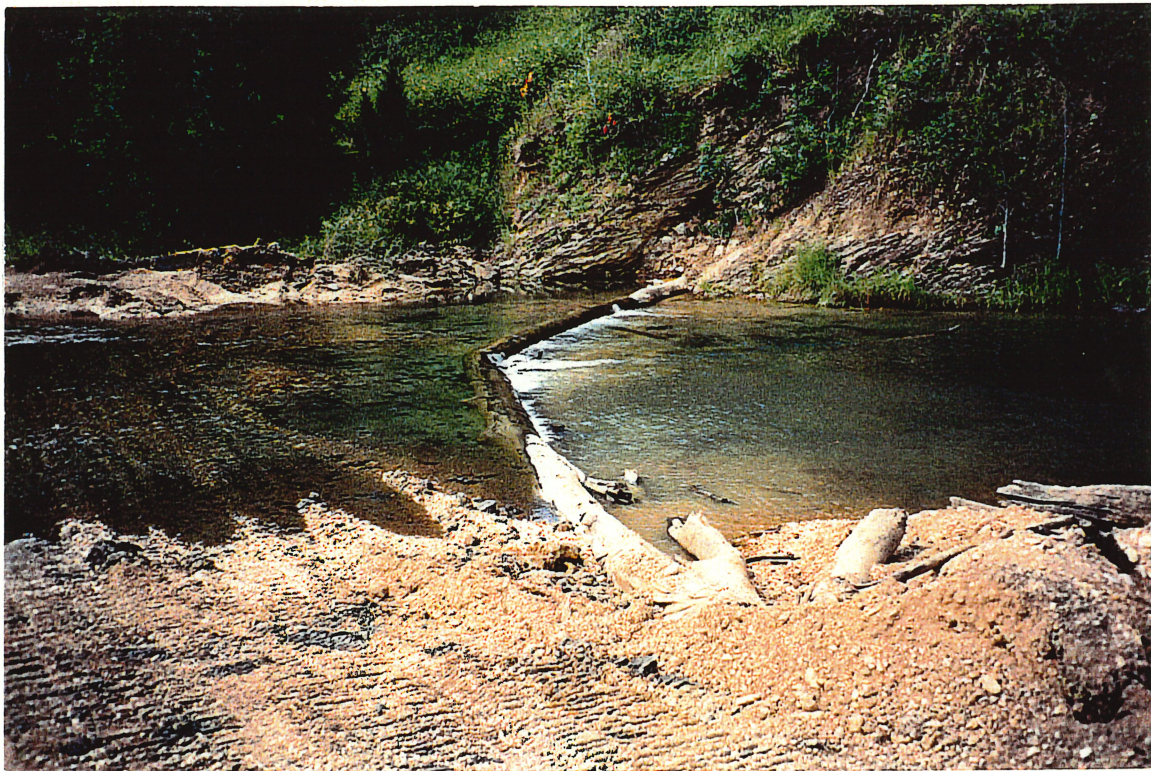
Plate 3.3 and 3.4 show the fate of a V-notch log sill that has been outflanked at Argents Hill on North Arm. This reach was oversteepened due to a meander cut-off in the 1980s. Figure 3.3 shows the sill just after completion, while Plate 3.4 shows it just after the May 1996 flood. The sill was soundly placed against bedrock on the left side of the channel but

Plate 3.3: Log sill constructed at Argent's Hill (N3). April 1996.

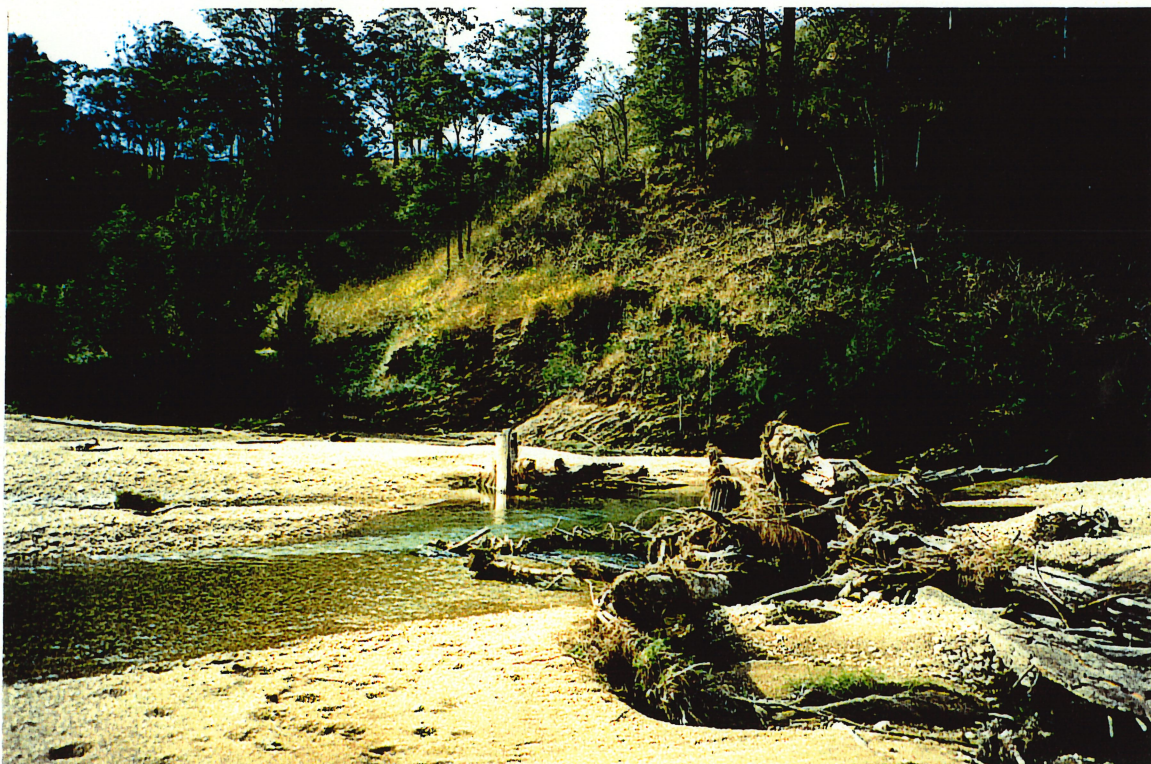
Plate 3.4: Log sill at Argent's Hill (N3) after the May 1996 flood. Undercut and outflanked

was only buried under gravel on the right side. The May flood, a one in five year event, caused the structure to be undercut and outflanked on the right side of the channel.

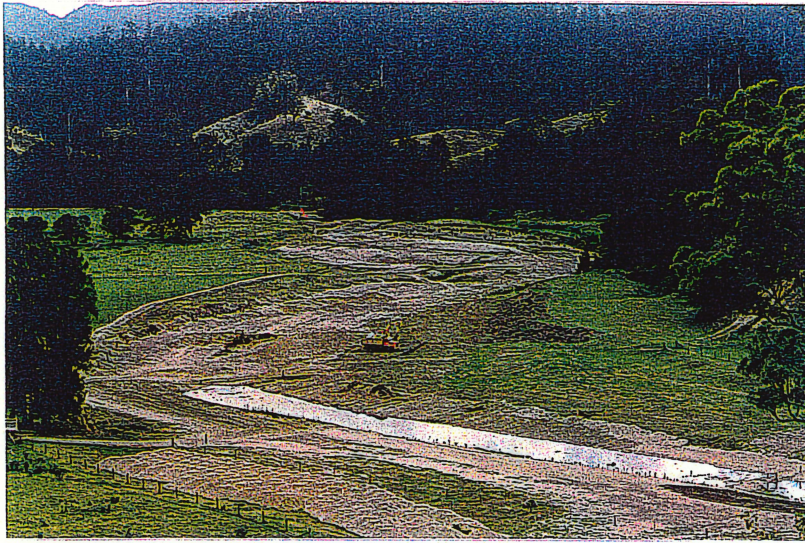
September 1995

Excavation has already commenced
V-notch log bed controls being constructed
Alignment set to approximate low flow channel
Design Width determined as 15 metres.

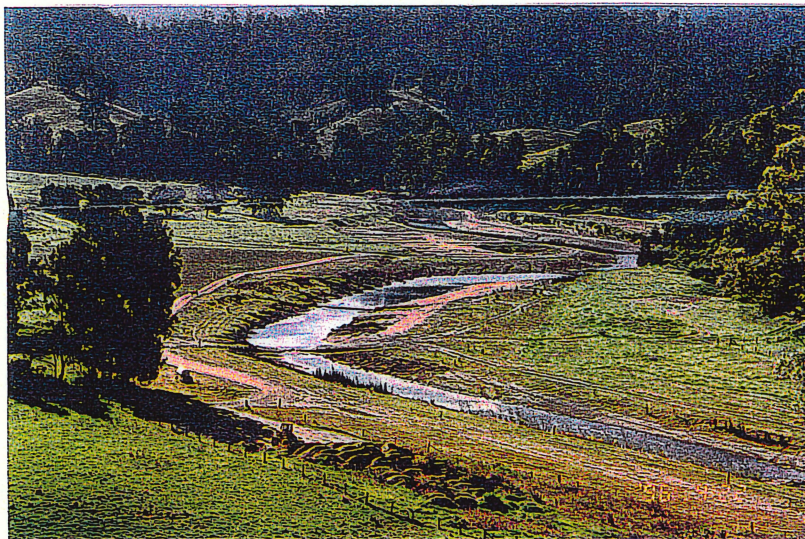
April 1996

Site almost completed
Bed control sills rebuilt following 1/96 flows
New designs trailed including straight sills and rock ramp
Brush groynes installed on outside bends for short term
protection until revegetation works established

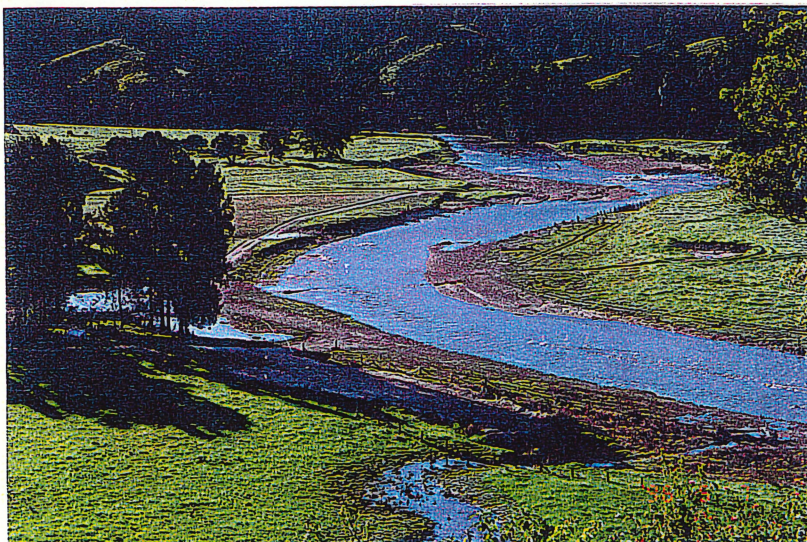
May 1996

Photograph taken on falling stage of ~ bankfull flood
Note river meander process (erosion on outside bends)
River is trying to reduce it's slope by getting longer

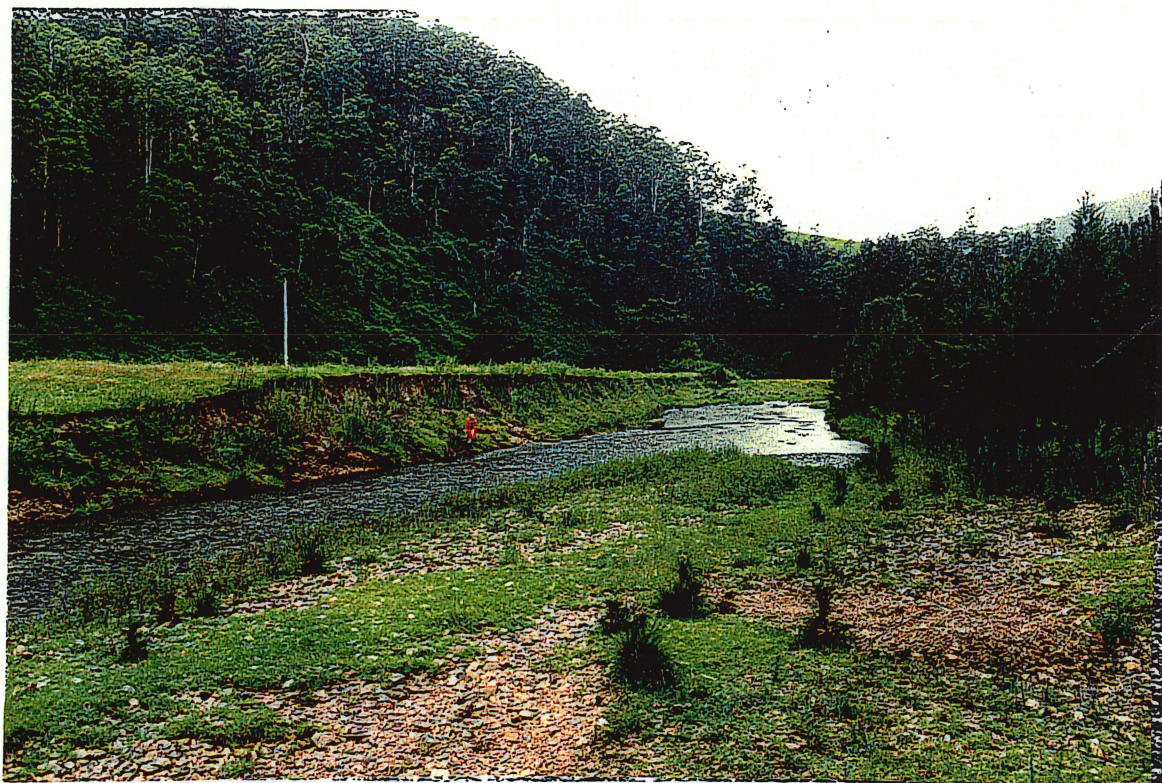
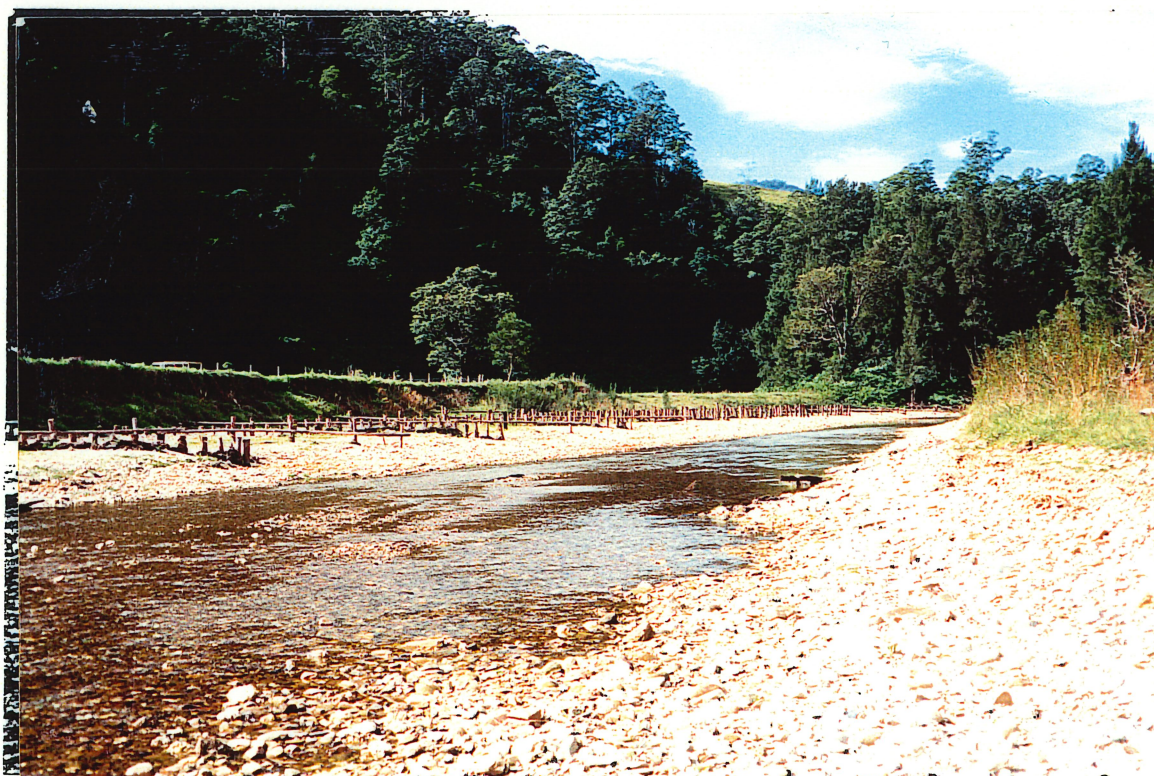
Plate 3.6: Downstream view of an eroded bank on Taylors Arm (between T2 and T3). (a) (above) In February 1996 before groynes were built, and (b) (below) June 1997 after the groynes were completed.

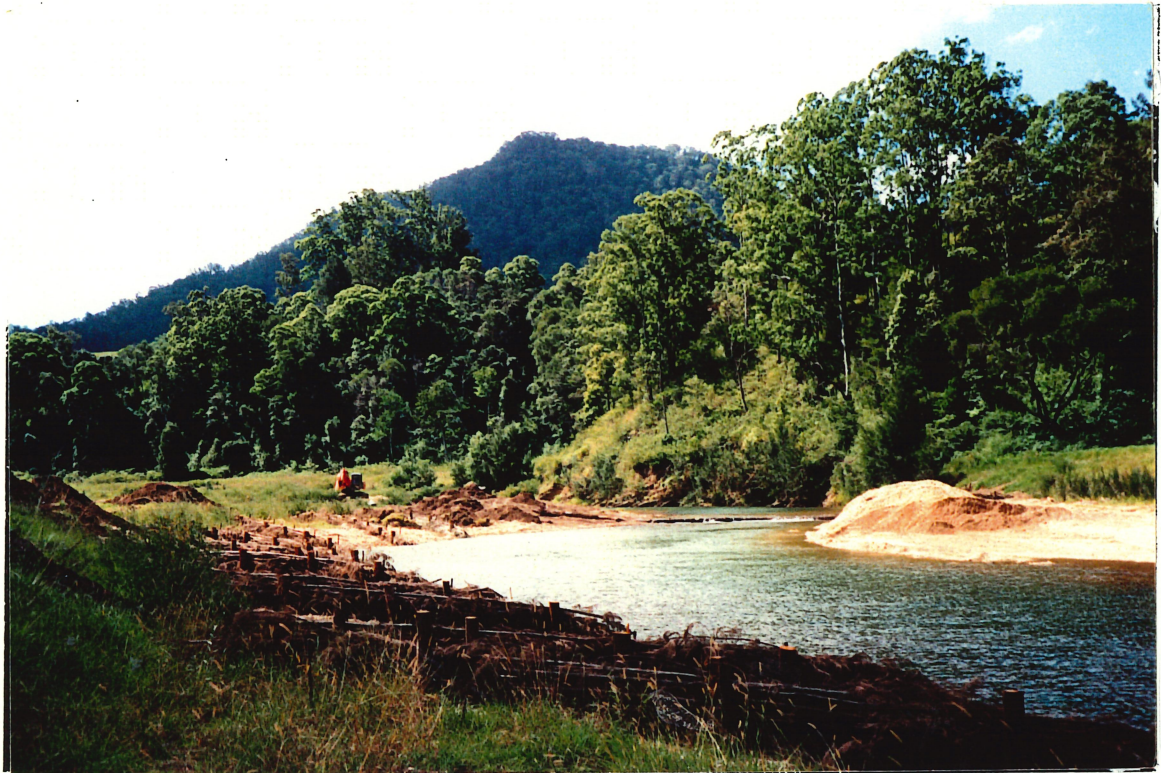
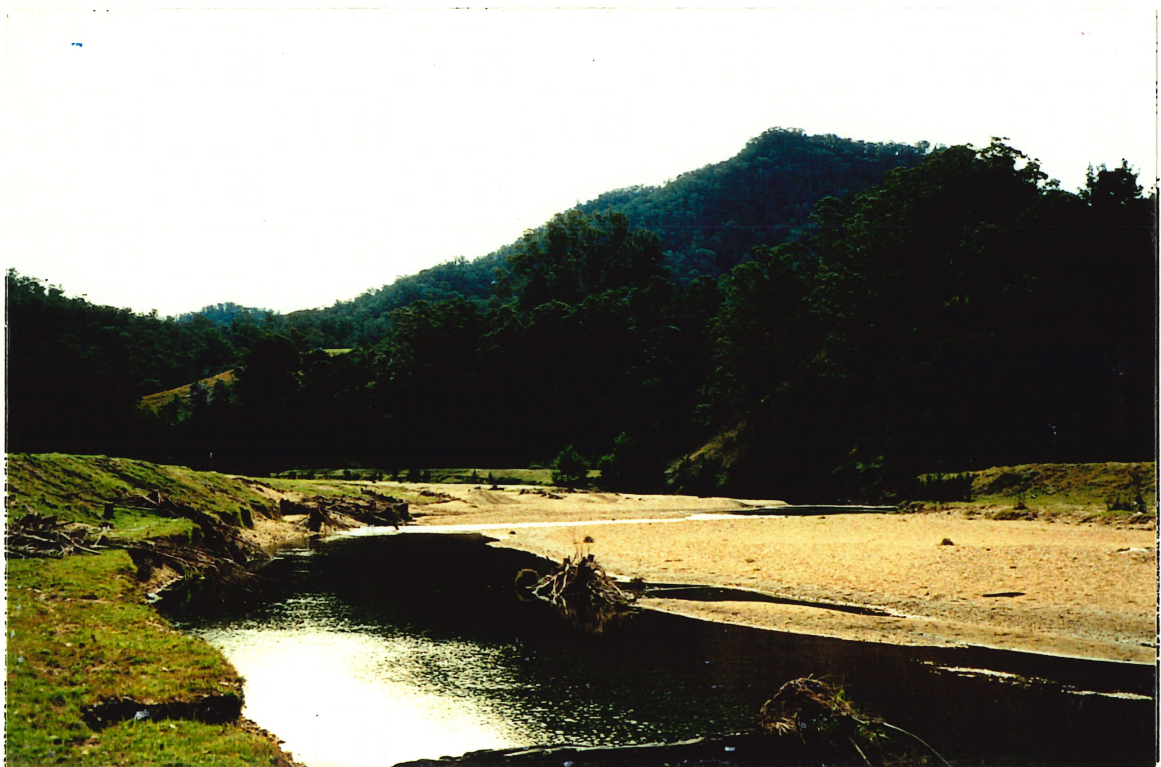
Plate 3.7: Brush groynes constructed at Argent's Hill (N3) on North Arm.
(a) (above) just after construction in April 1996. (b) (below) after the flood of May 1996.

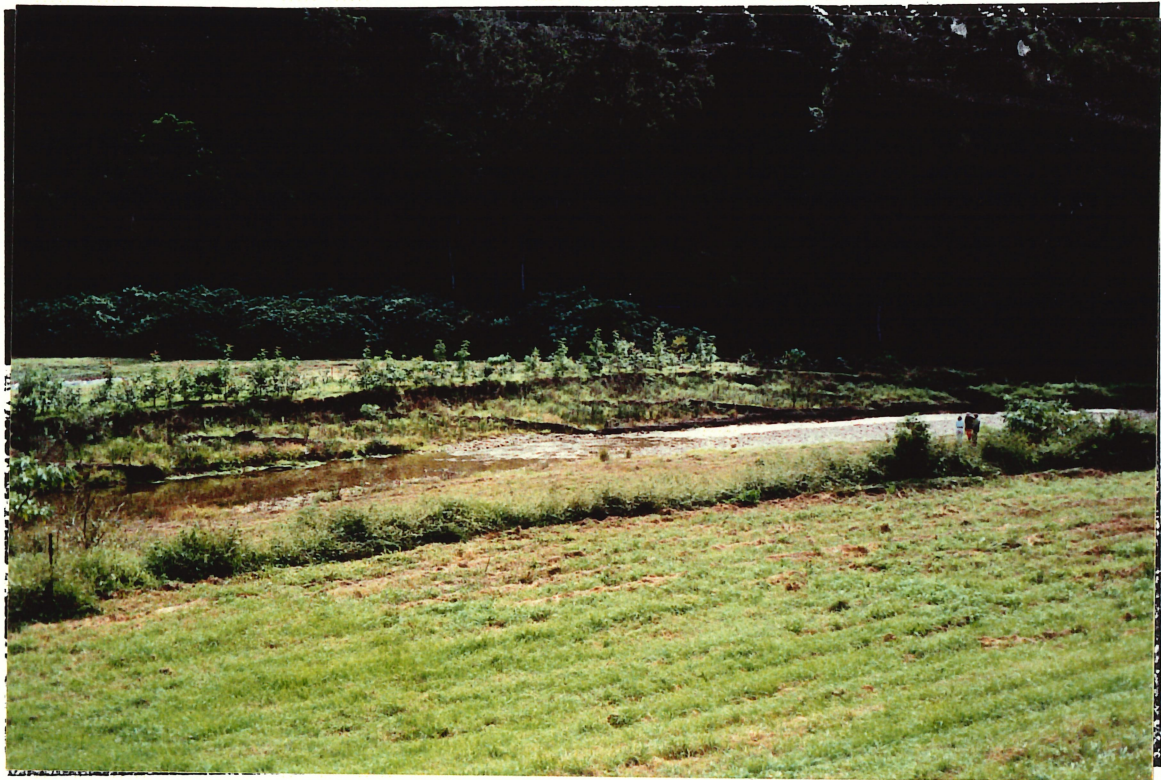
In October 1995 a gravel bench was constructed at the base of the left bank along the 130m reach, with 13 brush groynes made from locally felled casuarinas (Plate 3.8). After

Plate 3.8: Brush groynes on upper North Arm (upstream of N2) in June 1997. These groynes have survived a number of floods since construction in late 1995.

construction, 4000 seedlings were purchased and planted in November and December of 1995. Two floods in January 1996 caused the three brush groynes at the head of the works to scour, requiring minor repairs. The floods deposited silt between the groynes however and allowed a direct seeding trial to start with the site then being irrigated. The works survived the flood of May 1996 which destroyed the brush groynes at Argent's demonstration site further downstream (Plate 4.7). Casuarinas colonising a point bar on the right bank became a problem as the point bar developed towards the centre of the channel. The result was that the three downstream brush groynes became undercut. After a small works grant, the casuarinas were felled and a continuous brush groyne (30m long) was constructed parallel to the undercut bank (Plate 4.8). In November 1996, 230mm of rain over 24hrs on North Arm resulted in a flash flood. The groynes held up very well, the only damage being the loss of some seedlings. During 1997 ongoing maintenance and monitoring of the works have continued. Regular mowing, fertilising and mulching has resulted in excellent growth rates with many trees on the upper bank now about 1.5m in height. In general the site has proved an excellent example for the care and maintenance required of river works after the initial works are emplaced.

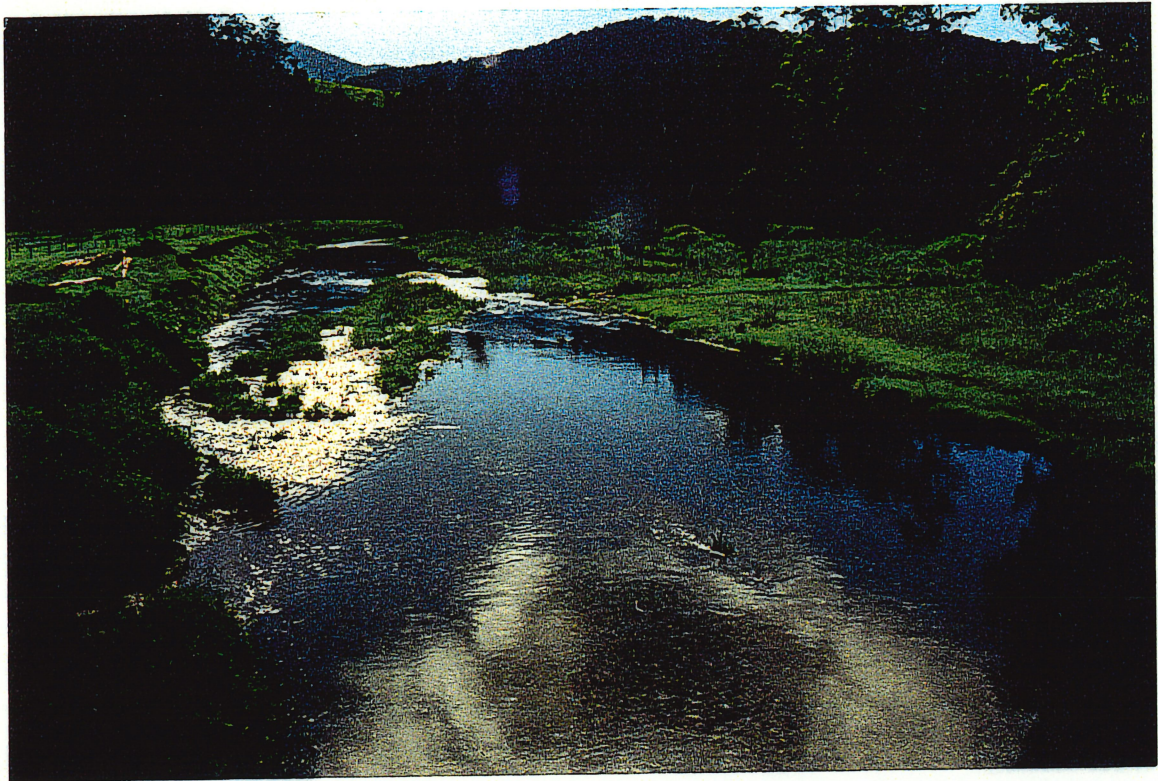
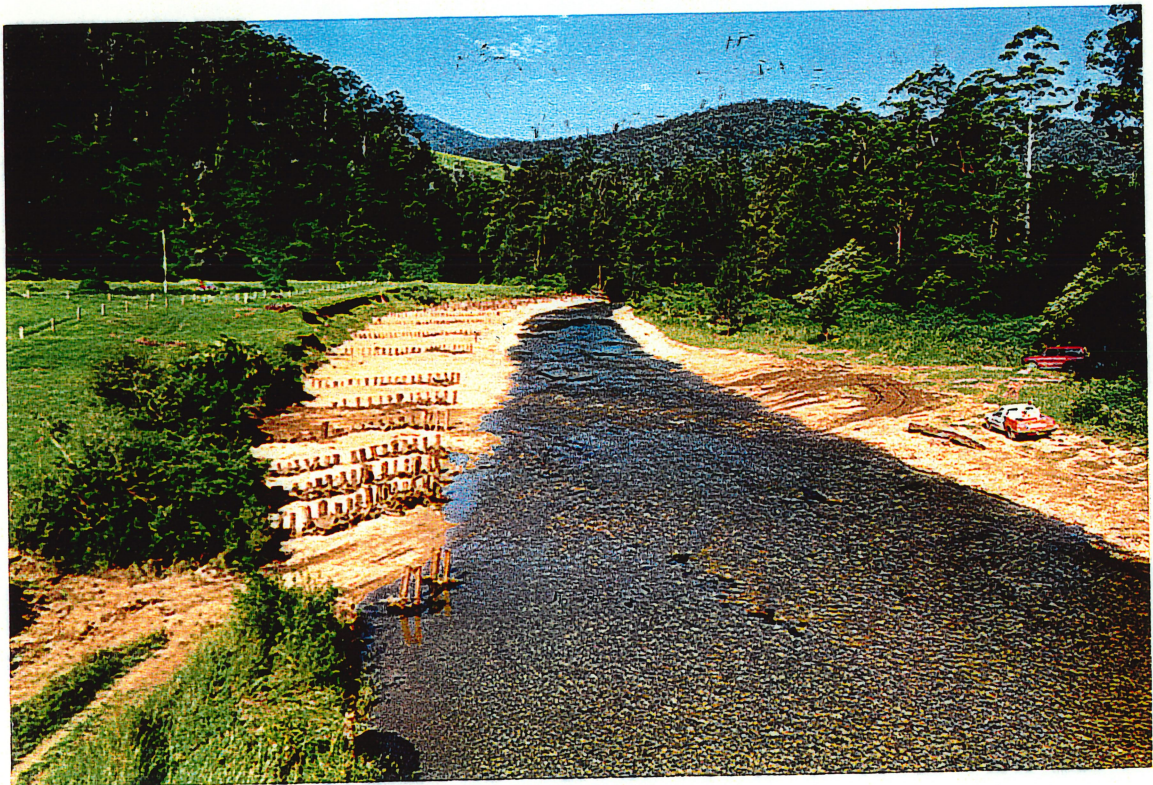
Plate 3.9: Pin groynes on Taylors Arm (between T2 and T3). (a) (above) Eroding bank in February 1996. (b) (below) after pin groyne construction in February 1997.

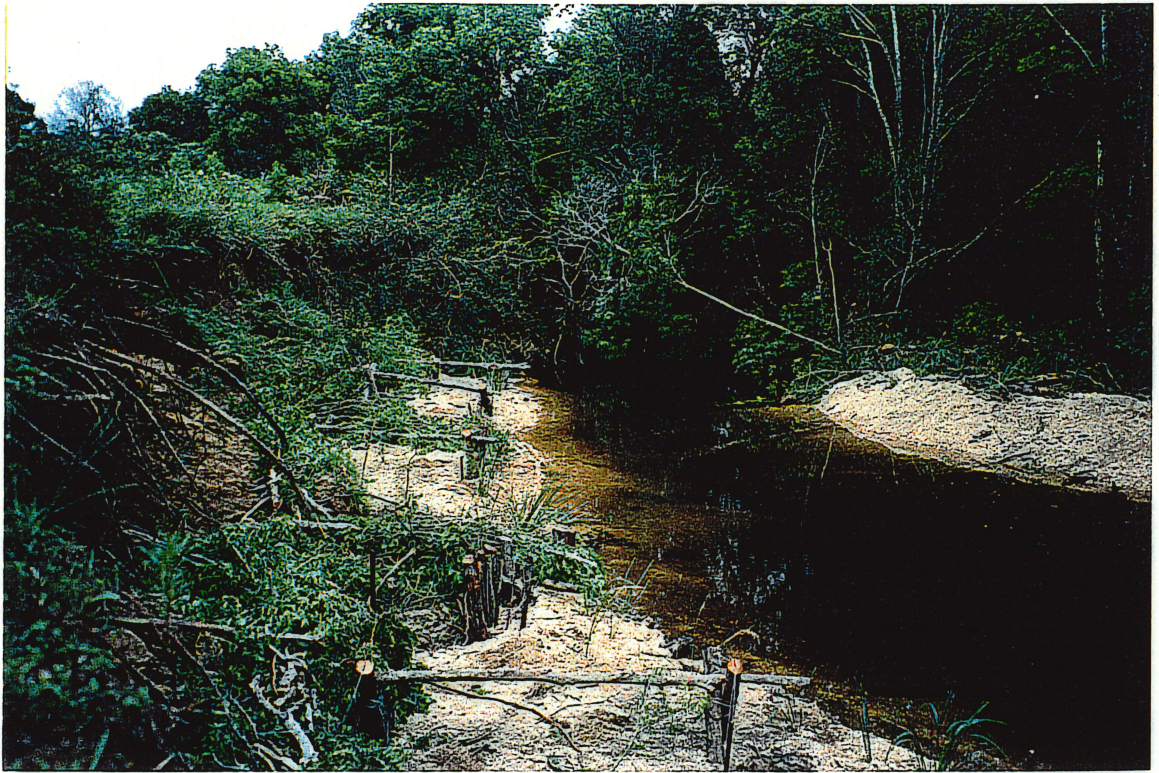
Plate 3.10: Jacks constructed by the Jobskills team at Deep Creek near Valla (upstream of D3). February 1997.

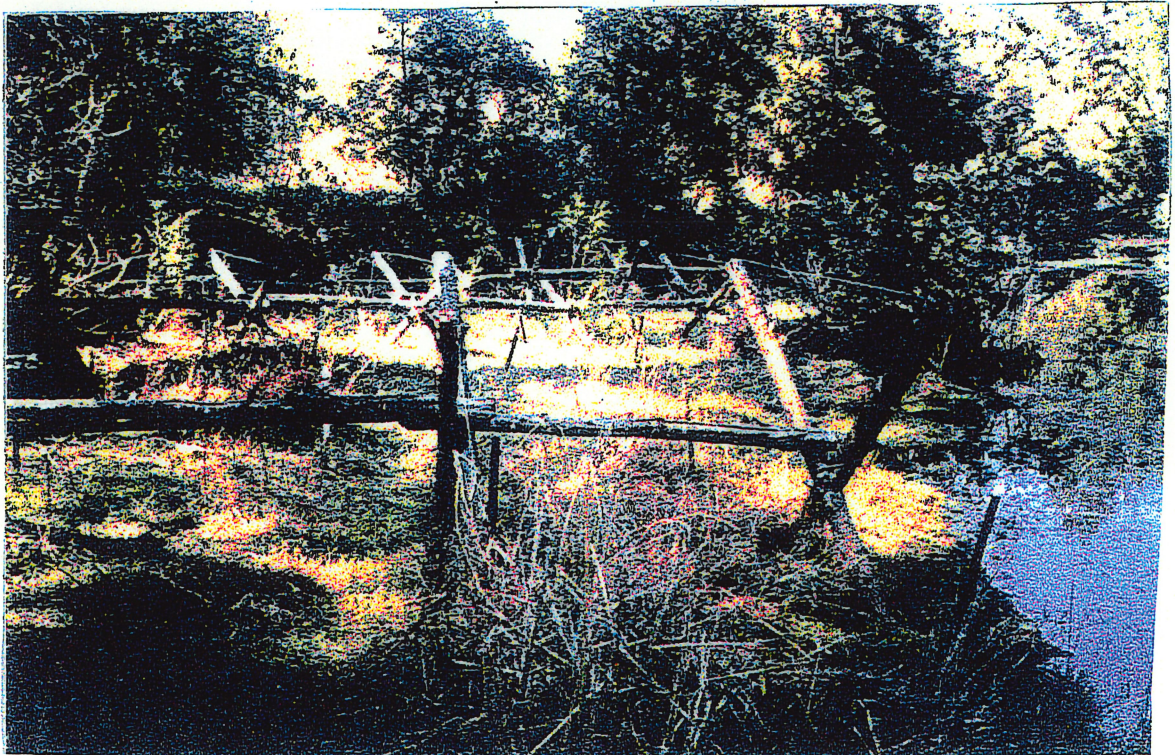
Plate 3.11: Successful jacks field on Taylors Arm downstream of T4. November 1996.

constructed on top of the previous field, allowing the bench to get built higher (see Plate 3.11).

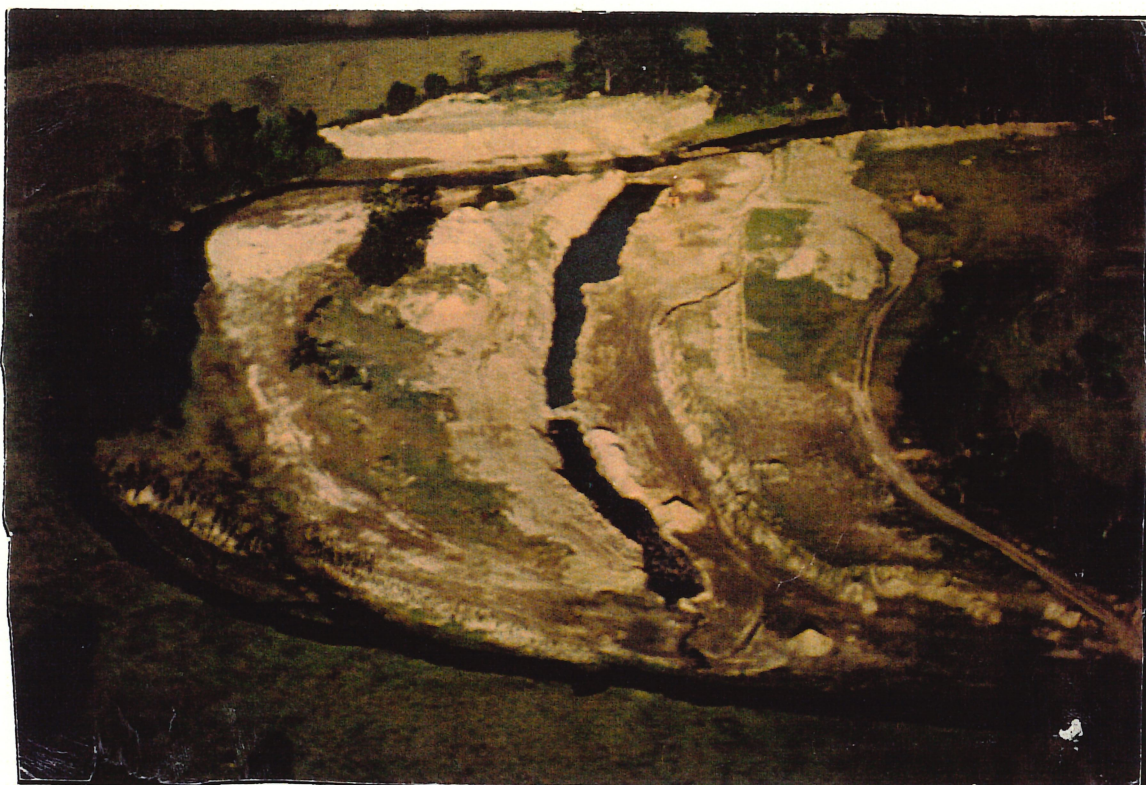
Plate 3.13: Channel realignment on North Arm (downstream of N4) in 1995.

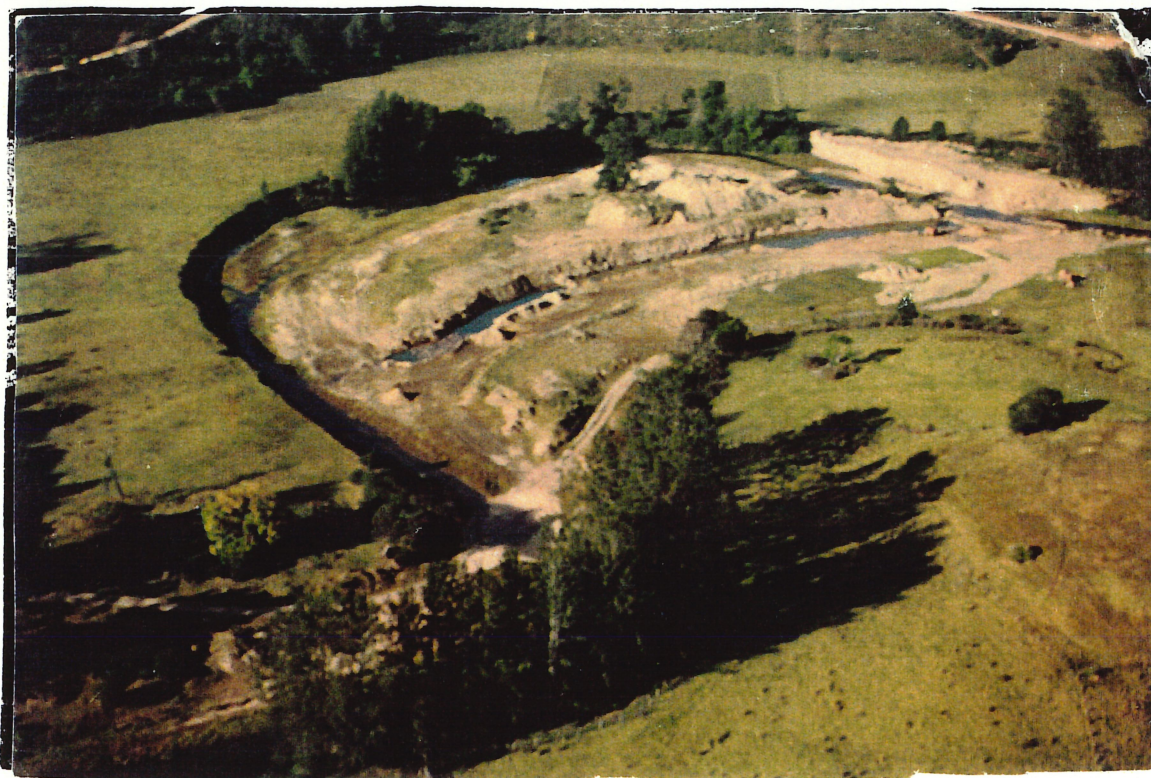
Plate 3.14: View of the gravel extracted from the channel realignment on North Arm in 1995.

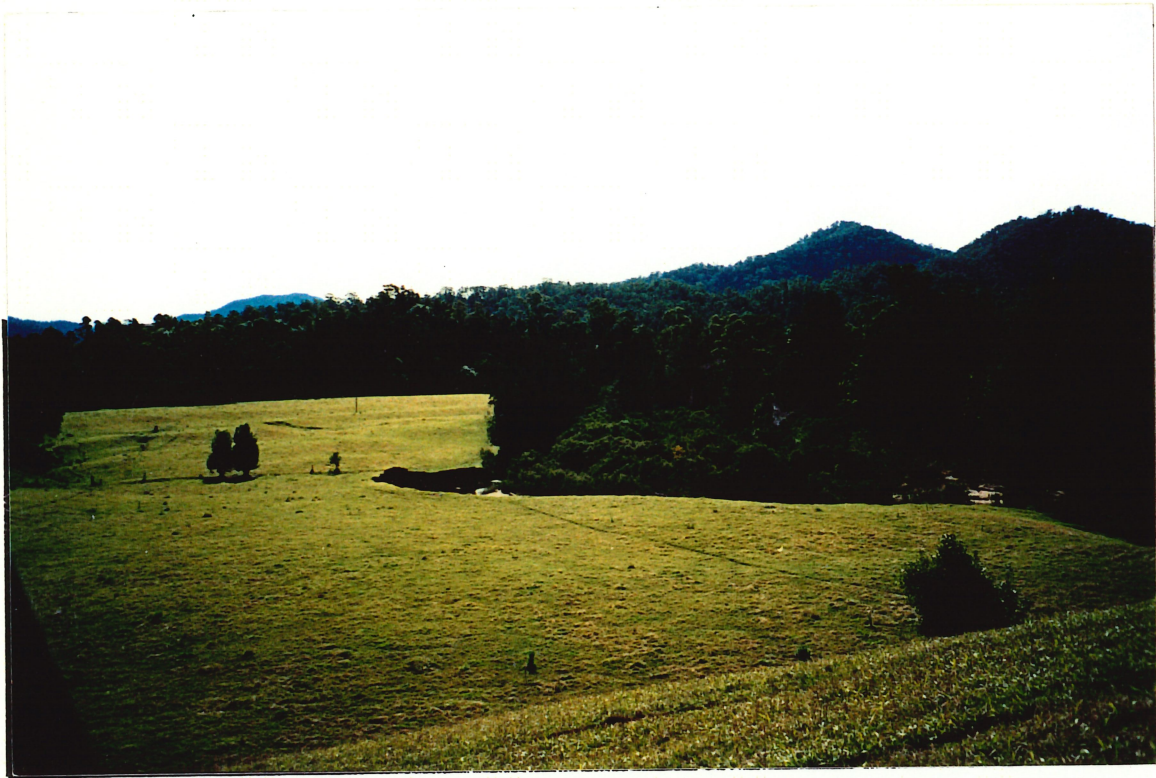
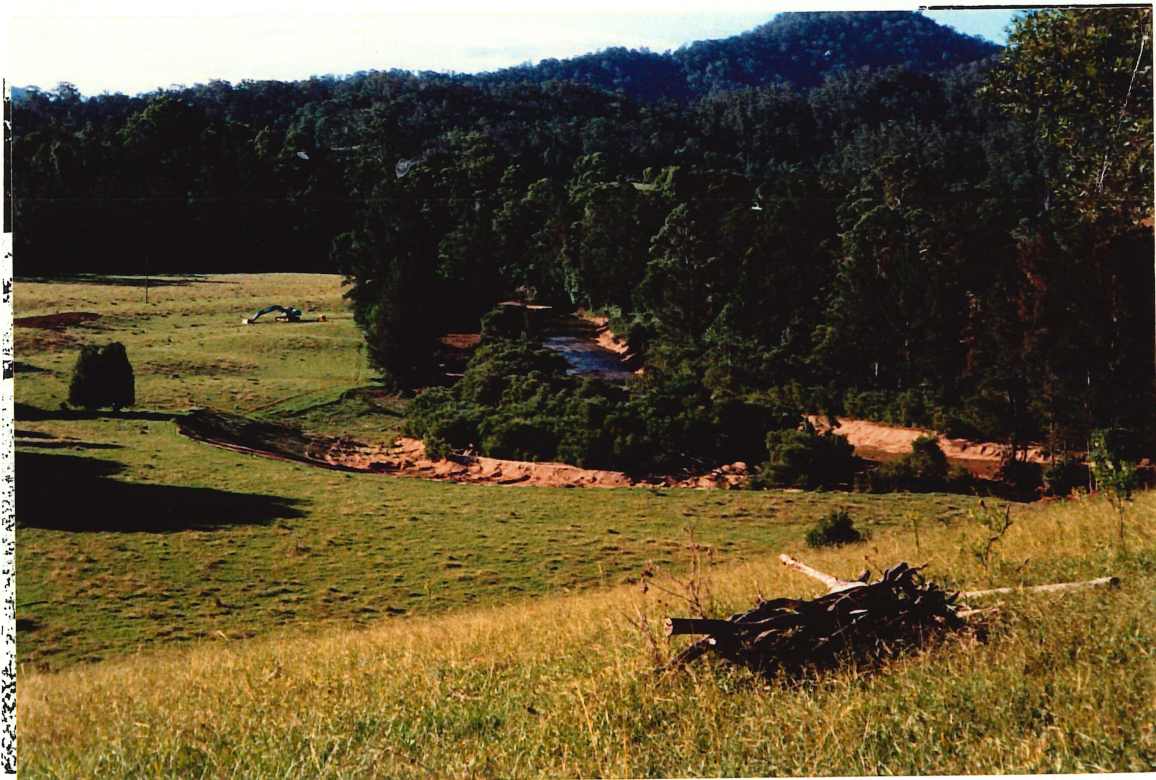
Plate 3.15: Upstream view of an eroded bank on Missabotti Creek (M4). (a) (above) Prior to realignment works in November 1996. (b) (below) after realignment work in June 1997.

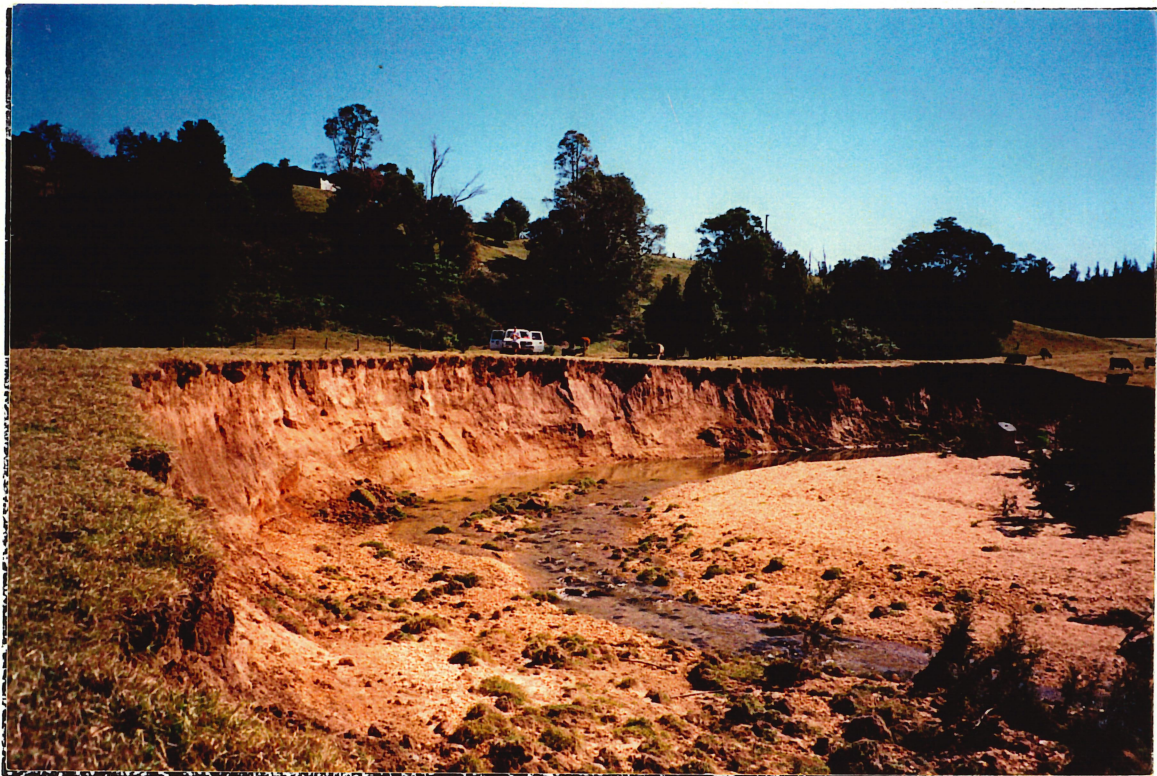
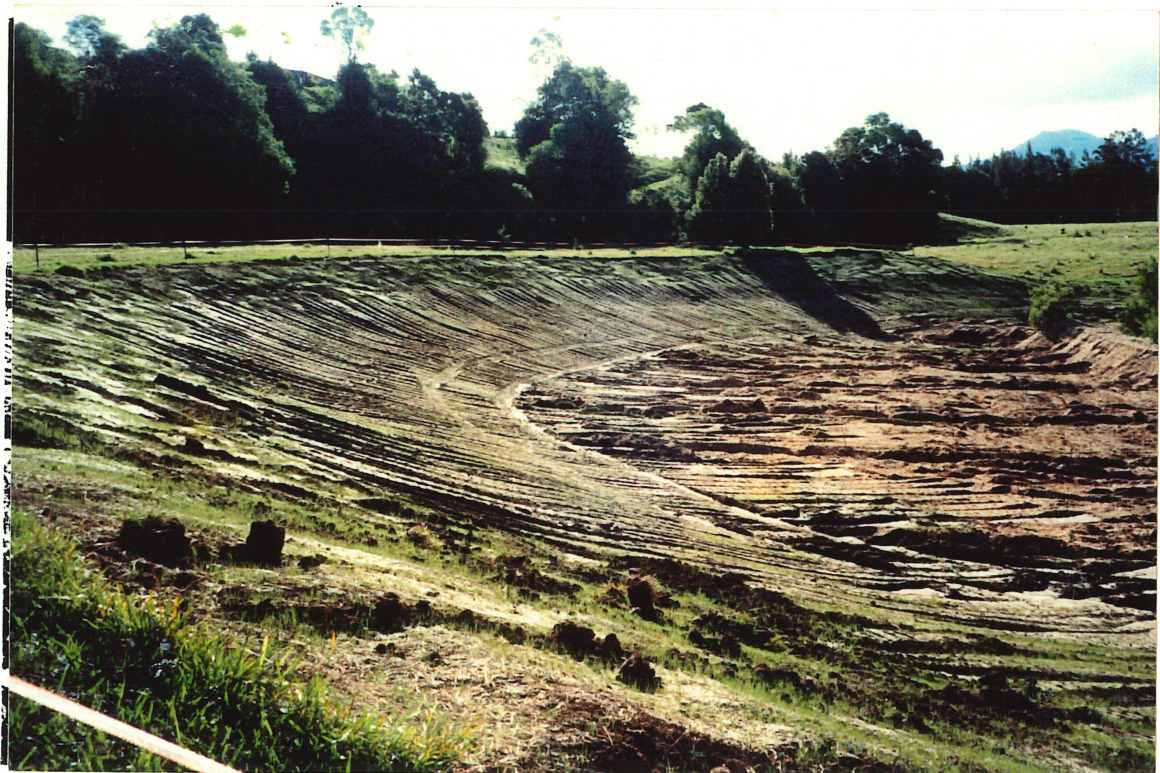
Plate 3.16: Upstream view of an eroded bank on Missabotti Creek (M4). (a) (above) Prior to realignment works in November 1996. (b) (below) after realignment work in April 1997.

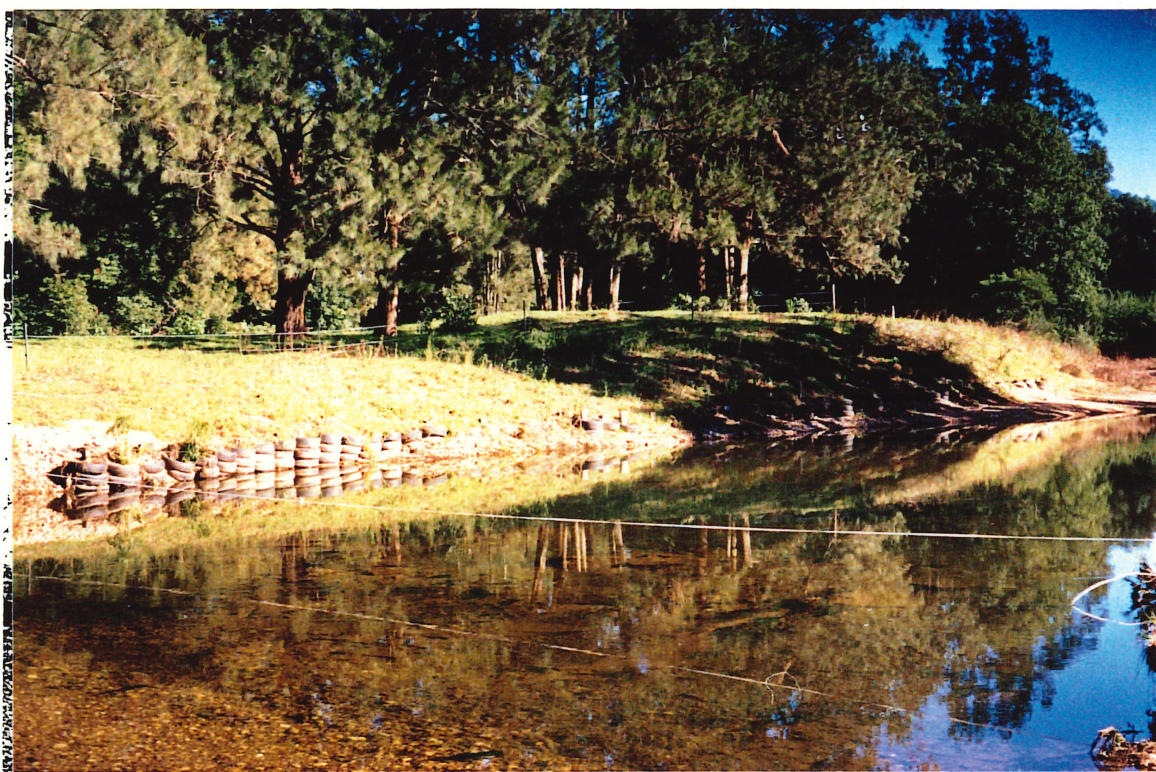
A tyre wall was constructed entirely by the landholder, without financial or government assistance, along two 30m lengths up- and downstream of a vehicle crossing. This reach is relatively straight but was undergoing channel expansion. The reason for this expansion appears to be due to two meander cut-offs that occurred between 1942 and 1991 between sites M2 and M3 (Background Report E). A 0.5-1.0m deep trench was dug along the bank face and wooden pylons were driven one metre beyond the base of the trench. Tyres were then dropped over each pylon, with the bottom two tyres placed below the low water mark in the trench. As each tyre was positioned, it was filled with gravel to weigh it down. It was then tied by wire to the tyre below. Each pylon contained 6-8 tyres with only the top 3 tyres above the ground surface. The pylon spacing allowed each column of tyres to be in contact with the next column to prevent breaching of the wall.

The tyre wall survived several minor floods over a period of twelve months with only minor repairs being needed. During this time there was no further bank retreat. However, the November 1996 flood resulted in flow getting in behind the wall on the upstream side of the vehicle crossing. Scour around the pylons led to the failure of the tyre wall (Plate 3.18) with the majority of tyres washing downstream. The downstream tyre wall has

Plate 3.17: Tyre wall on Missabotti Creek (M3). The wall survived the floods of May 1996.

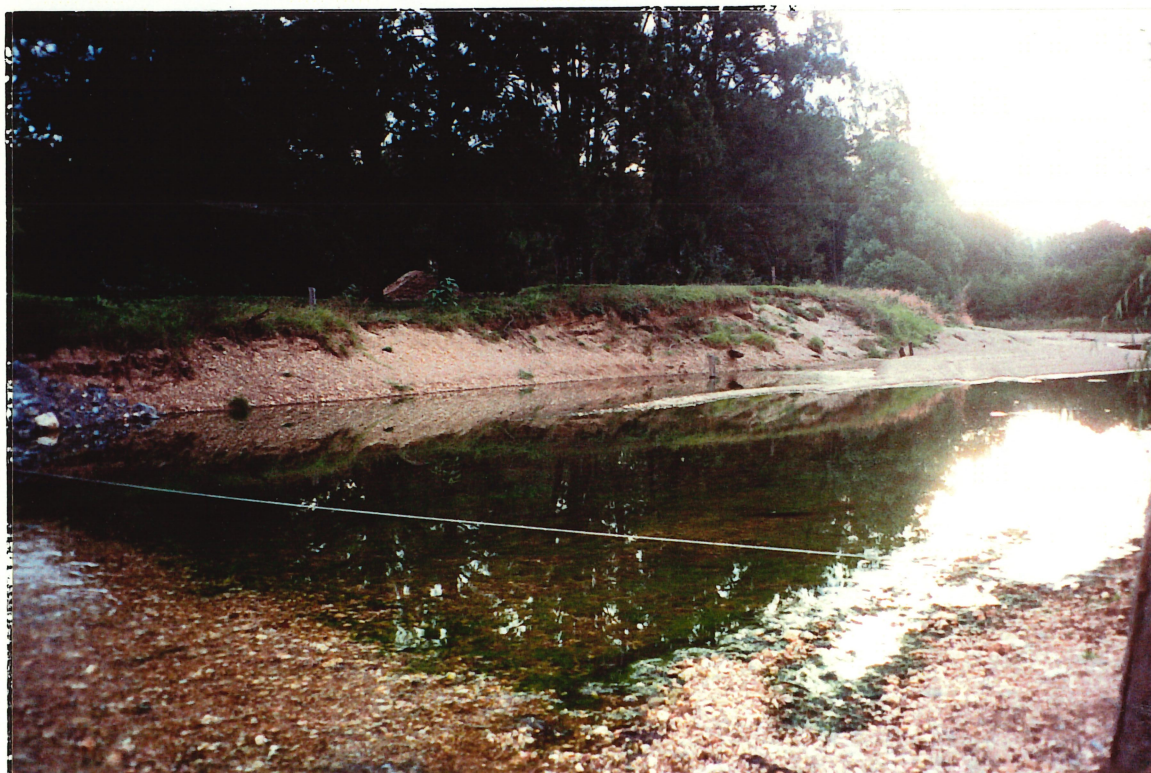
Plate 3.18: View of the failed tyre wall at M3 one year later in June 1997.

remained intact but requires constant repairs as flow has scoured behind it. After each flood gravel is bulldozed behind the wall but invariably is eroded out during the next flood.

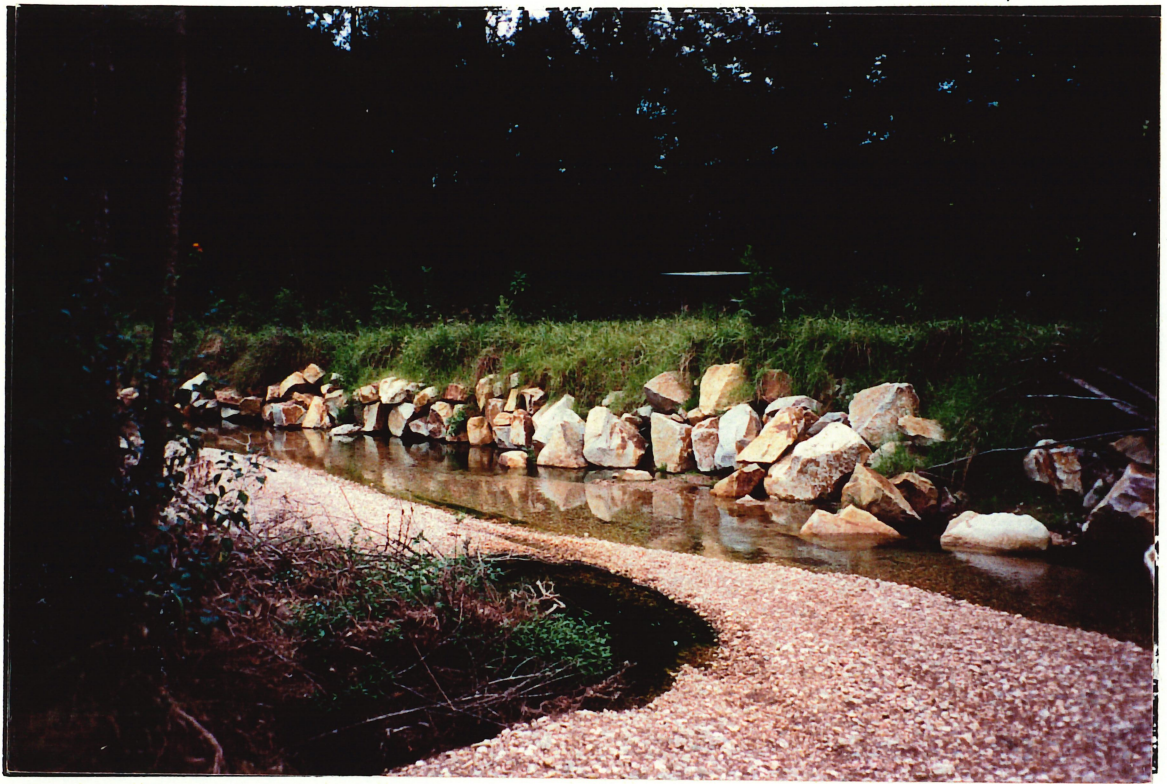
Plate 3.19: Rock wall on Missabotti Creek (between M2 and M3). June 1997.
