Nambucca Valley River and Catchment Management Study

Technical Report F River Management and Rehabilitation

December 1999

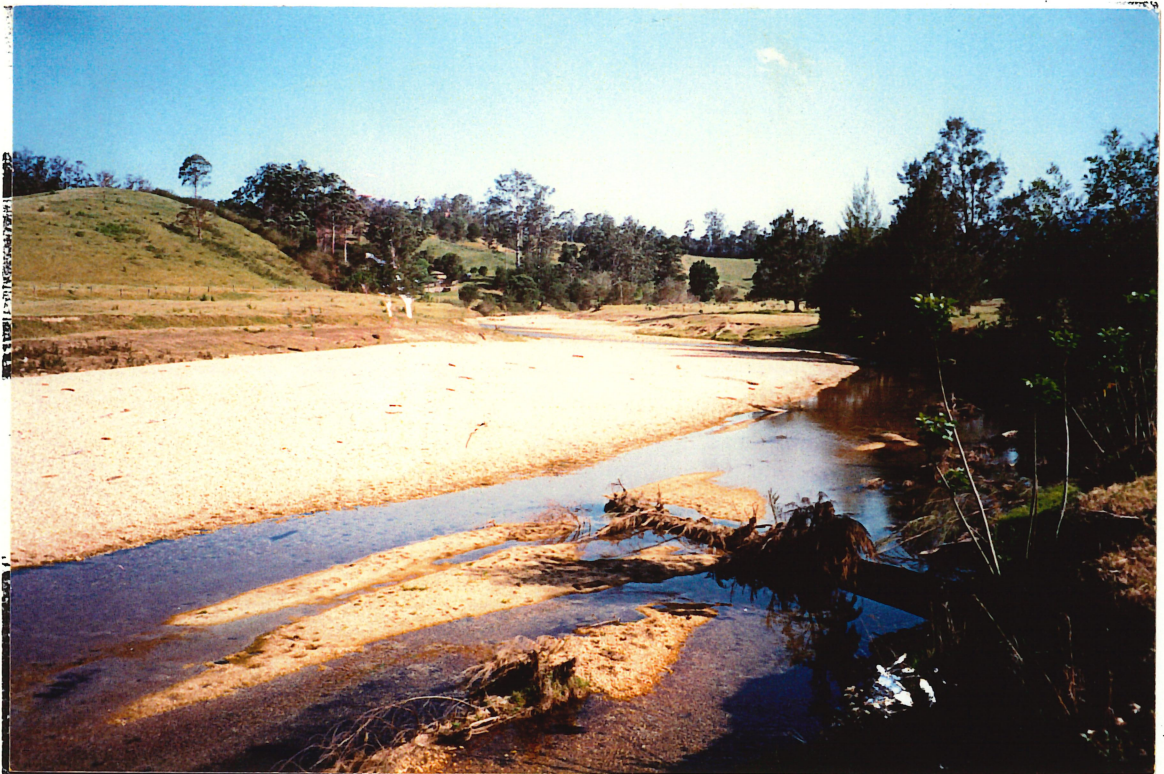
Plate 3.20: Extensive point bar looking upstream on North Arm (N4) in July 1996. Many residents want this type of gravel accumulation removed to ease pressure on the outside bank.

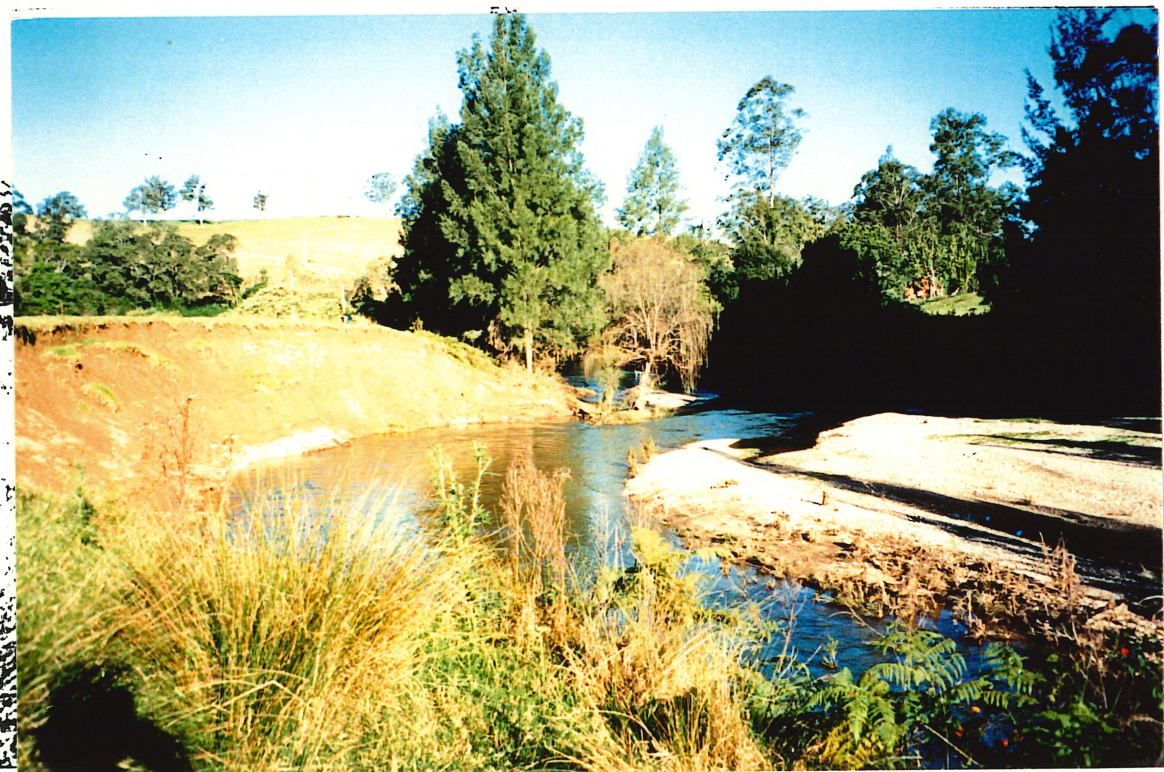
Plate 3.21: Extensive point bar looking upstream on Taylors Arm (T5). July 1996.

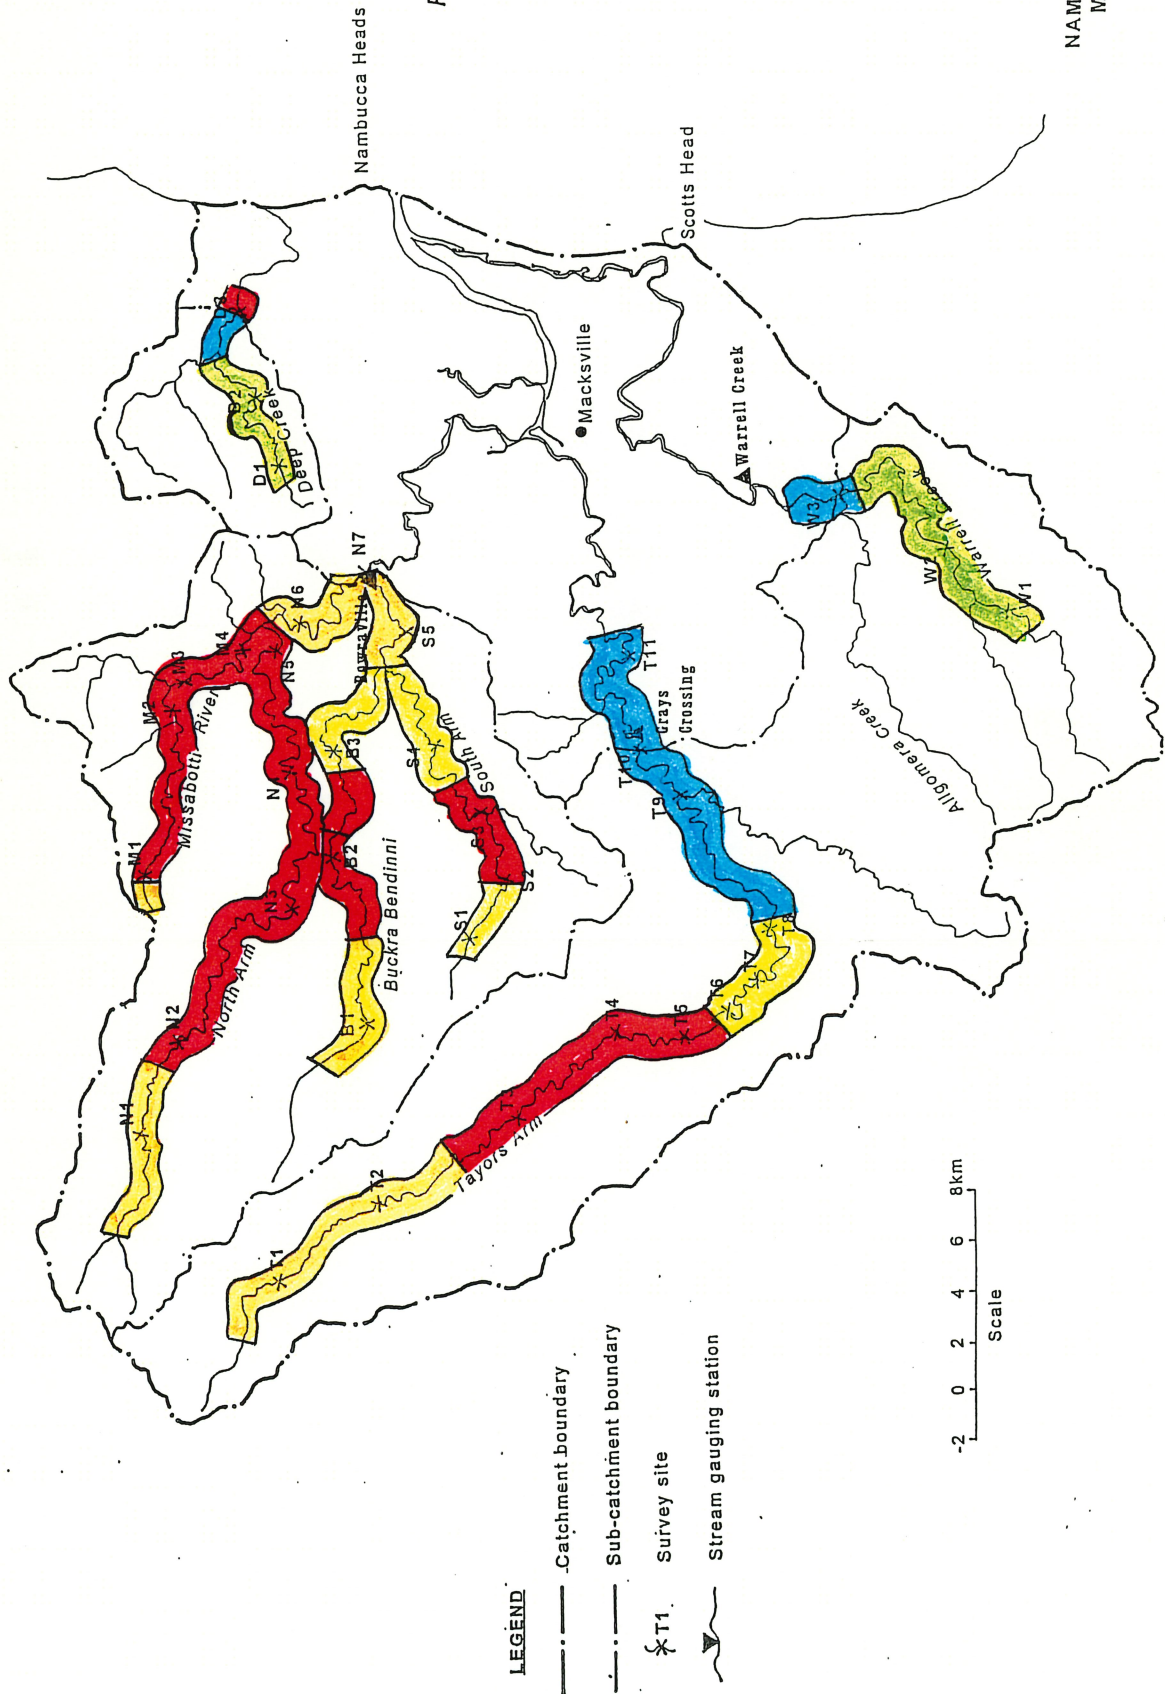
Figure 4.1: Comparative states of degradation of the reaches of the Nambucca Catchment.
