Nambucca Valley River and Catchment Management Study

Technical Report D Riparian Vegetation and Related Issues

December 1999

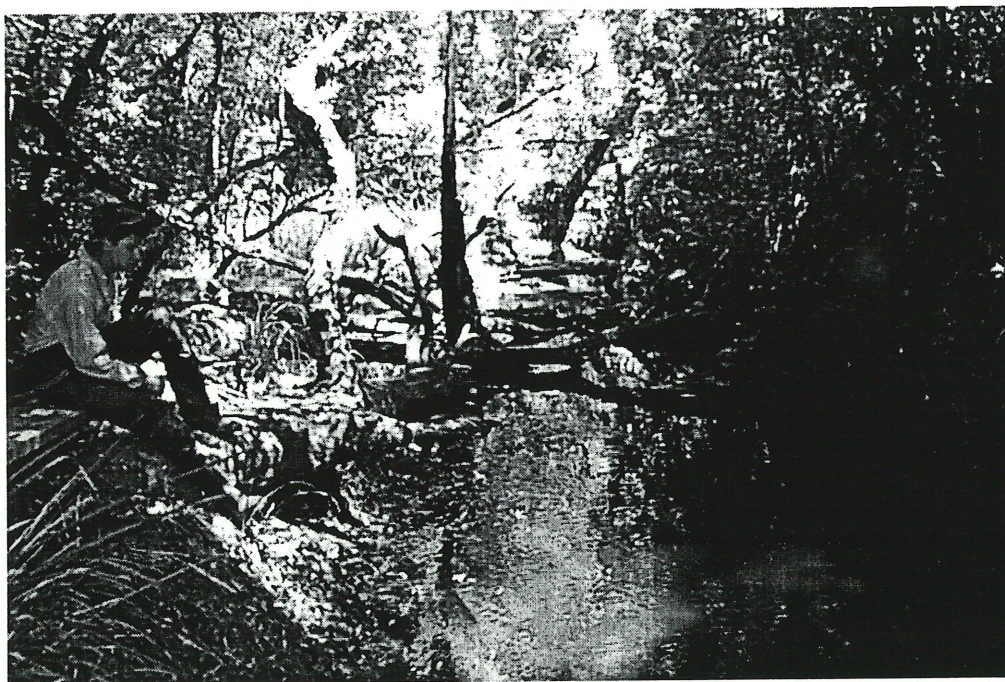
Plate 1: An example of LWD loads in a pristine alluvial river - Thurra River, East Gippsland Vic. at a catchment area of approx. 180km²

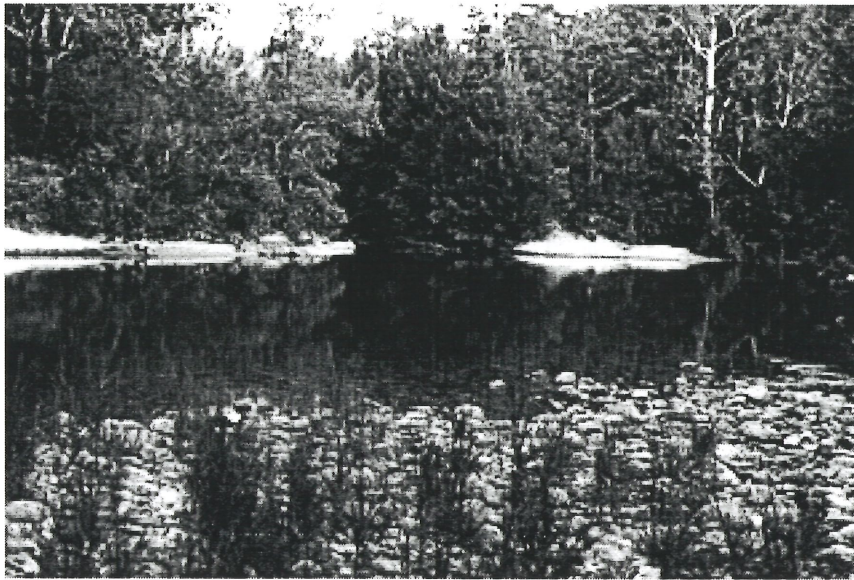
Plate 2: *River Oak colonisation on the relatively pristine upper reaches of Tuross River*

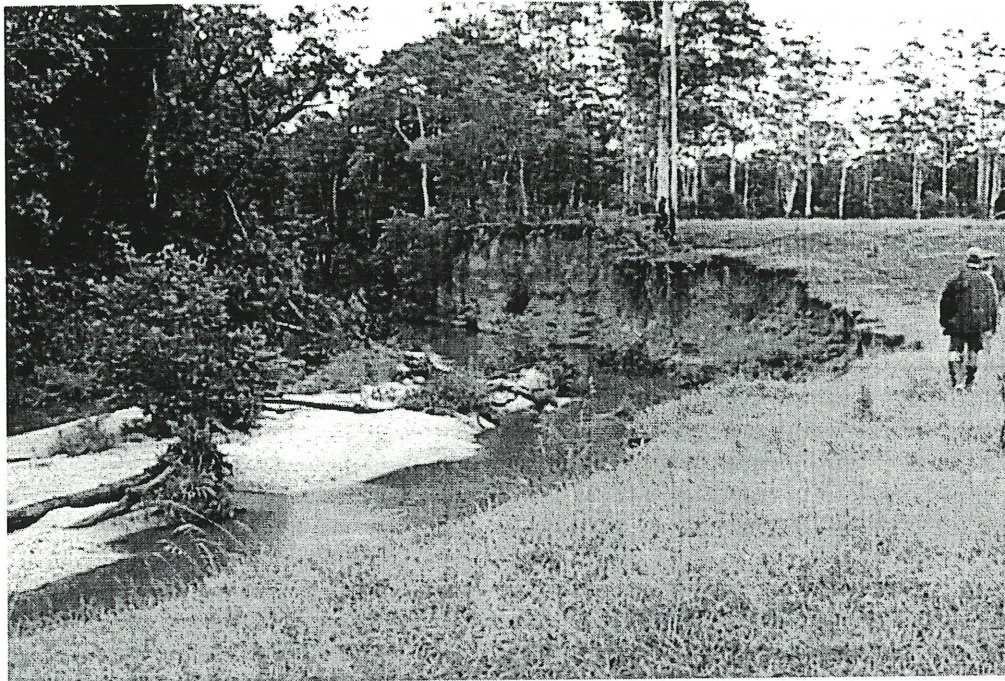
Plate 3: *Protruding tree roots in bank subject to mass failure associated with local bed degradation, Site D3 on Deep Creek*

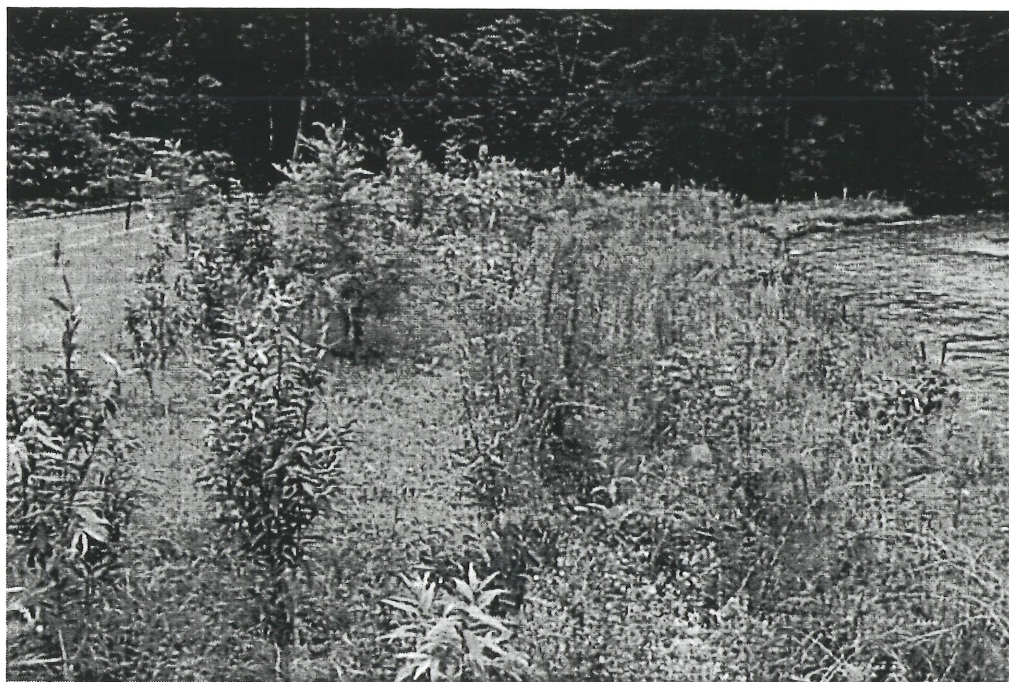
Plate 4: *Apparently successful revegetation and brush groyne works on upper North Arm*

Without wanting to pre-empt the report reviewing the works already in place, in many respects it is probably too early to fully assess the success or otherwise of these works. Provided the banks at these sites are either transitional or sub-critical, bed-load transport is not excessive, and bed degradation is not excessive, these works should be successful.
