Landslides in the Nambucca Shire

Reducing your risk

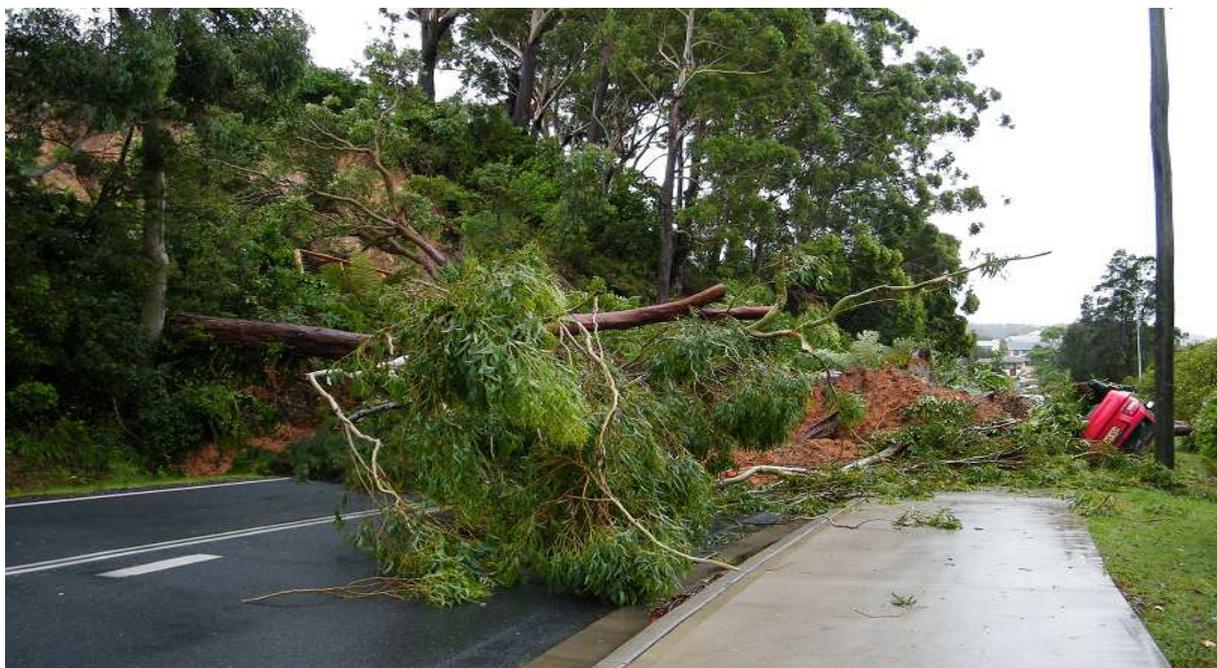
This landslide on Riverside Drive Nambucca Heads took a passing car with it after heavy rains in 2009

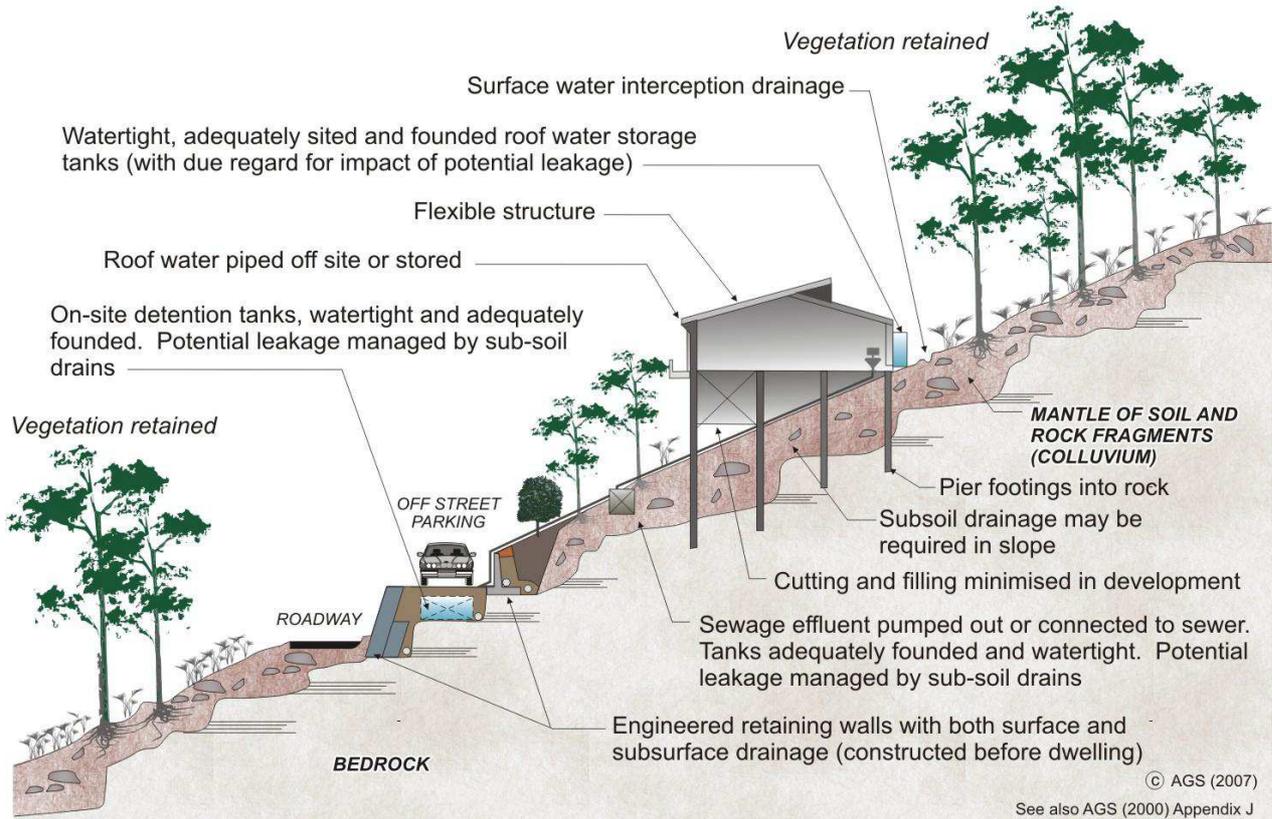
EXAMPLES OF **GOOD** HILLSIDE CONSTRUCTION PRACTICE

- Roadways and parking areas are paved and have kerbs which prevent water discharging straight into the hillside.
- Cuttings are supported by retaining walls.

- Retaining walls are engineer designed to withstand the expected lateral earth pressures and surcharges and include drains to prevent water pressures developing in the backfill. Where the ground slopes steeply down towards the high side of a retaining wall, the force can be two or more times that in level ground.

- Sewage, whether treated or not, is taken away in pipes or contained in properly founded tanks so it cannot soak into the ground.
- Surface water from roofs and other hard surfaces is piped away to a discharge point and not allowed to infiltrate the ground.

- Surface loads are minimised. No fill embankments have been built. The house is a lightweight structure. Foundation loads have been taken down below the level at which a landslide is likely to occur and preferably to rock.

- Flexible structures have been used because they can tolerate a certain amount of movement with minimal signs of distress and maintain their function.

- Vegetation clearance on soil slopes has been minimal as trees and other vegetation take large quantities of water out of the ground each day, which lowers the groundwater table which in turn helps stabilise the slope.

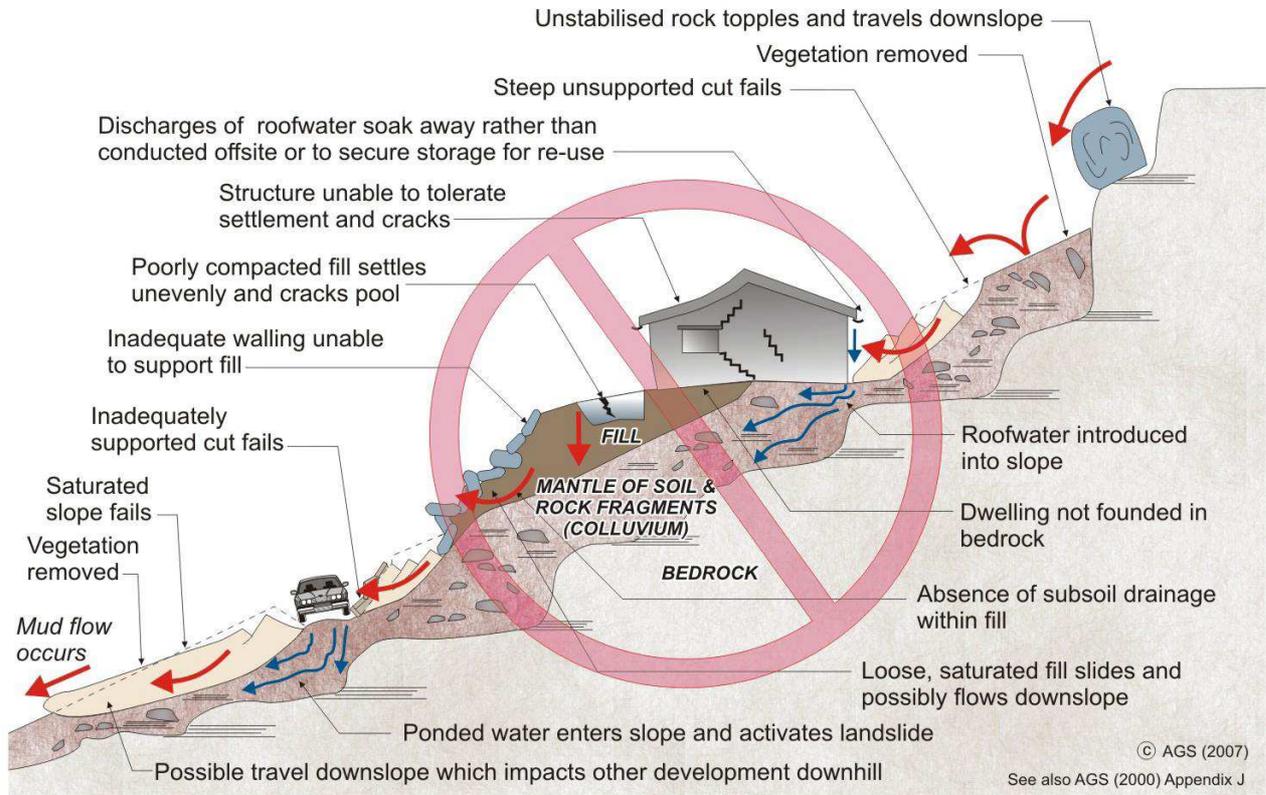
EXAMPLES OF **POOR** HILLSIDE CONSTRUCTION PRACTICE

- Roadways and parking areas are unpaved and don't have proper drains or gutters, causing surface water to pond and soak into the ground.
- Cut and fill has been used to balance earthworks quantities and level the site, leaving unstable cut faces and adding large surface loads to the ground. Failing to properly compact the fill leads to settlement which will continue for several years after construction. The house and pool have been built on the fill and have settled with it and cracked.

- Retaining walls have been avoided to cut cost and hand place rock walls used instead. The walls have not been designed with engineering principles and are likely to fall.

- A heavy, rigid house has been built on shallow, conventional footings. Not only has the brickwork cracked but it is also likely to collapse in a landslide.

- Soak-away drainage has been used for sewage and surface water run-off from roofs and pavements, which soaks into the ground and raises the water table.

- Rock debris from landslides greater up the slope seems likely to pass through the site. Even quite small boulders are likely to weigh many tonnes and do a lot of damage when they begin to roll.

- Vegetation has been completely cleared, leading to a possible rise in the water table.

Poor construction practice is not as unusual as one might expect, usually because they save the developer or the owner money. Dealing with the impacts of these poor practices is likely to be much more expensive than the small savings at the construction stage.
