Nambucca Shire Council
 Bourville Off-River Storage
 Environmental Impact Statement

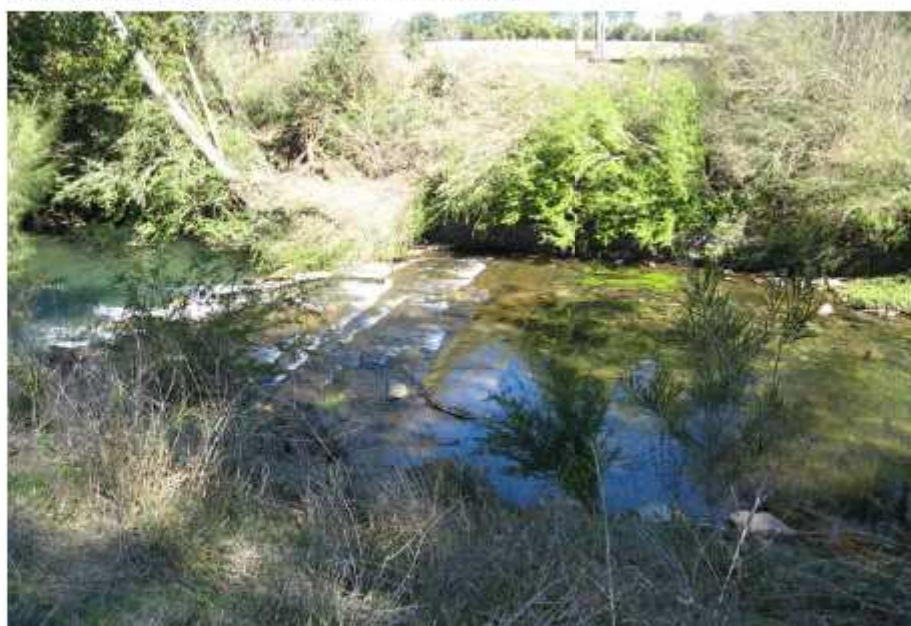
The existing bores located on the true right bank floodplain are linked to the existing headworks via a bed level pipeline crossing. Some of the bores within the existing borefield are located within 20 metres of the channel bank and have the potential to be impacted by future flood events. Bank erosion is also evident adjacent to the existing pipeline crossing. This structure comprises a concrete encased pipe with loose rock placed on the downstream side to restrict scour (Figure 8-3). A vertical drop of approximately 1 to 1.5 metres is exhibited across the overall structure. As a result, the structure acts as a key bed control, maintaining the level of the channel bed in the immediate upstream reach. Hence, given the propensity for the channel to undergo vertical adjustments (Hydroilex, 2008), it is proposed that the crossing be retained.

Figure 8-4 Existing Pipeline Crossing

Instead, to improve fish passage, it is proposed that a fish passage structure and bank revetment works be installed on the true left (western) bank to allow fish to bypass the existing pipeline crossing obstruction in line with the concepts developed by Hydroilex and detailed in Appendix B. Further development of the design for a fish passage and bank revetment would be undertaken in conjunction with the river stabilisation design during the detailed design phase of the Proposal.

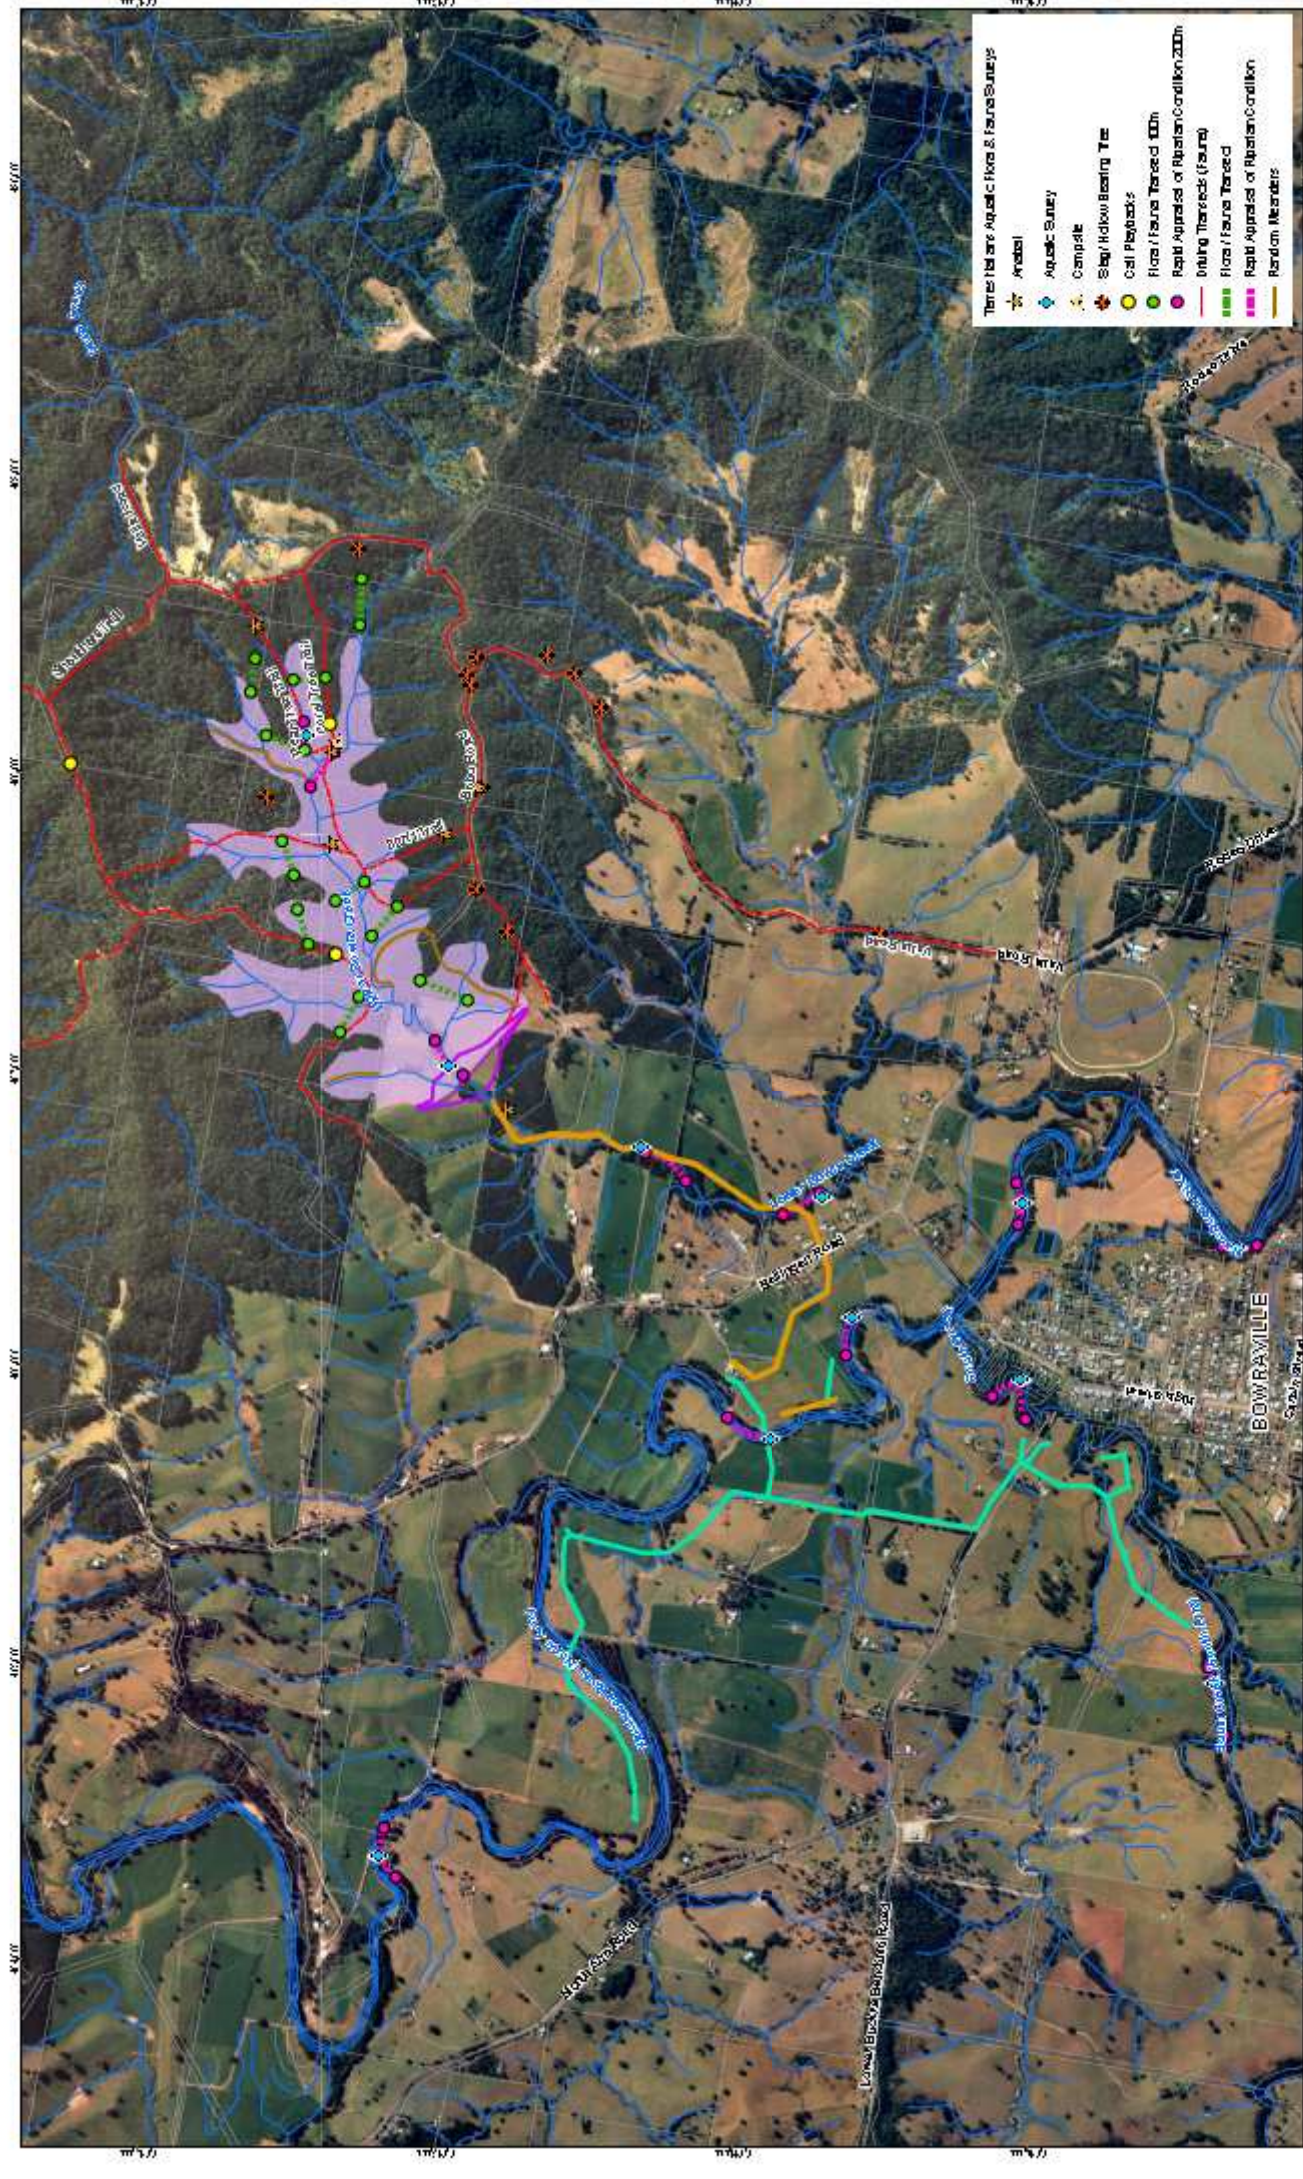
Where applicable, vegetation communities have been classified with reference to *North East New South Wales: Field Key to Forest Ecosystems* (DECCW, 2004). Communities that don't fit these classifications have been classified based on dominant canopy species and floristic structure (i.e. riparian vegetation dominated by Camphor Laurel and Small-leaf Privet). The survey locations in the inundation area were based upon covering the different vegetation communities, as depicted in Biosis's Figure 3 *Vegetation communities present in the study area* (Biosis, 2005). The survey locations of the current study are shown in Figure 9-1.

The vegetation communities recorded are summarised in Table 9-2, whilst the survey locations are shown in Figure 9-1 above and details pertaining to each community are described below. Additionally Table 9-2 summarises the dominant canopy species, approximate areas to be impacted and condition assessment scoring for each vegetation community identified in the study area.

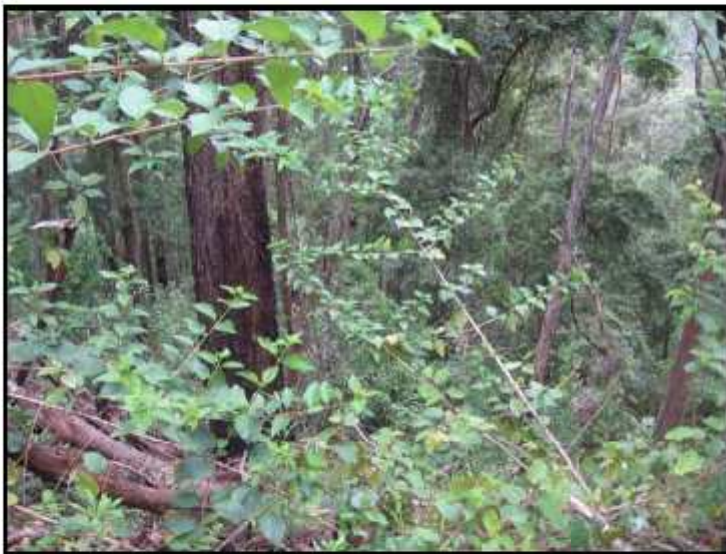
Figure 9-3 Degree of Lantana infestation within the inundation area

Figure 9-3 below depicts the degree of Lantana infestation encountered in the inundation area.

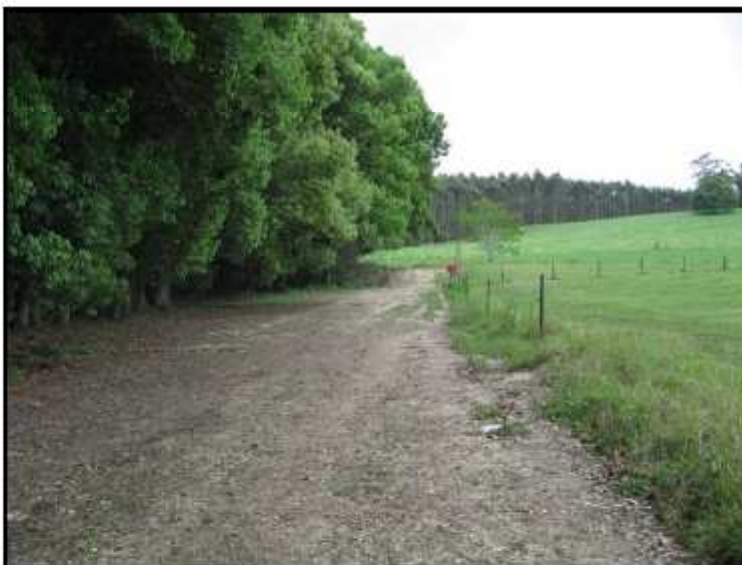
Figure 9-4 Degree of Camphor Laurel infestation along the lower reaches of Bowra Creek

Figure 9-4 depicts Camphor Laurel infestation along the lower reaches of Bowra Creek.

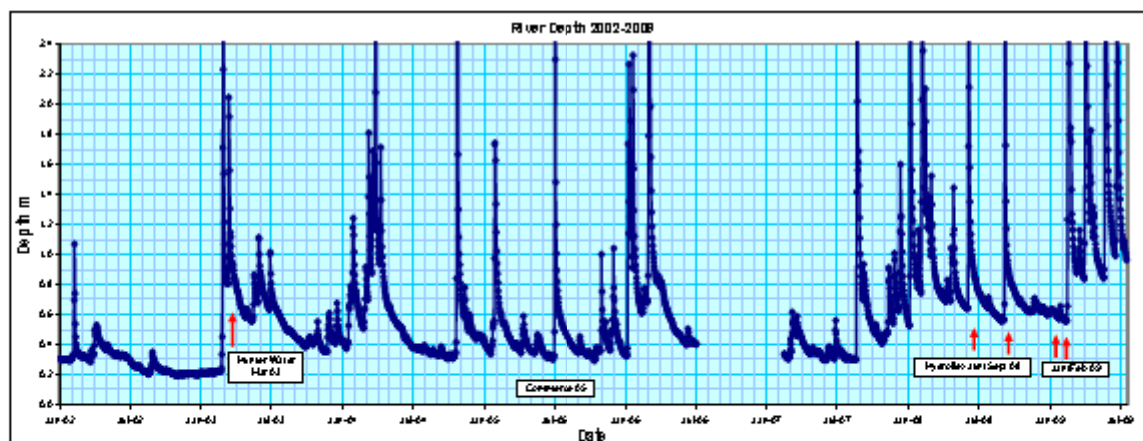
Nambucca River flows are not monitored on a consistent basis, however the river level monitoring gauge at Bowraville (Station ID 205006) does provide a close approximation of river flows. The relatively short duration of peak river flows from storm events (or flooding) between January 2004 and June 2009 (Ref BoM) can be seen in Figure 10-1 below.

Figure 10-1 Nambucca River Levels

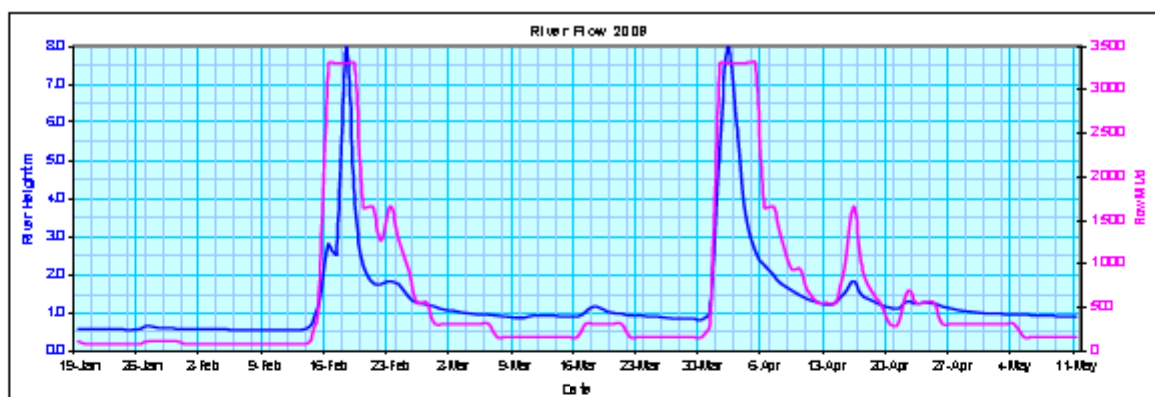
River flows were collected between January and May 2008 and the correlation between river level and volumetric flow (Ref. BoM) is detailed in Figure 10-2 below.

Figure 10-2 River Levels vs Flows

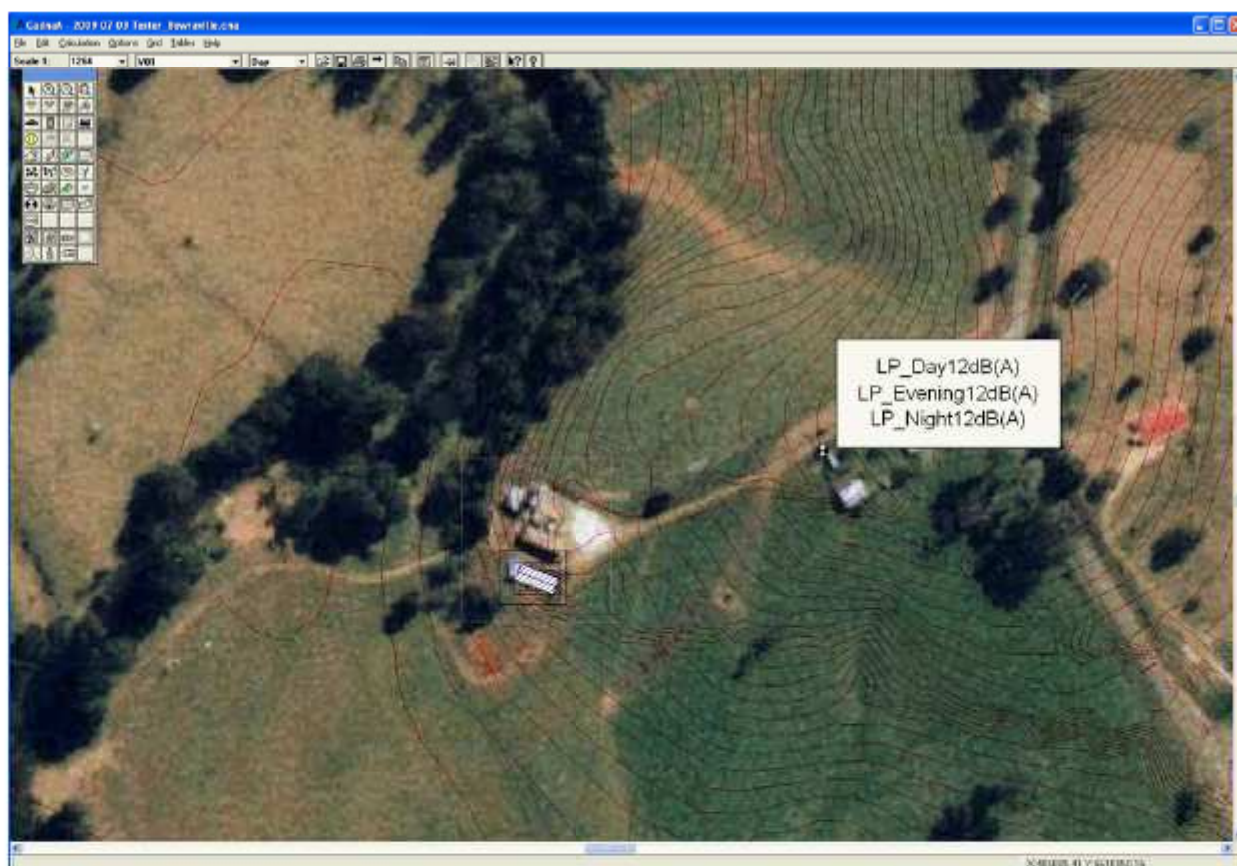
Figure 12-7 Operational Noise Assessment

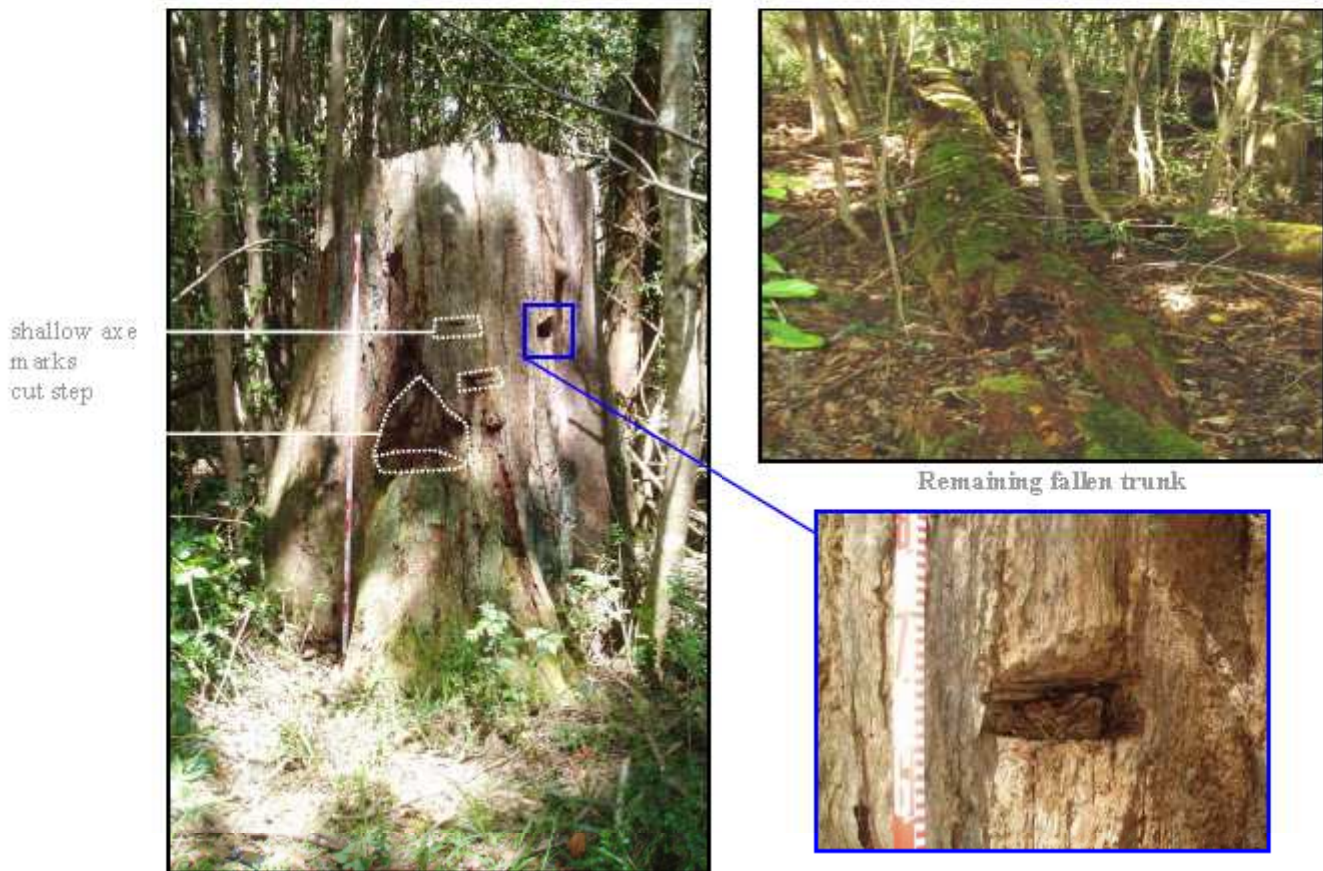
The tree has been felled with a cross-cut saw and cut approximately 2.4 m above the ground. A springboard slot, 16 cm wide, 7 cm high and 12 cm deep is situated 1.6 m above the ground on the eastern face of the stump. Several shallow axe slots occur below this, at 1.4 and 1.5 m above the ground. A step, 60 cm wide and inset 20 cm and 60 cm high has been cut below the shallow axe marks, at 1 m above the ground. Another springboard slot, 16 cm wide, 5 cm high and 6 cm deep has been cut on the southern stump face, approximately 1.7 m above the ground, with a shallow axe mark also placed next to it 40 cm to the left. Some 20 cm above the slot is cut bench, 50 cm wide and 20 cm deep. A long section of now rotten tree trunk is situated 15 m away from the stump.

Figure 14-1 NWSH1 – Forestry stump and felled trunk, with detail of springboard slot.

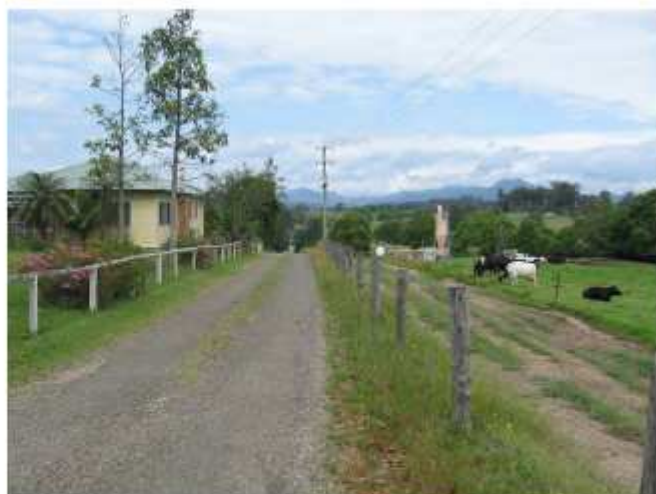
Generally the available sight distance to the north considerably exceeds the sight distance requirements for an approach speed of 80 km/h. To the south, where vehicle speeds would not be greater than 60 km/h the sight distance also meets the 80 km/h requirement even though the sight line is restricted by vegetation on the inside of a curve. With minor clearing an extra 30m of sight distance would be attainable. Figure 15-3 shows the headworks access whilst Figure 15-4 illustrates the sight distance towards Bowraville from the access.

Figure 15-3 Access lane to Headworks

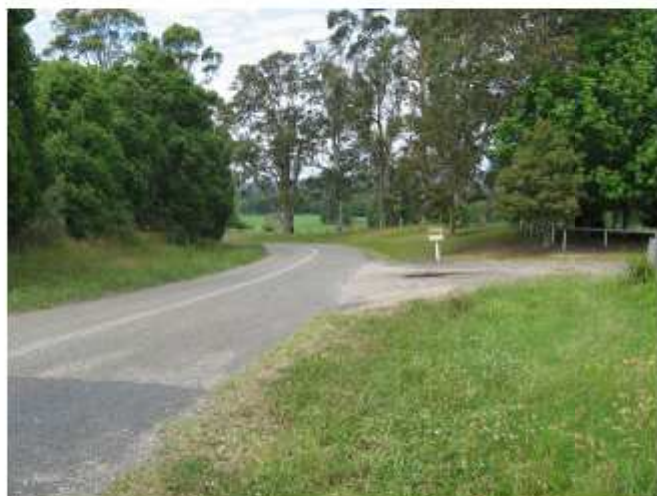
Figure 15-4 Headworks access sight line toward Bowraville

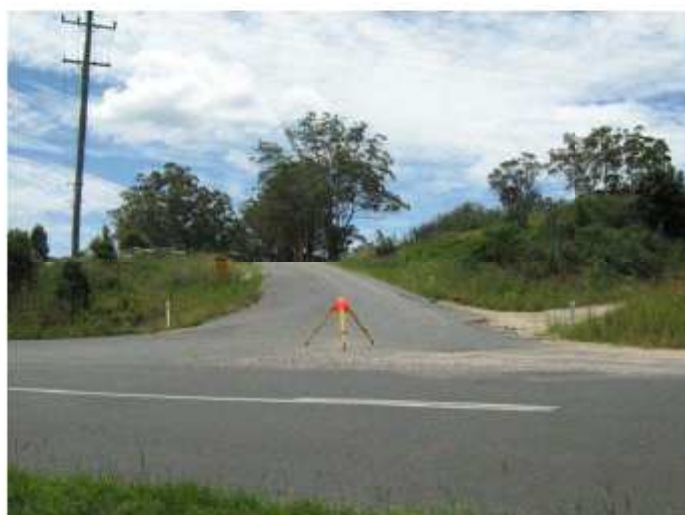
Valla Road currently provides the most readily accessible route to the storage site. It forms a T-junction with Rodeo Drive opposite the Bowraville Showground. A photo of the intersection is shown below. The sealed pavement ends just beyond the crest shown in the photo below, 70m from Rodeo Drive. "Turning Trucks" and a "Gravel Road with Loose Surface" signage indicates the conditions that may be encountered further along Valla Road.

Figure 15-5 Current condition of the intersection of Valla Road with Rodeo Drive

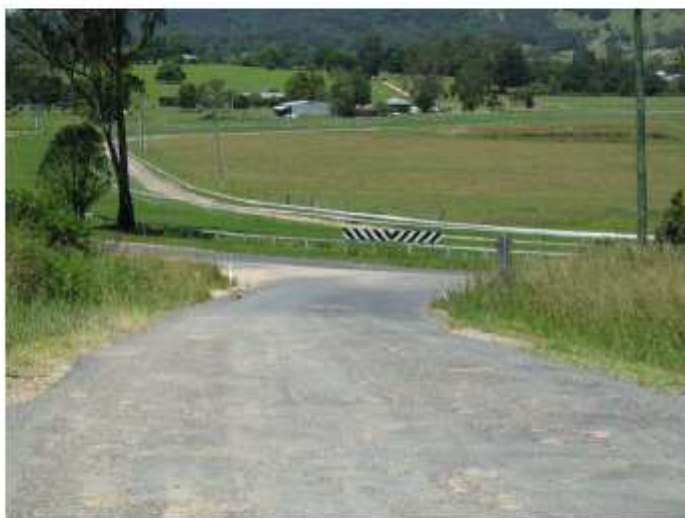
Therefore, it is considered that the intersection would provide satisfactory access to the storage site via this route for light vehicles. The increased usage of the intersection would warrant the installation of intersection warning signs on both approaches in Rodeo Drive. Figure 15-6, Figure 15-7 and Figure 15-8 illustrate the approaches to the intersection from Valla Road, from Macksville and from Bowraville respectively.

Figure 15-6 Valla Road approach to Rodeo Drive

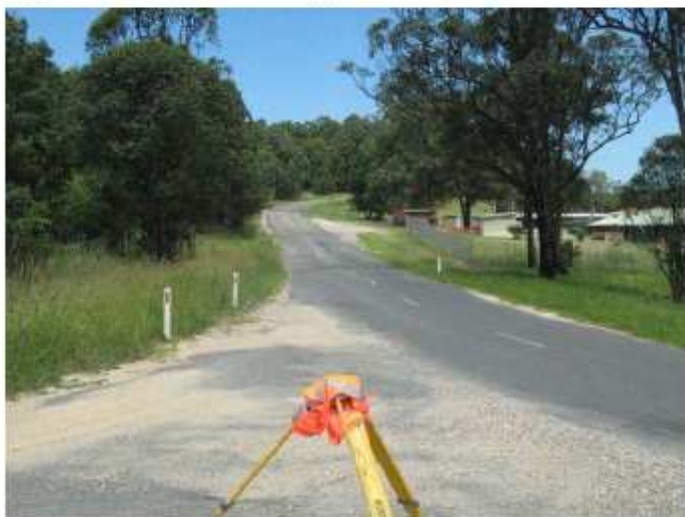
Given that vehicles approaching from Bowraville enter the available sight distance 60m after exiting the 60 km/h urban speed zone, the design approach speed could be considered to be say 80 km/h. For 80 km/h the minimum SISD is 170m and the desirable ASD is 114m.

Figure 15-7 Valla Road intersection sight line toward Macksville

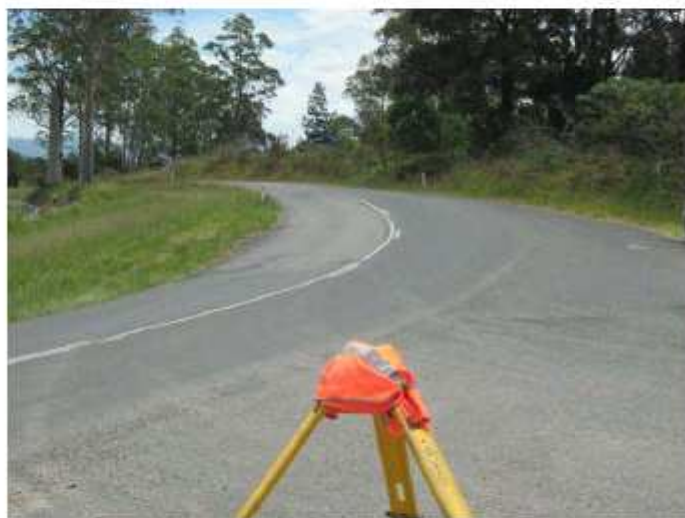
Figure 15-8 Valla Road Intersection sight line toward Bowraville

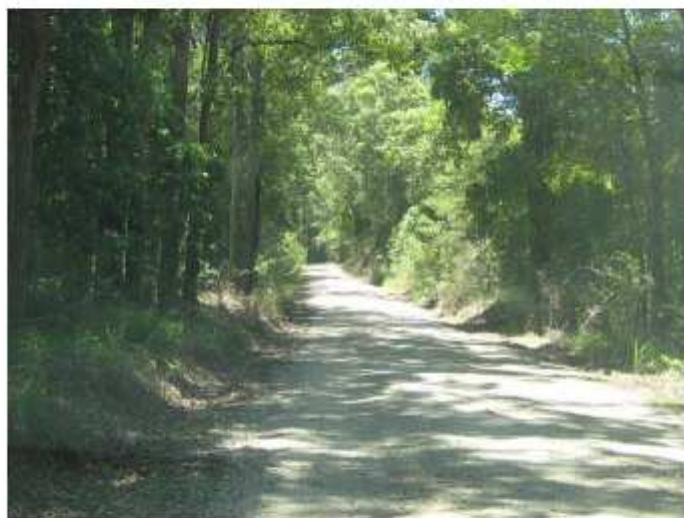
Advice from NSC is that the use of Valla Road for the cartage of construction materials south of Marriott's Quarry is not permitted. Figure 15-9 shows the typical pavement and roadside conditions along Valla Road.

Figure 15-9 Valla Road - typical view of pavement and roadside conditions

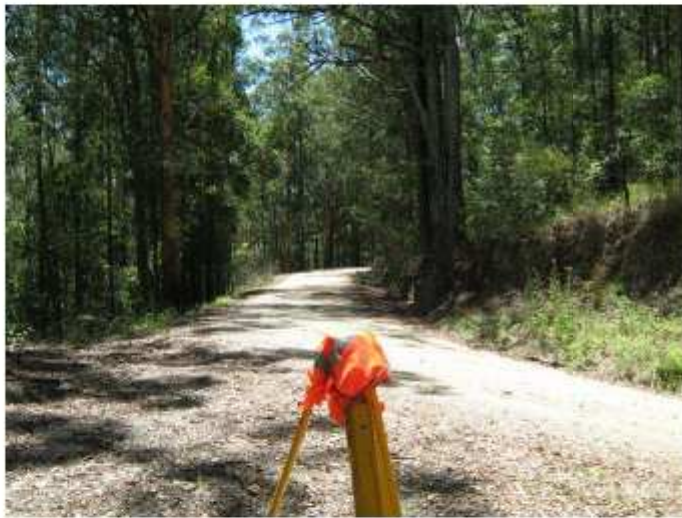
The use of the Bobo Road to enable heavy vehicles and long loads to access the storage site would require the implementation of traffic control measures during the work period to ensure that conflicts do not arise when the intersection is obstructed by large turning vehicles. It would be expected that the implementation of traffic controls would be an integral part of the worksite Traffic Management Plan for the project. Figure 15-10 and Figure 15-11 illustrate the sight lines available from the Bobo/ Valla Road intersection.

Figure 15-10 Sight line north along Valla Road

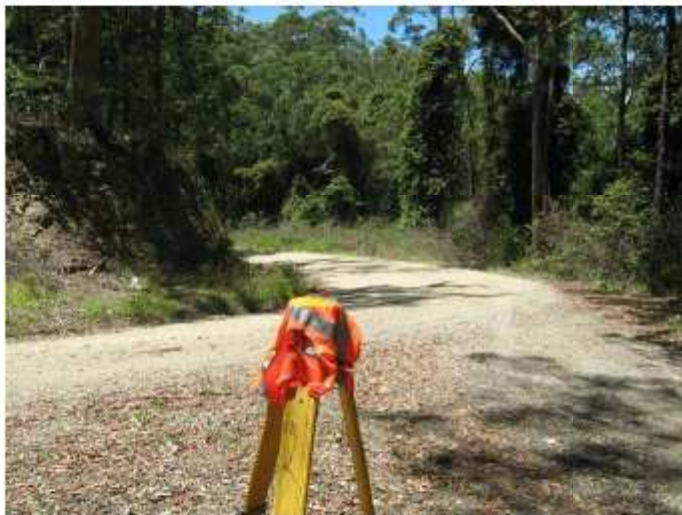
Figure 15-11 Sight line south along Valla Road

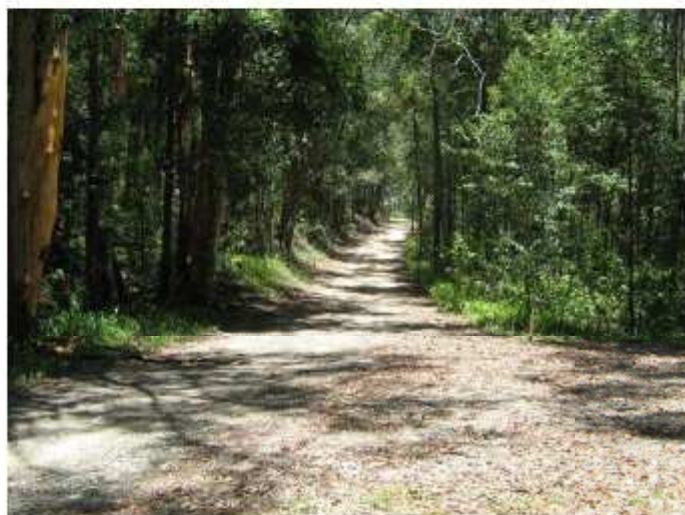
In its current form the track would not be suitable for site access for either workmen or for deliveries of plant and materials. Figure 15-12 shows the current condition of Bobo Road.

Figure 15-12 Eastern end of Bobo Road looking from Valla Road

It is anticipated the preferred site access would be via this link road from Valla Road. To be suitable for access during construction Bobo Road would need to be upgraded to a 6 metre formation with 3 metre wide bitumen seal. NSC's current standards for such works, as contained in Development Control Plan No 4 – Subdivision, are expected to be suitable for upgrading of the road to suit construction traffic and for the occasional post construction visitors to the storage.
