Nambucca District Water Supply Environmental Impact Assessment

Cultural Heritage Assessment of Ancillary Areas

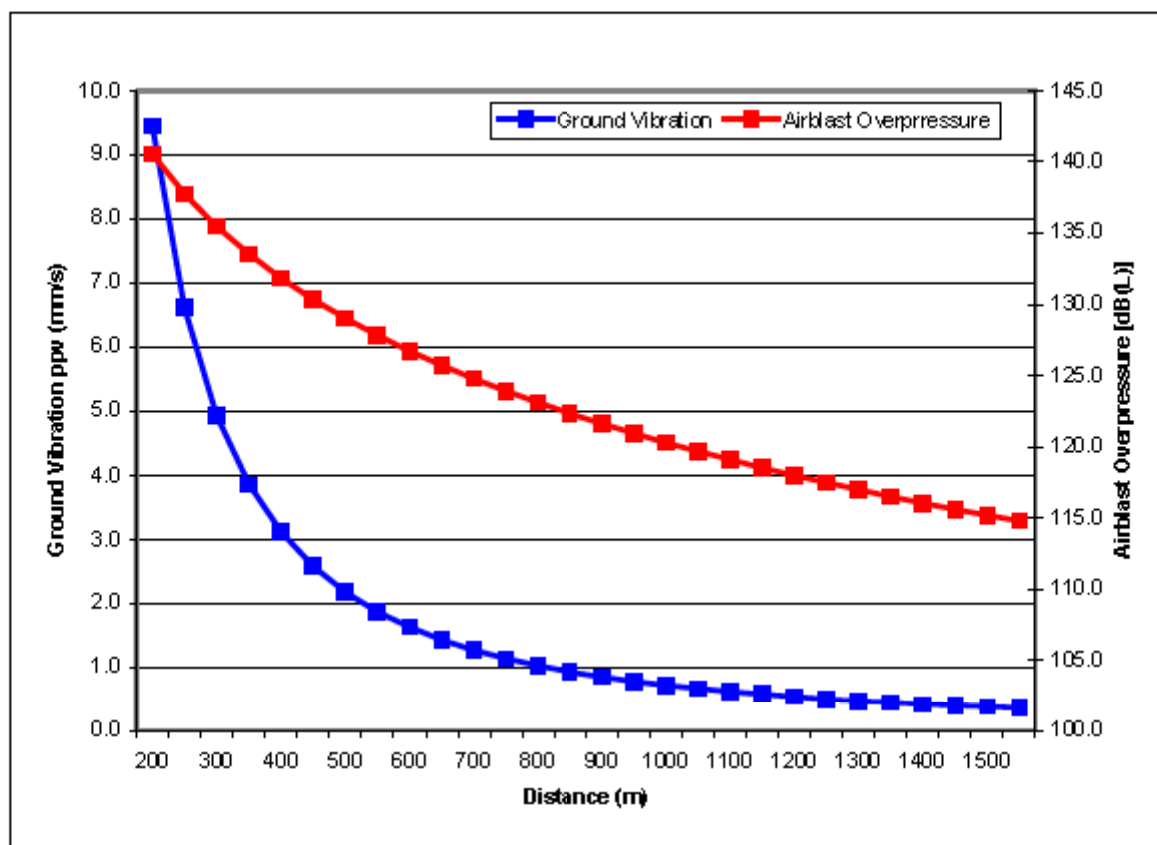
Figure 6 Airblast and Ground Vibration Predictions

Figure 6 displays a graph of the estimated airblast overpressure and ground vibration levels against the distance from the blast.

Estimations of airblast overpressure indicates that the recommended peak noise level of 115 dB(L) may be reached at up to 1500 metres from the blast location. However, as attenuation loss from screening of local terrain features has not been taken into account, these estimations are considered to be conservative.

Estimations of ground vibration levels indicates that the 5 mm/sec recommended limit may be reached at up to 300 metres from the blast location.

Estimations of airblast overpressure indicates that the recommended peak noise level of 115 dB(L) may be reached at up to 1500 metres from the blast location. Estimations of ground vibration levels indicates that the 5 mm/sec recommended limit may be reached at up to 300 metres from the blast location. As attenuation loss from screening of local terrain features has not been taken into account, these estimations are considered to be conservative.

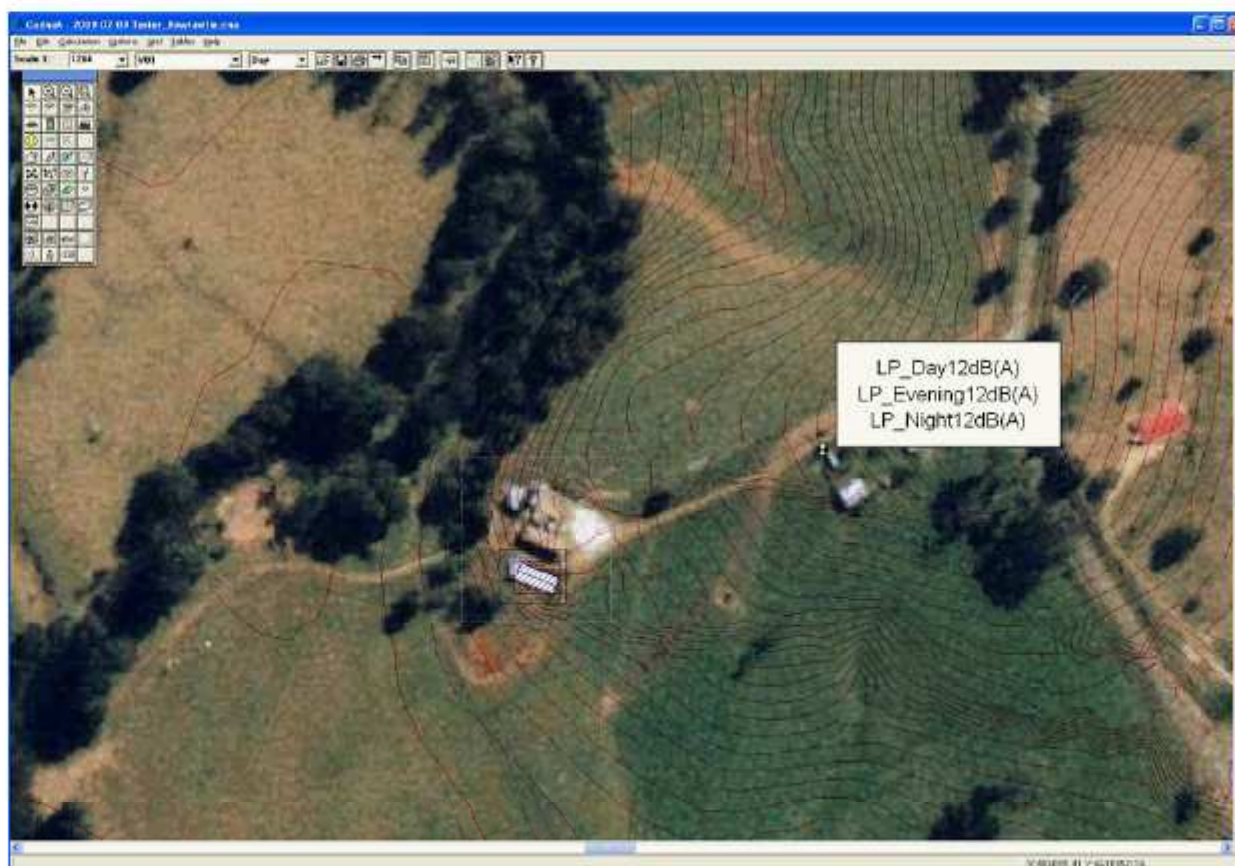
Figure 7 Operational Noise Assessment

For continuous operation of two pumps within the headworks building, predicted contribution based on modelling at the nearest residential boundary would be approximately 12 dB(A) under neutral conditions. Table 4-9 documents the results of the modelling whilst Figure 7 illustrates the proximity of the nearest residential dwelling to the existing and proposed headworks building.

The operational criteria for the Proposal would be 36dB for day & 35dB for evening & night and therefore 12dB would likely be inaudible. The main contributor to the increase in noise would be the proposed non-acoustic louvre (2m x 1m) on southern side of headworks building followed by the corrugated steel roof with insulation/sarking and then the proposed brick embankments of the building. The roller door (sheet steel) is a lower contributor due to its location on the southern side of the building.

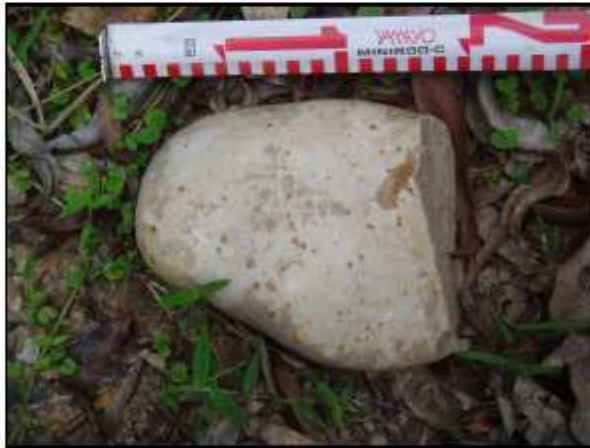
Figure 6.1 NWS1 – alluvial cobble manuport

This item, recorded in 2004, is a dark grey/brown, fine-grained volcanic alluvial cobble with a light grey/green patina (Figure 6.1). The cobble is broken transversely and retains an alluvial surface with a weathered cortex over 90% of its surface. There is some recent flake removal and one old flake scar with a degree of weathering. The dimensions of the item are: 156 x 112 x 57 mm.

This item is classified as a manuport, that is, an object or fragment of an object carried by human agency to the locality in which it is found, but which may not display any other features of past use. It is not certain that the manuport has an Aboriginal origin, however most non-Aboriginal explanations, such as a hearth stone, road or construction material can be largely discounted. There remains a possibility that it represents random loss from heavy machinery, an open vehicle or a tray back.

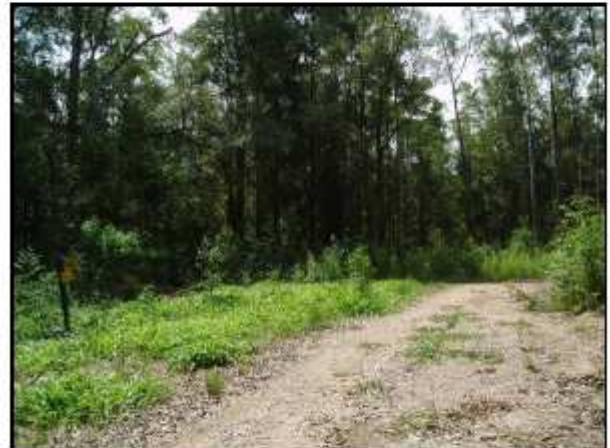
Figure 6.2 Location of NWS1

The item was found on a well graded and excavated forestry track platform (Step Road), situated on the crest of a spurline shoulder, some 50 m from, and 10 m higher than the proposed maximum storage level. The track was approximately six metres wide in this location (Figure 6.2). No other alluvial pebbles were visible on the track or on adjacent natural ground. There does not appear to be any imported or road metal gravels in the general vicinity.

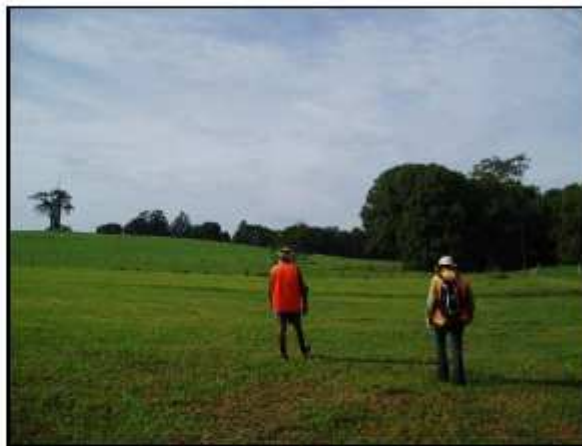
Figure 6.3 NWPAD1 looking south

This potential archaeological deposit comprises creek flats and basal slopes associated with Bowra Creek. (Figures 6.3 and 6.4). Proposed pipeline routes 1, 3, 4 and 5 run parallel to Bowra Creek and through NWSPAD1 (from the already formed vehicle tracks to Bellinger Drive).

Visibility along the pipeline routes in the area of the PAD was very poor at <5%. It is considered that there is moderate potential for subsurface archaeological deposits to be present in this area and for these deposits to be relatively intact.

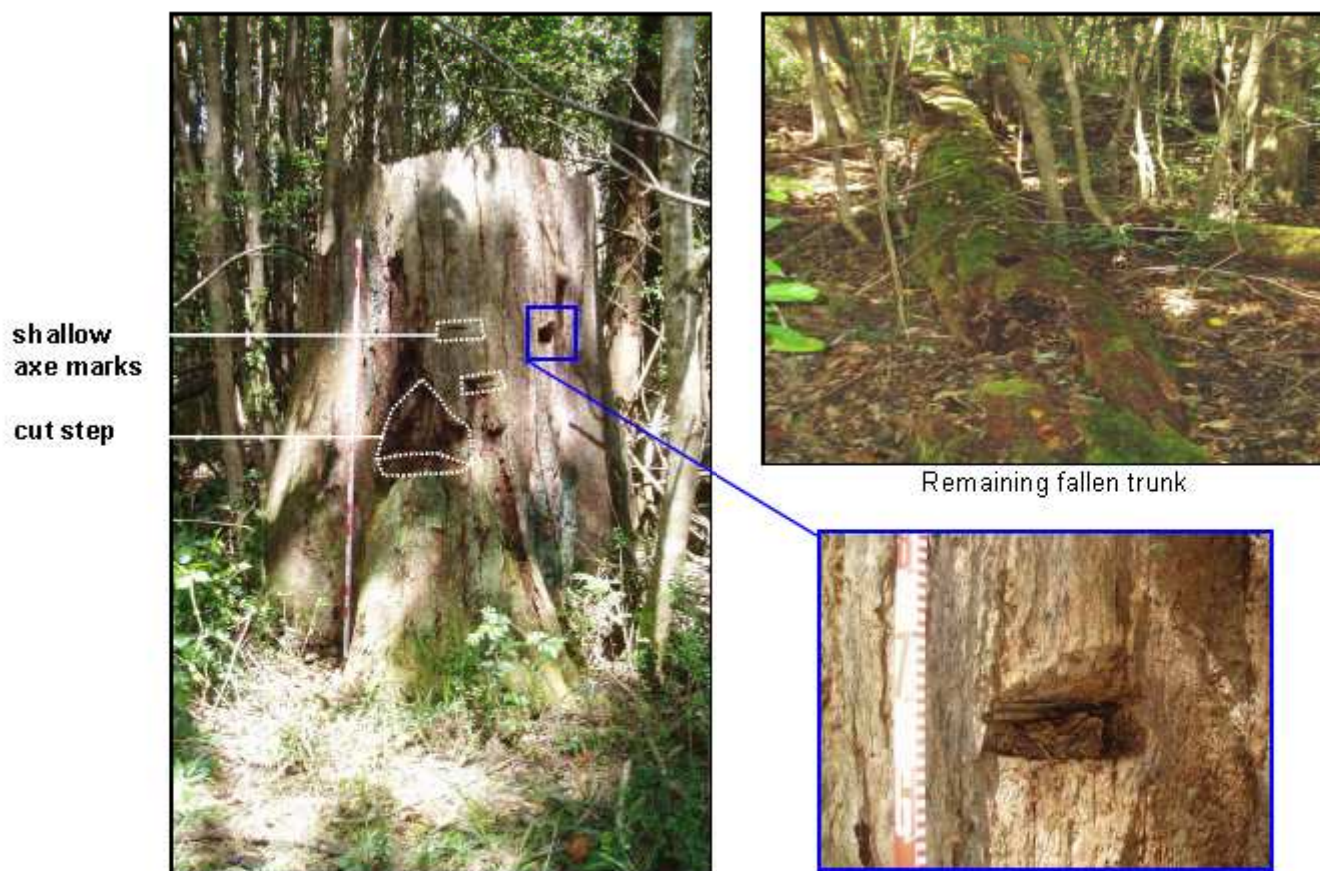
The tree has been felled with a cross-cut saw and cut approximately 2.4 m above the ground. A springboard slot, 16 cm wide, 7 cm high and 12 cm deep is situated 1.6 m above the ground on the eastern face of the stump (Figure 6.5 detail). Several shallow axe slots occur below this, at 1.4 and 1.5 m above the ground. A step, 60 cm wide and inset 20 cm and 60 cm high has been cut below the shallow axe marks, at 1 m above the ground. Another springboard slot, 16 cm wide, 5 cm high and 6 cm deep has been cut on the southern stump face, approximately 1.7 m above the ground, with a shallow axe mark also placed next to it 40 cm to the left. Some 20 cm above the slot is cut bench, 50 cm wide and 20 cm deep.

A long section of now rotten tree trunk is situated 15 m away from the stump. The trunk is about 28 m long and has a diameter of 85 cm at its proximal end. It is aligned 198° and extends to the bank of Bowra Creek (Figure 6.5). This is probably the remaining section of the felled trunk, which indicates that a bole of approximate 15 m length was harvested following the tree felling.

Figure 6.5 NWSH1 – Forestry stump and felled trunk, with detail of springboard slot.

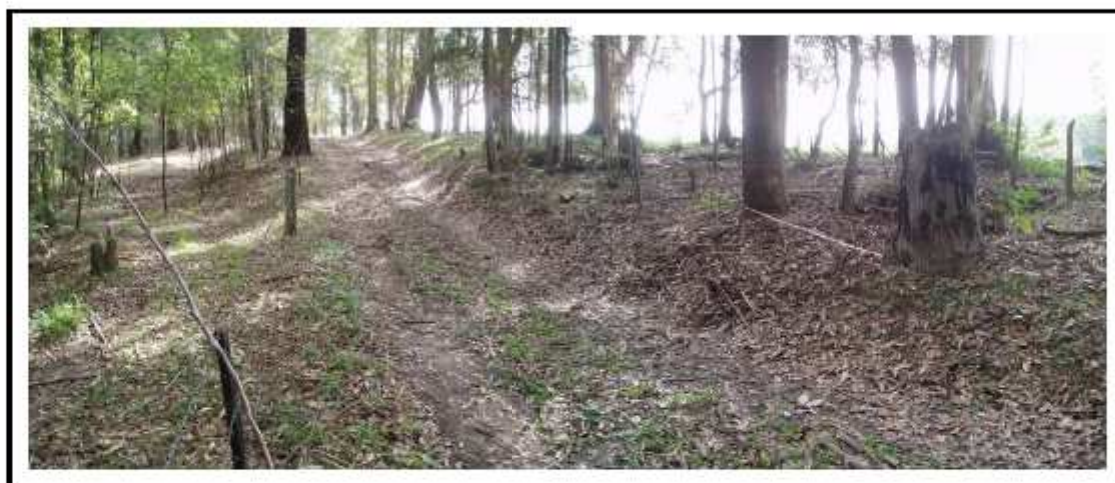
The site is located on the crest of a spurline shoulder, at the edge of a small forest remnant within dairy farm grasslands (Figures 6.6). The site now comprises a shallow rectangular and elongated earthen pit with approximate dimensions 3.4 m long and 1.2 m wide. Low spoil mounds are located on the eastern side of the pit and cover an area of 3 x 2.6 m. The pit is aligned at right angles to the spurline (318°), and is situated 2 m from a vehicle track that traverses the spurline. The track follows a fenceline and cuts off a small bend in a presumably older but better benched track, situated just downslope of the fenceline track (Figure 6.6). The pit is now 55 cm deep but has clearly filled with forest litter and sediment since its abandonment. No evidence for bricks or a former brick lining was evident in or around the pit.

Figure 6.6 General view of location of charcoal pit – NWSH2 (right, next to 2 scale), looking southwest.

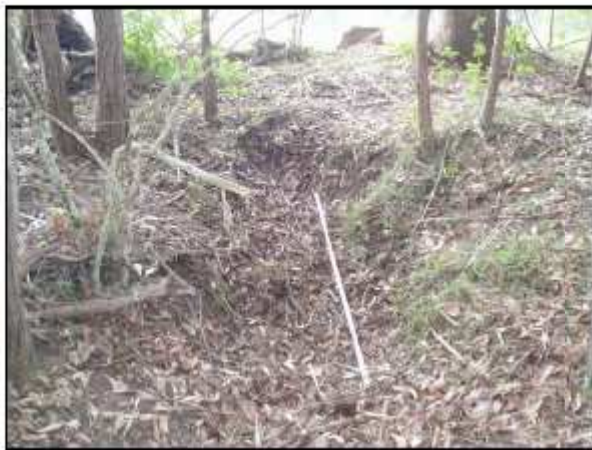
Figure 6.7 NWSH2 – View of pit remains looking northwest.

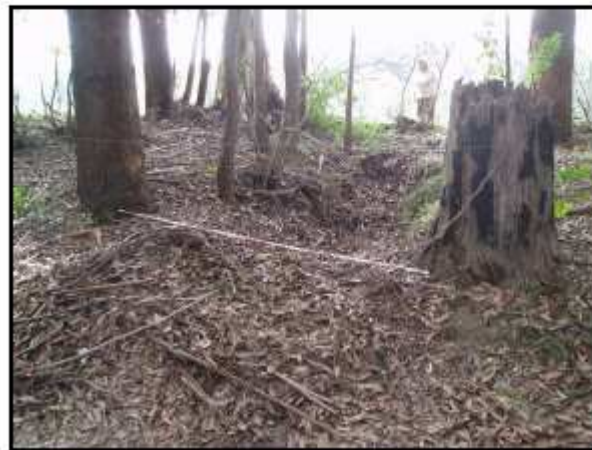
Figure 6.8 NWSH2 – View of pit remains from current track way, looking northwest.

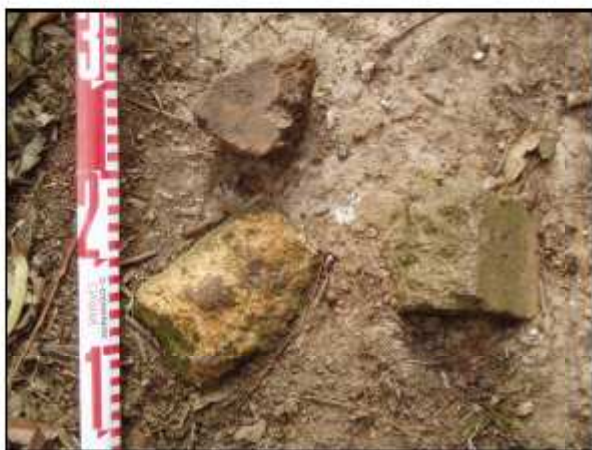
Approximately 70 m southwest along the track from the pit, a small scatter of brick fragments was encountered (Figure 6.9 and 6.10). These may be traces of the bricks used in the reported brick kiln, and which were presumably later removed and reused. Two of the three fragments appear to be hand moulded sandstock bricks with a coarse aggregate and no frog (10.5 cm wide and 7.7 cm deep). The other fragment is clearly later in age, being machine moulded and with a rectangular frog (7.7 cm deep). If all of these fragments relate to the charcoal kilns, then it suggests that bricks for the kiln were collected from a number of sources, including probable nineteenth century former structures.

Figure 6.9 Brick remnants found in general vicinity of NWSH2

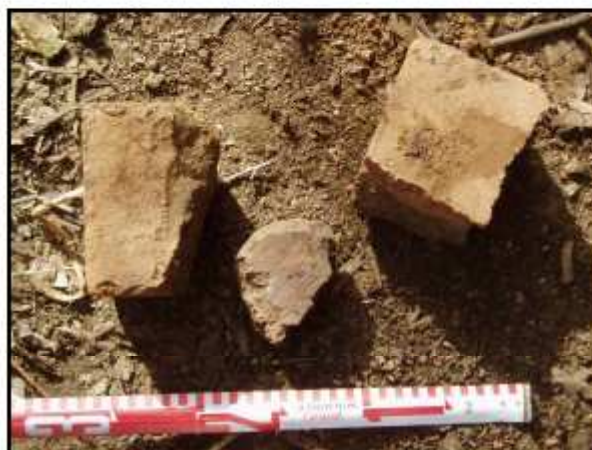
Figure 6.10 Reverse side of brick remnants found in general vicinity of NWSH2. Not machine moulded brick fragment on right

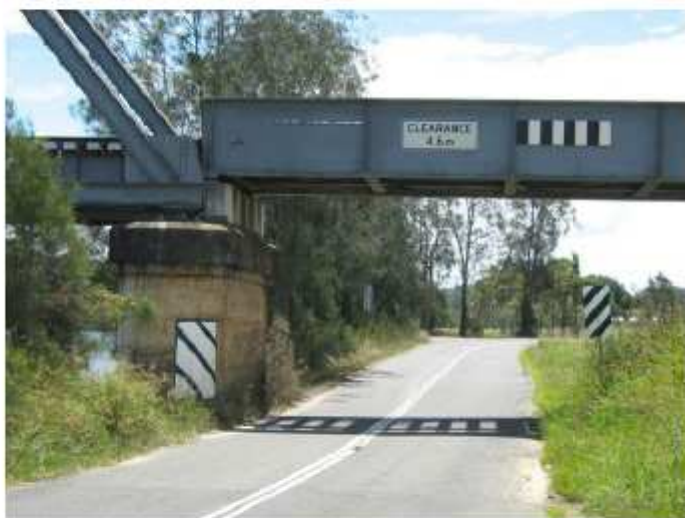
Figure 5 First rail underpass with deficient signage.

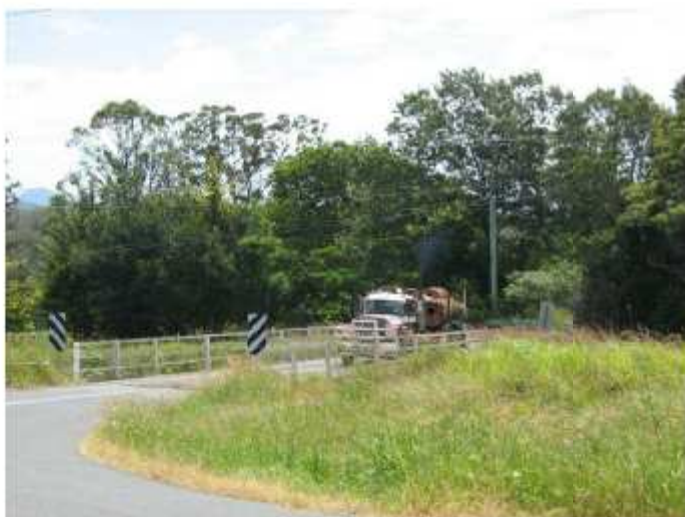
- ▶ At 3.85 km the road descends into a cutting and turns 90° under the second rail underpass. The bridge piers are behind the road shoulders. The general arrangement appears to be satisfactory. The vertical clearance to the road is not signposted as the height appears to be above the highest level requiring signage.

Figure 6 2nd rail crossing - long load using full road width.

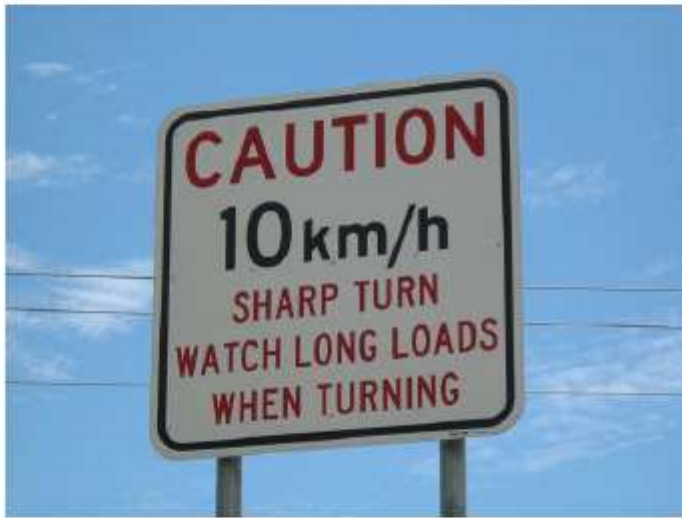
Figure 7 Non standard signage at second rail crossing.

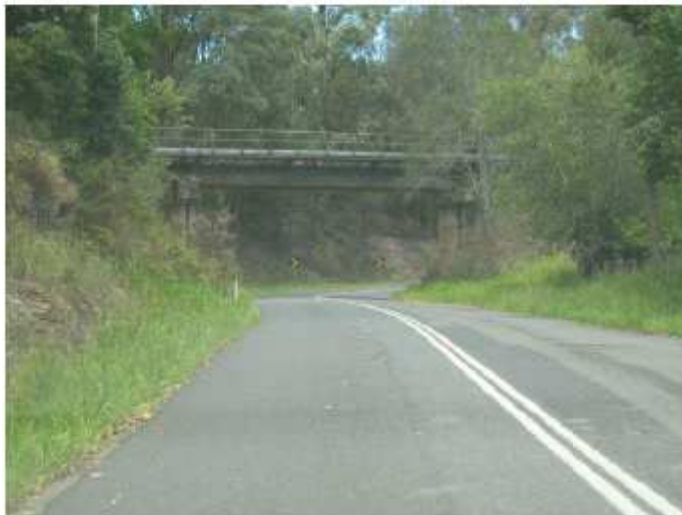
Figure 8 Third rail crossing on Rodeo Drive with high clearance.

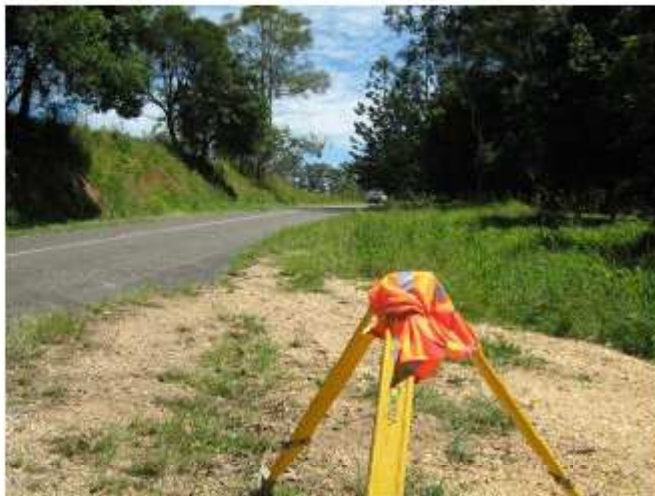
Figure 11 Intersection sight line northward along Bellingin Road.

If the northern approach design speed exceeds 60 km/h (SISD 113m minimum) then the long term use of the intersection for access following construction could not be recommended without improvement of the sight distance available.

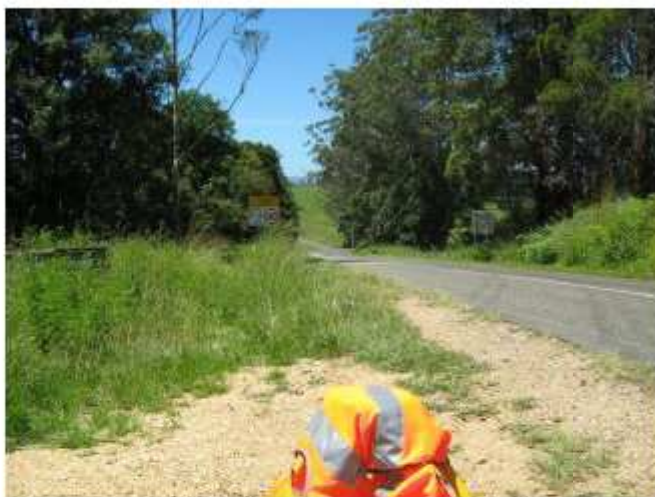
Figure 12 Intersection sight line southward along Bellingin Road.

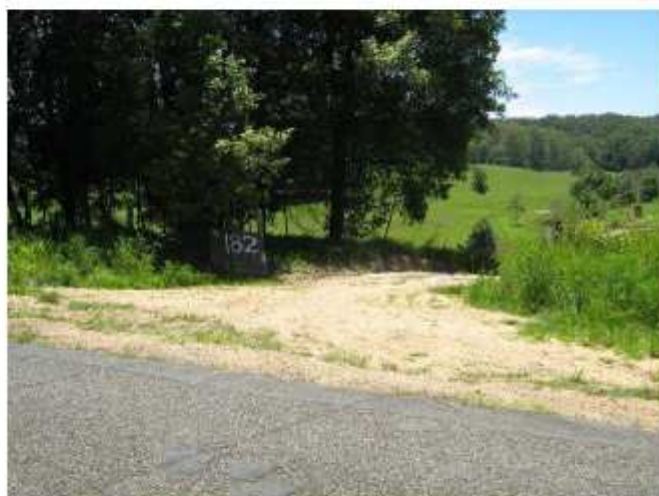
Figure 13 Current condition of Link Road intersection with Bellingin Road.

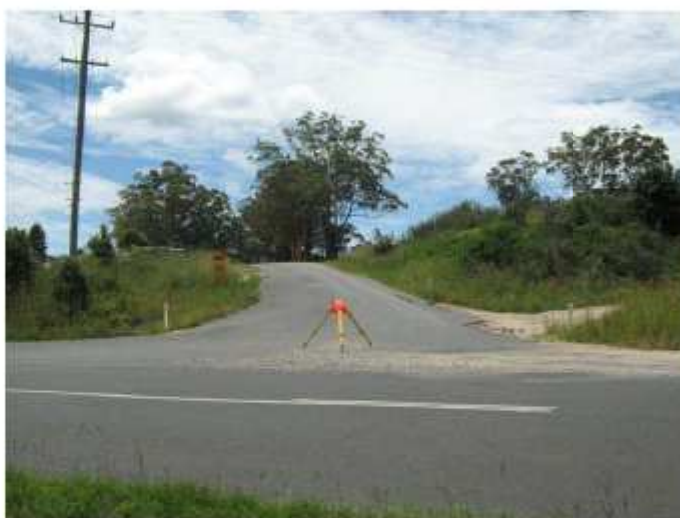
Figure 18 Current condition of the intersection of Valla Road with Rodeo Drive.

The Valla Road intersection is located on a sweeping curve in Rodeo Drive. Characteristics of the intersection are as noted below:

Therefore, it is considered that the intersection will provide satisfactory access to the dam site via this route for light vehicles. The increased usage of the intersection would warrant the installation of intersection warning signs on both approaches in Rodeo Dr.

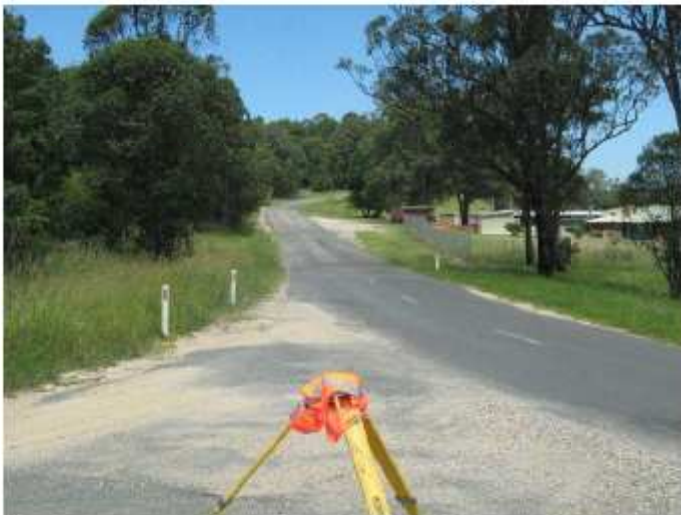
Figure 20 Valla Road intersection sight line toward Macksville.

Given that vehicles approaching from Bowraville enter the available sight distance 60m after exiting the 60 km/h urban speed zone, the design approach speed could be considered to be say 80 km/h. For 80 km/h the minimum SISD is 170m and the desirable ASD is 114m.

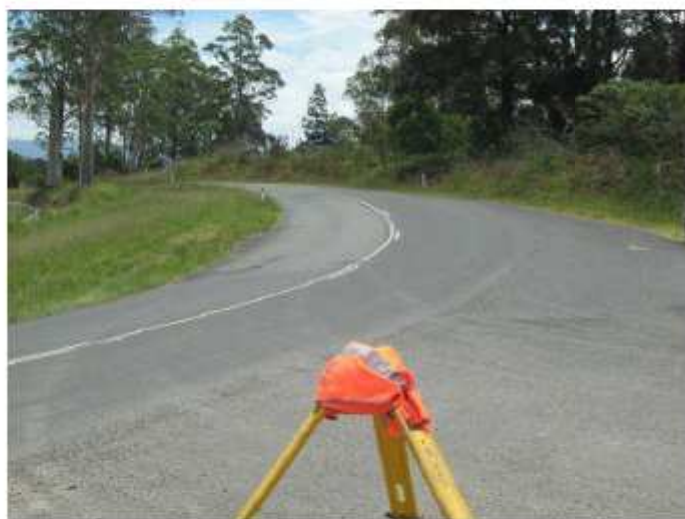
Figure 21 Valla Road Intersection sight line toward Bowraville.

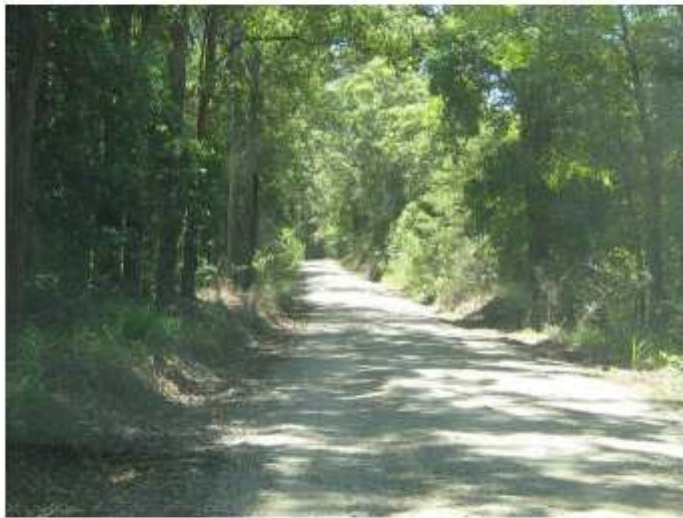
Figure 22 Valla Road - typical view of pavement and roadside conditions.

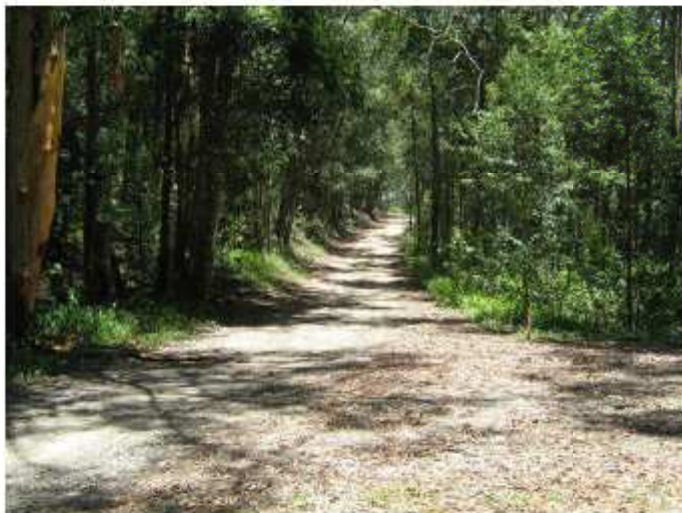
It is anticipated the preferred site access will be via this link road from Valla Road. To be suitable for access during construction the road would need to be upgraded to a standard similar to the opening of a new rural road. NSC's current standards for such works are expected to be suitable for upgrading of the road to suit construction traffic and for the occasional post construction visitor to the dam site.

Figure 25 The start of the link road from Valla Road.

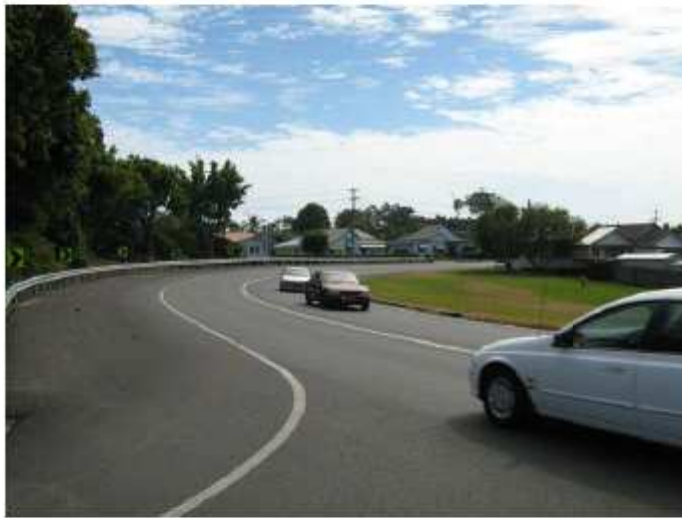
Figure 28 Driver's sight line north of Rodeo Dr.

The SISD at the intersection was assessed for a vehicle turning left and right from Rodeo Drive. The available sight distance north was 115m across the chord of the curve and a "filtered" sight distance of 120m was available onto the bridge superstructure to vehicles approaching from Macksville. Some obstruction to the line of sight was presented by bridge railings and guardfencing. For a design speed of 50 km/h the minimum and desirable SISD is 89m and 96m respectively on level approaches. Therefore, the intersection is expected to work satisfactorily

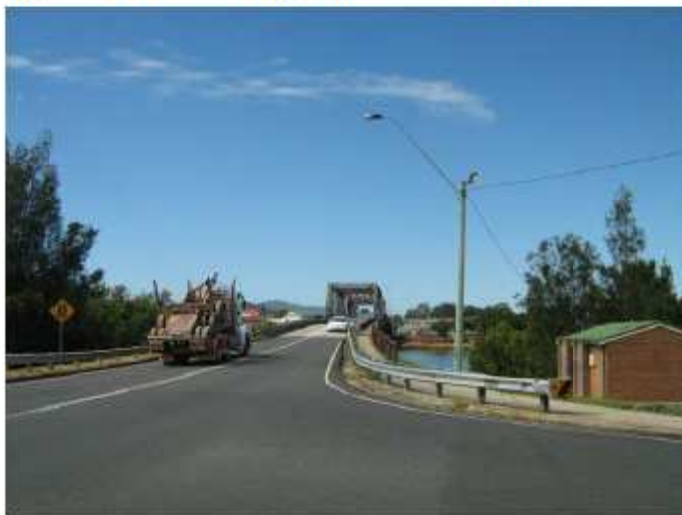
Figure 29 Driver's sight line south of Rodeo Dr.
