## Appendix A – Coastal Hazard Calculations

This Appendix describes the derivation of coastal hazards based on analysis of photogrammetry data and modelling.

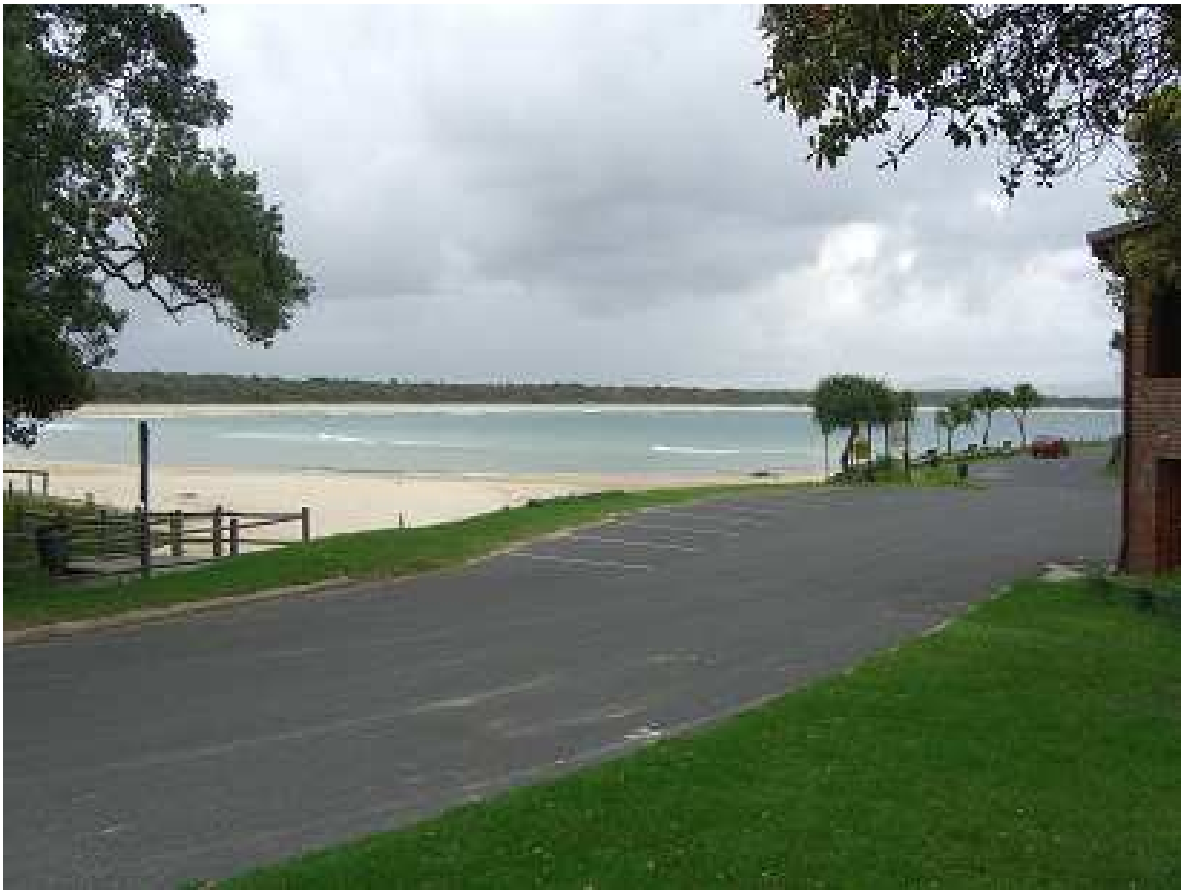
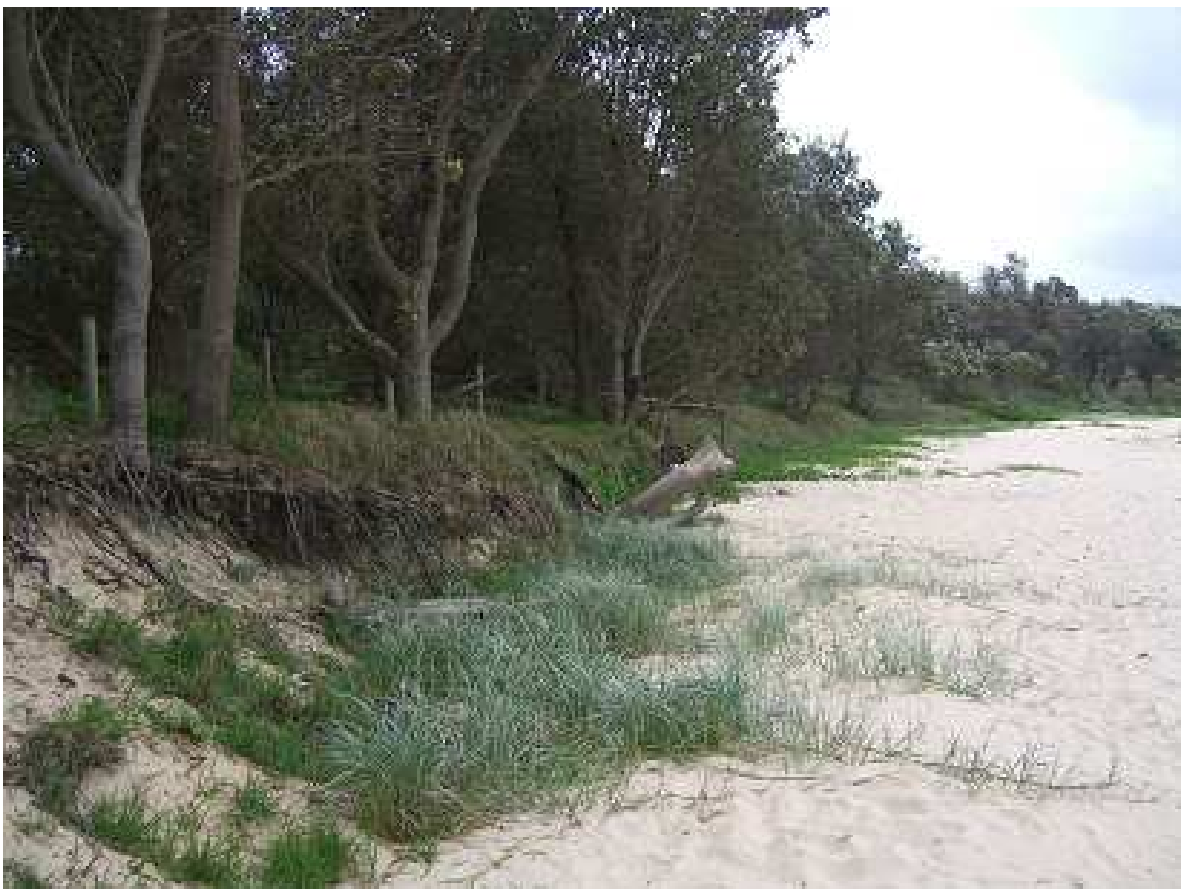
**Figure A.9 – Top – Forster Beach car park (Block 2).  
Bottom – Forster Beach dune visible erosion (Block 2-3)**

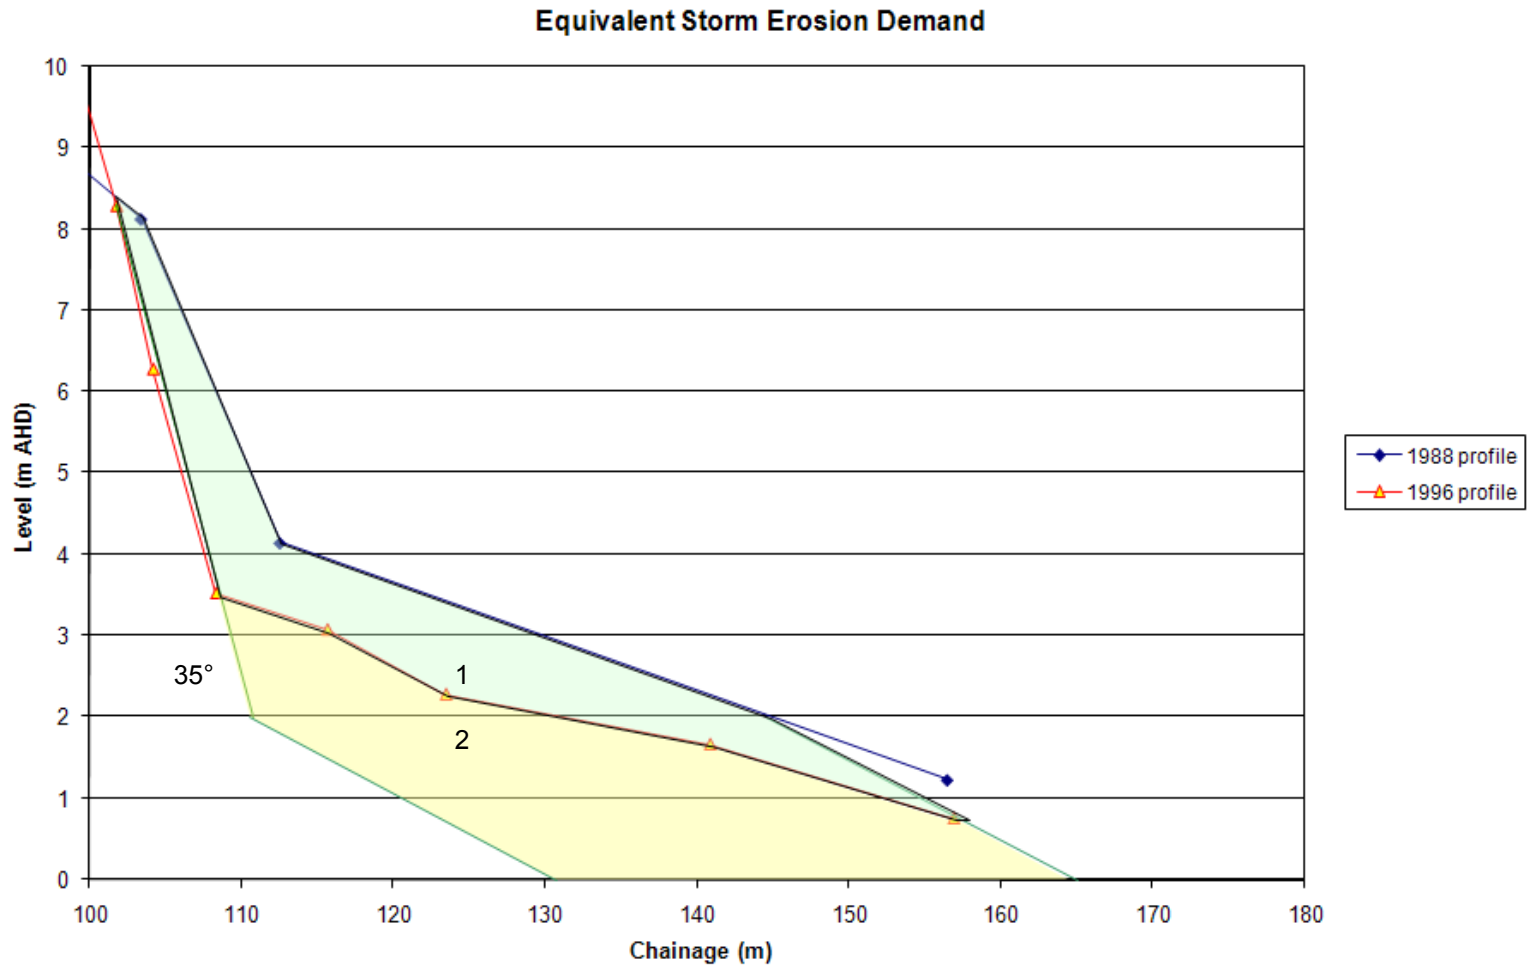
**Figure A.19** – Determination of Equivalent storm erosion, Scotts Head 1988 – 1996

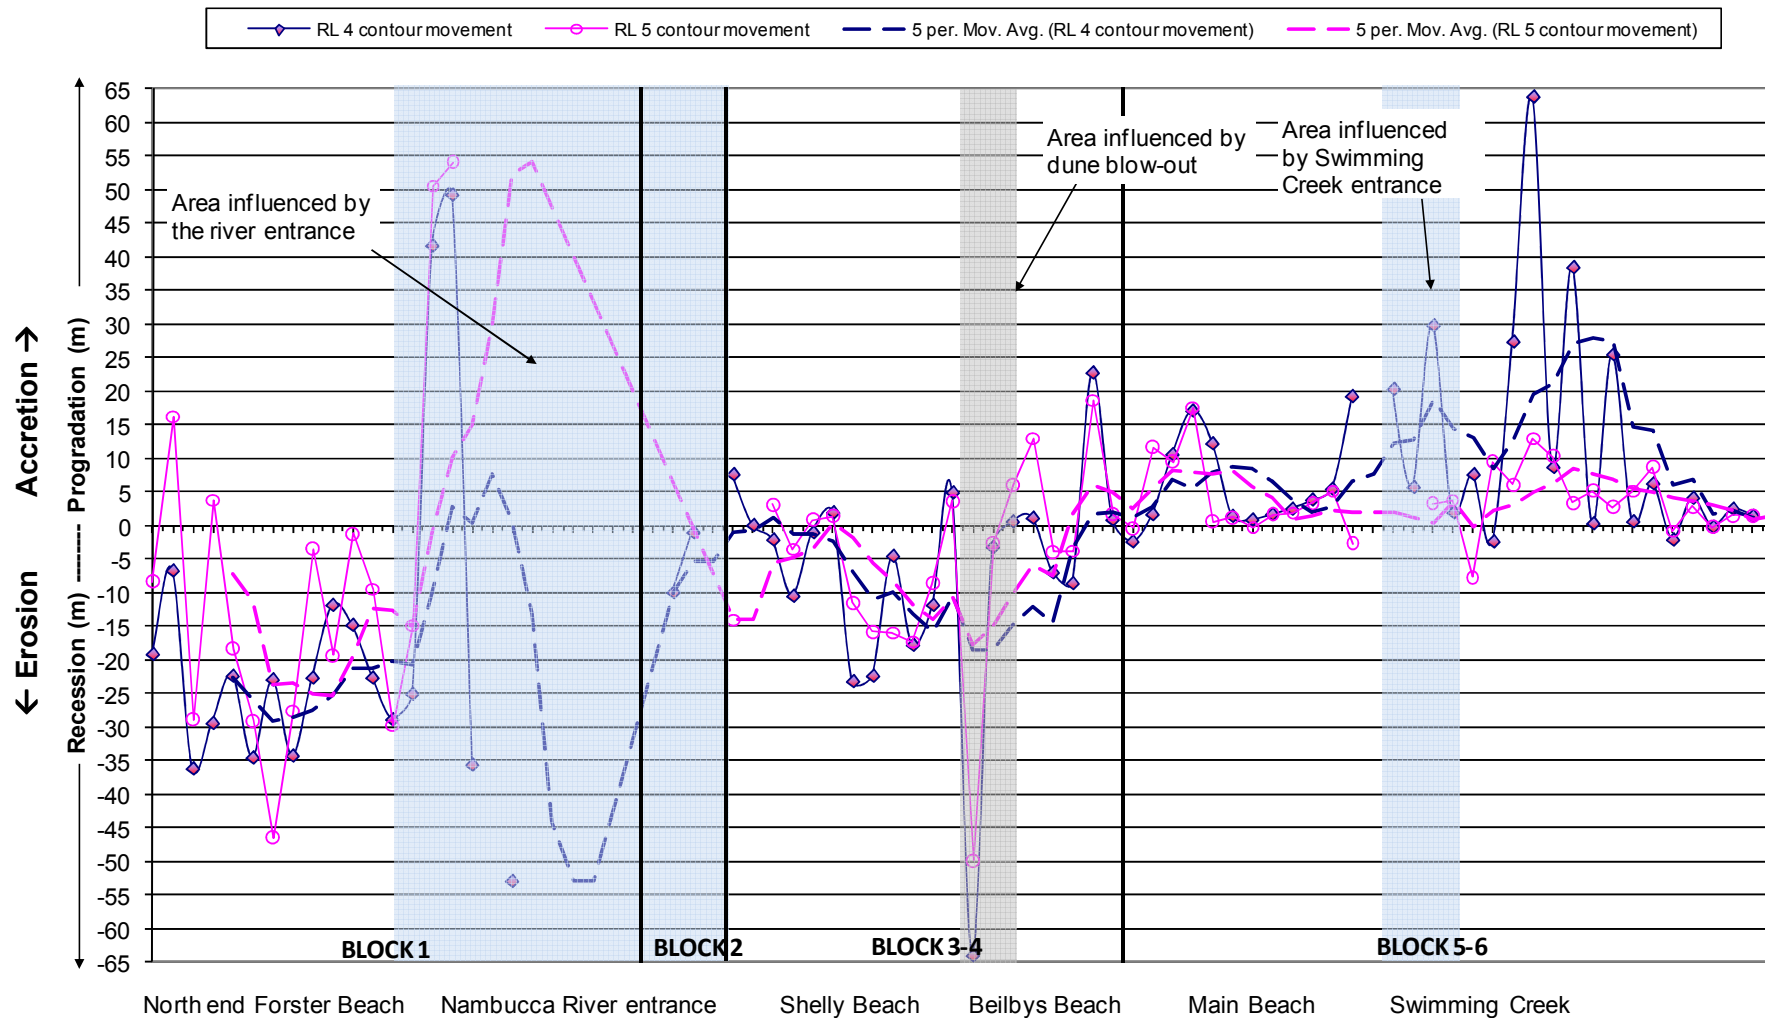
Figure A.23 – Movement of RL 4 and RL 5 contours, Nambucca Heads, 1942 – 2004.

Dune face locations were analysed over the length of the study area, by examining the relative location of the RL 4.0 m and RL 5.0 m contours over the various years of photogrammetric data. Dune face locations over the entire photogrammetric record are plotted in Figure A.23, for the 2004 photogrammetry relative to the 1942 photogrammetry. It can be seen from this Figure that the RL 4.0 m and RL 5.0 m contours underwent large fluctuations near the entrance to Nambucca River, and that they are generally landward of their 1942 locations at the northern end of Forster Beach, Shelly Beach and Beilbys Beach (indicating some net recession between 1942 and 2004). At Main Beach and Swimming Creek, the location of these contours has moved seaward between 1942 and 2004, indicating some net progradation (accretion).

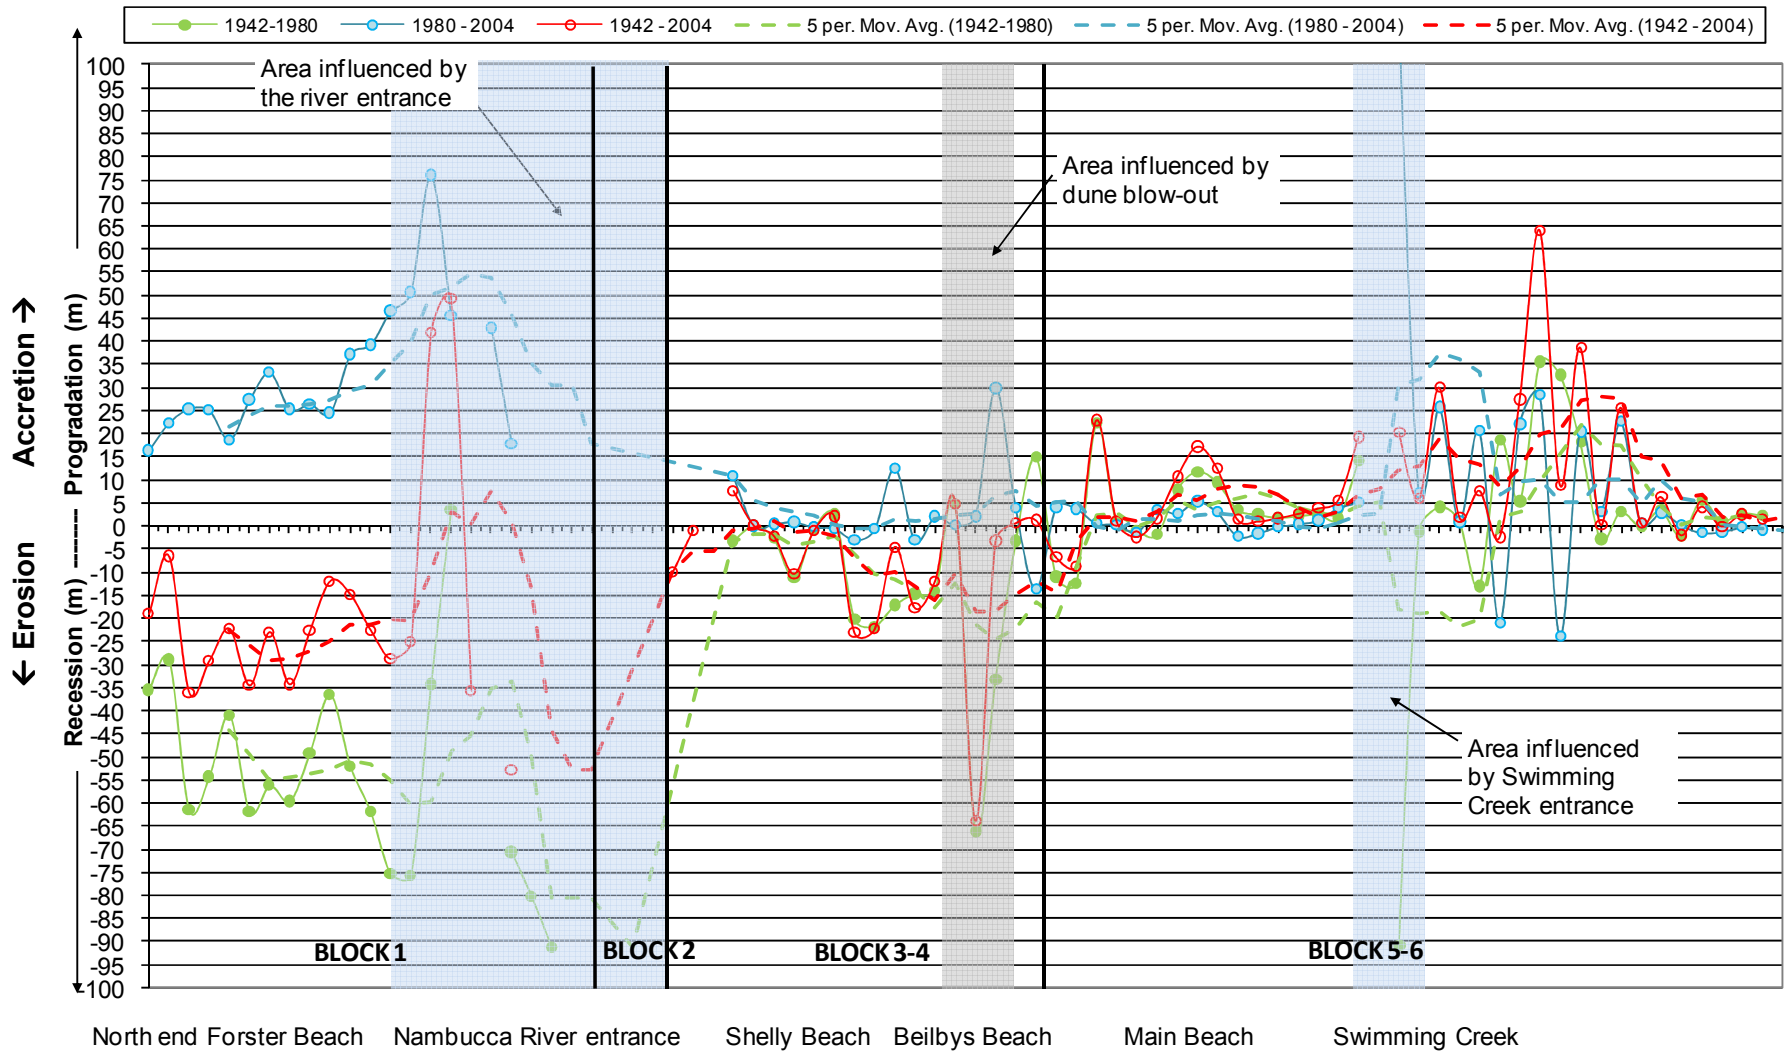
Figure A.24 - Movement of RL 4 contour, Nambucca Heads 1942 – 1980 – 2004

Figure A.24 analyses the movement of the RL 4.0 m contour between the dates of 1942, 1980 and 2004 photography. It can be seen that, for all Blocks, there has been a general landward movement between 1942 and 1980 (indicating recession), and a general seaward movement between the 1980 and 2004 photography (indicating beach recovery).

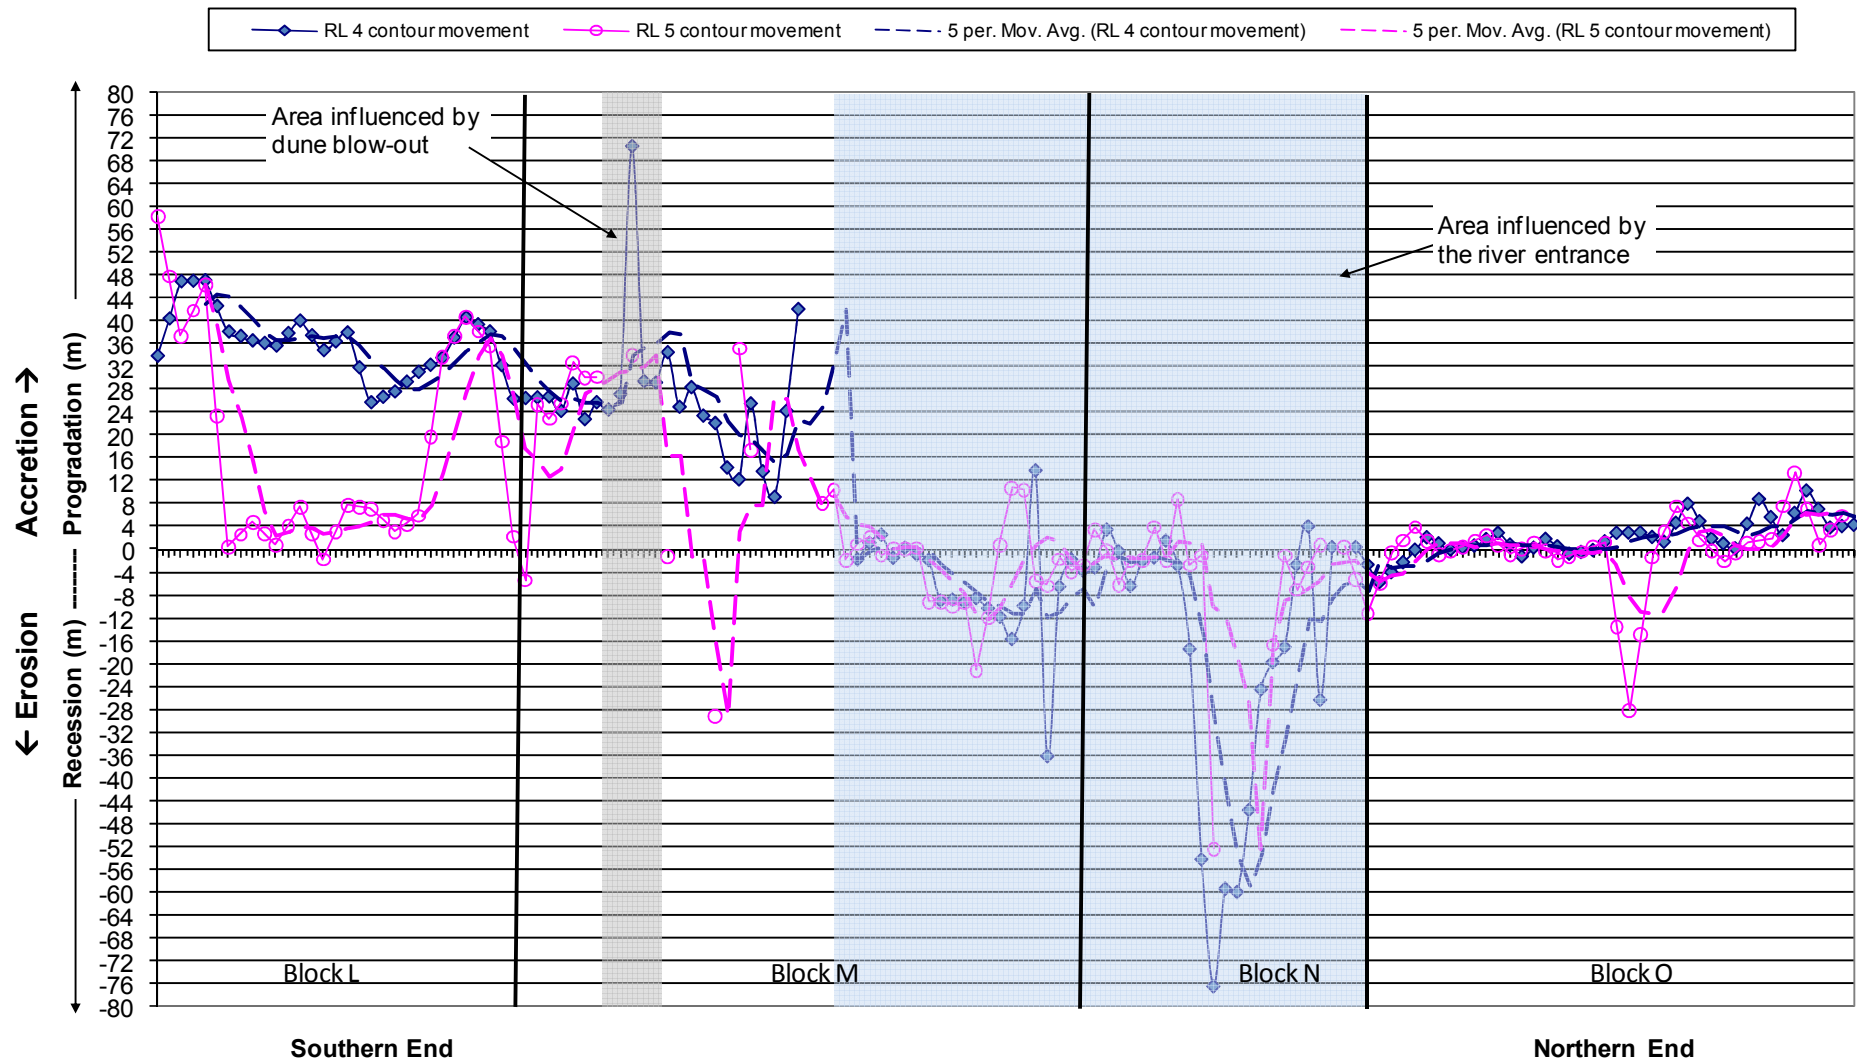
Figure A.26 – Movement of RL 4 and RL 5 contours, 1942 – 2004.

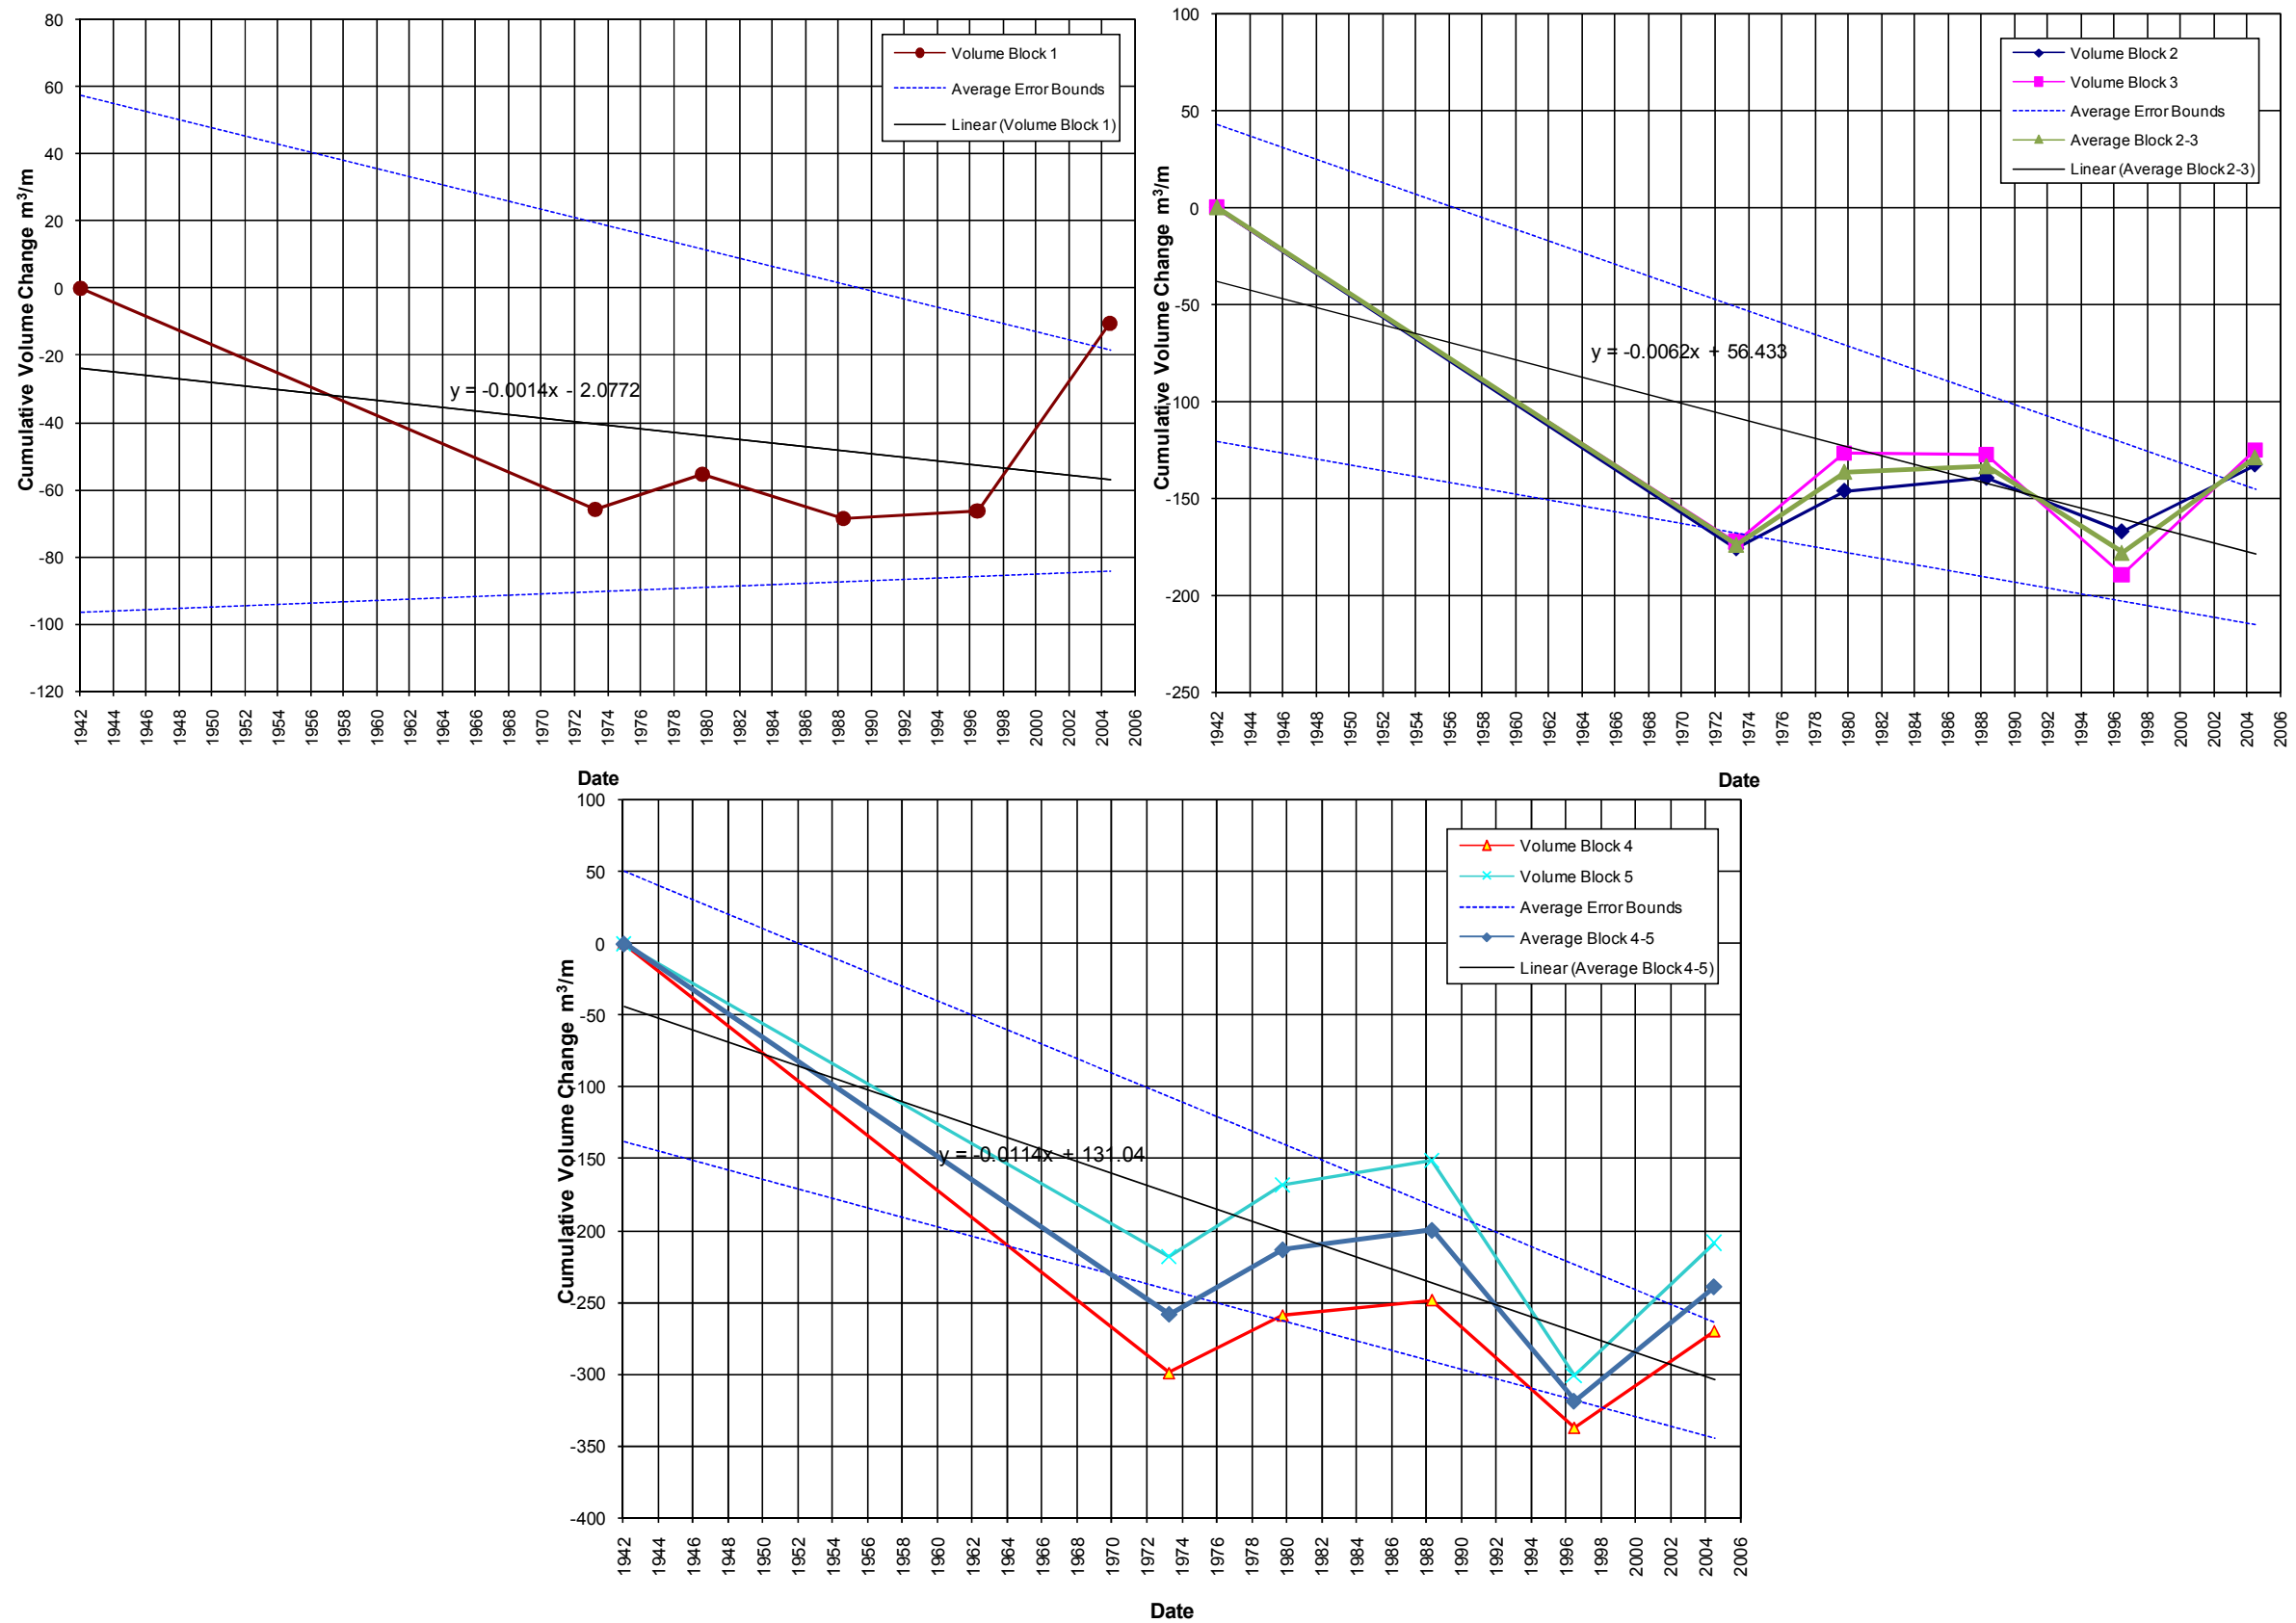
Figure A.28 – Long term recession volume analysis at Scotts Head for the different Block 1, 2-3 and 4-5 (1942 – 2004).

It should be noted that the erosion is occurring in episodic bursts most likely brought about by storm activity. In periods characterised by little storm activity, beach recovery or little change occurs. Some of the observed changes in beach volume could be due to anthropogenic influence, such as reshaping of the dune in areas where major development is located, due to construction works.

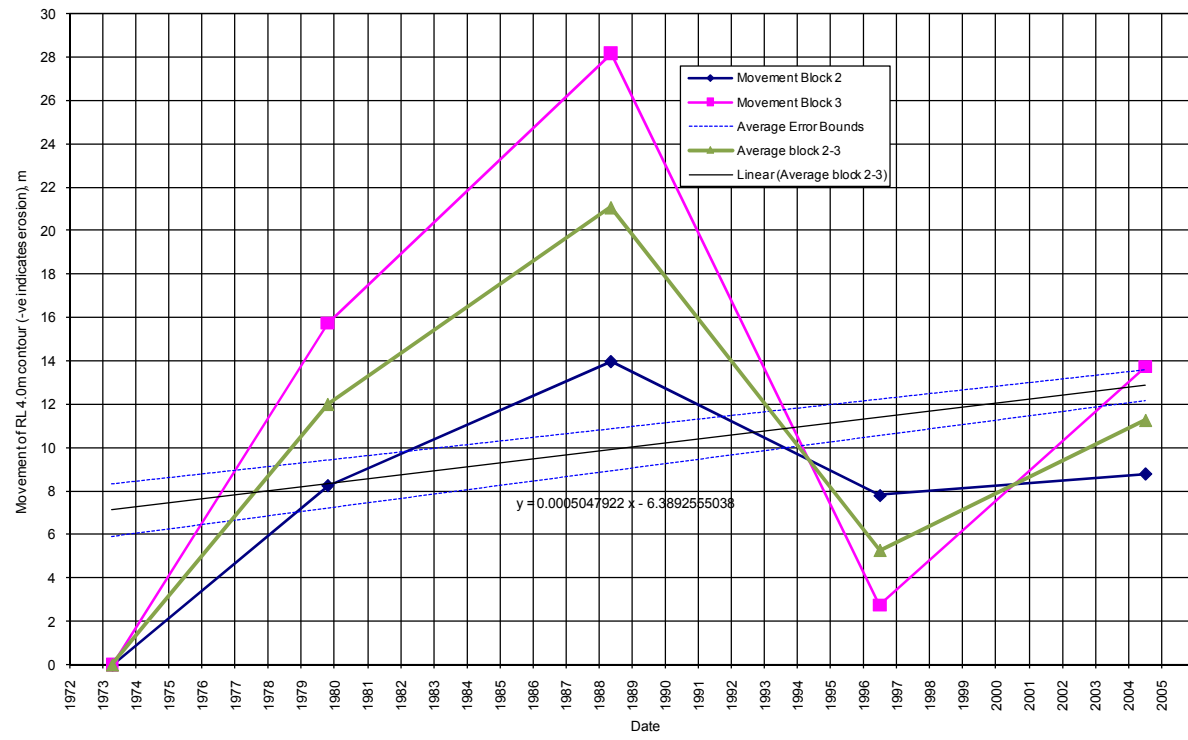
Figure A.32 – Scotts Head - long term recession dune face analysis for the Block 1, 2-3 and 4-5, 1973 – 2004.

Figure A.32 shows the cumulative movement of the 4.0 m AHD contour over time for Scotts Head as well as the average dune movement for each of the blocks, between 1942 and 2004. Negative values represent dune recession. It can be seen that there was a general pattern of dune face recession between 1942 and 1980 along Little Beach with the dune face being relatively stable between 1980 and 2004. It can also be seen that the dune movement of Forster Beach is fluctuating periodically, alternating between recession and progradation.

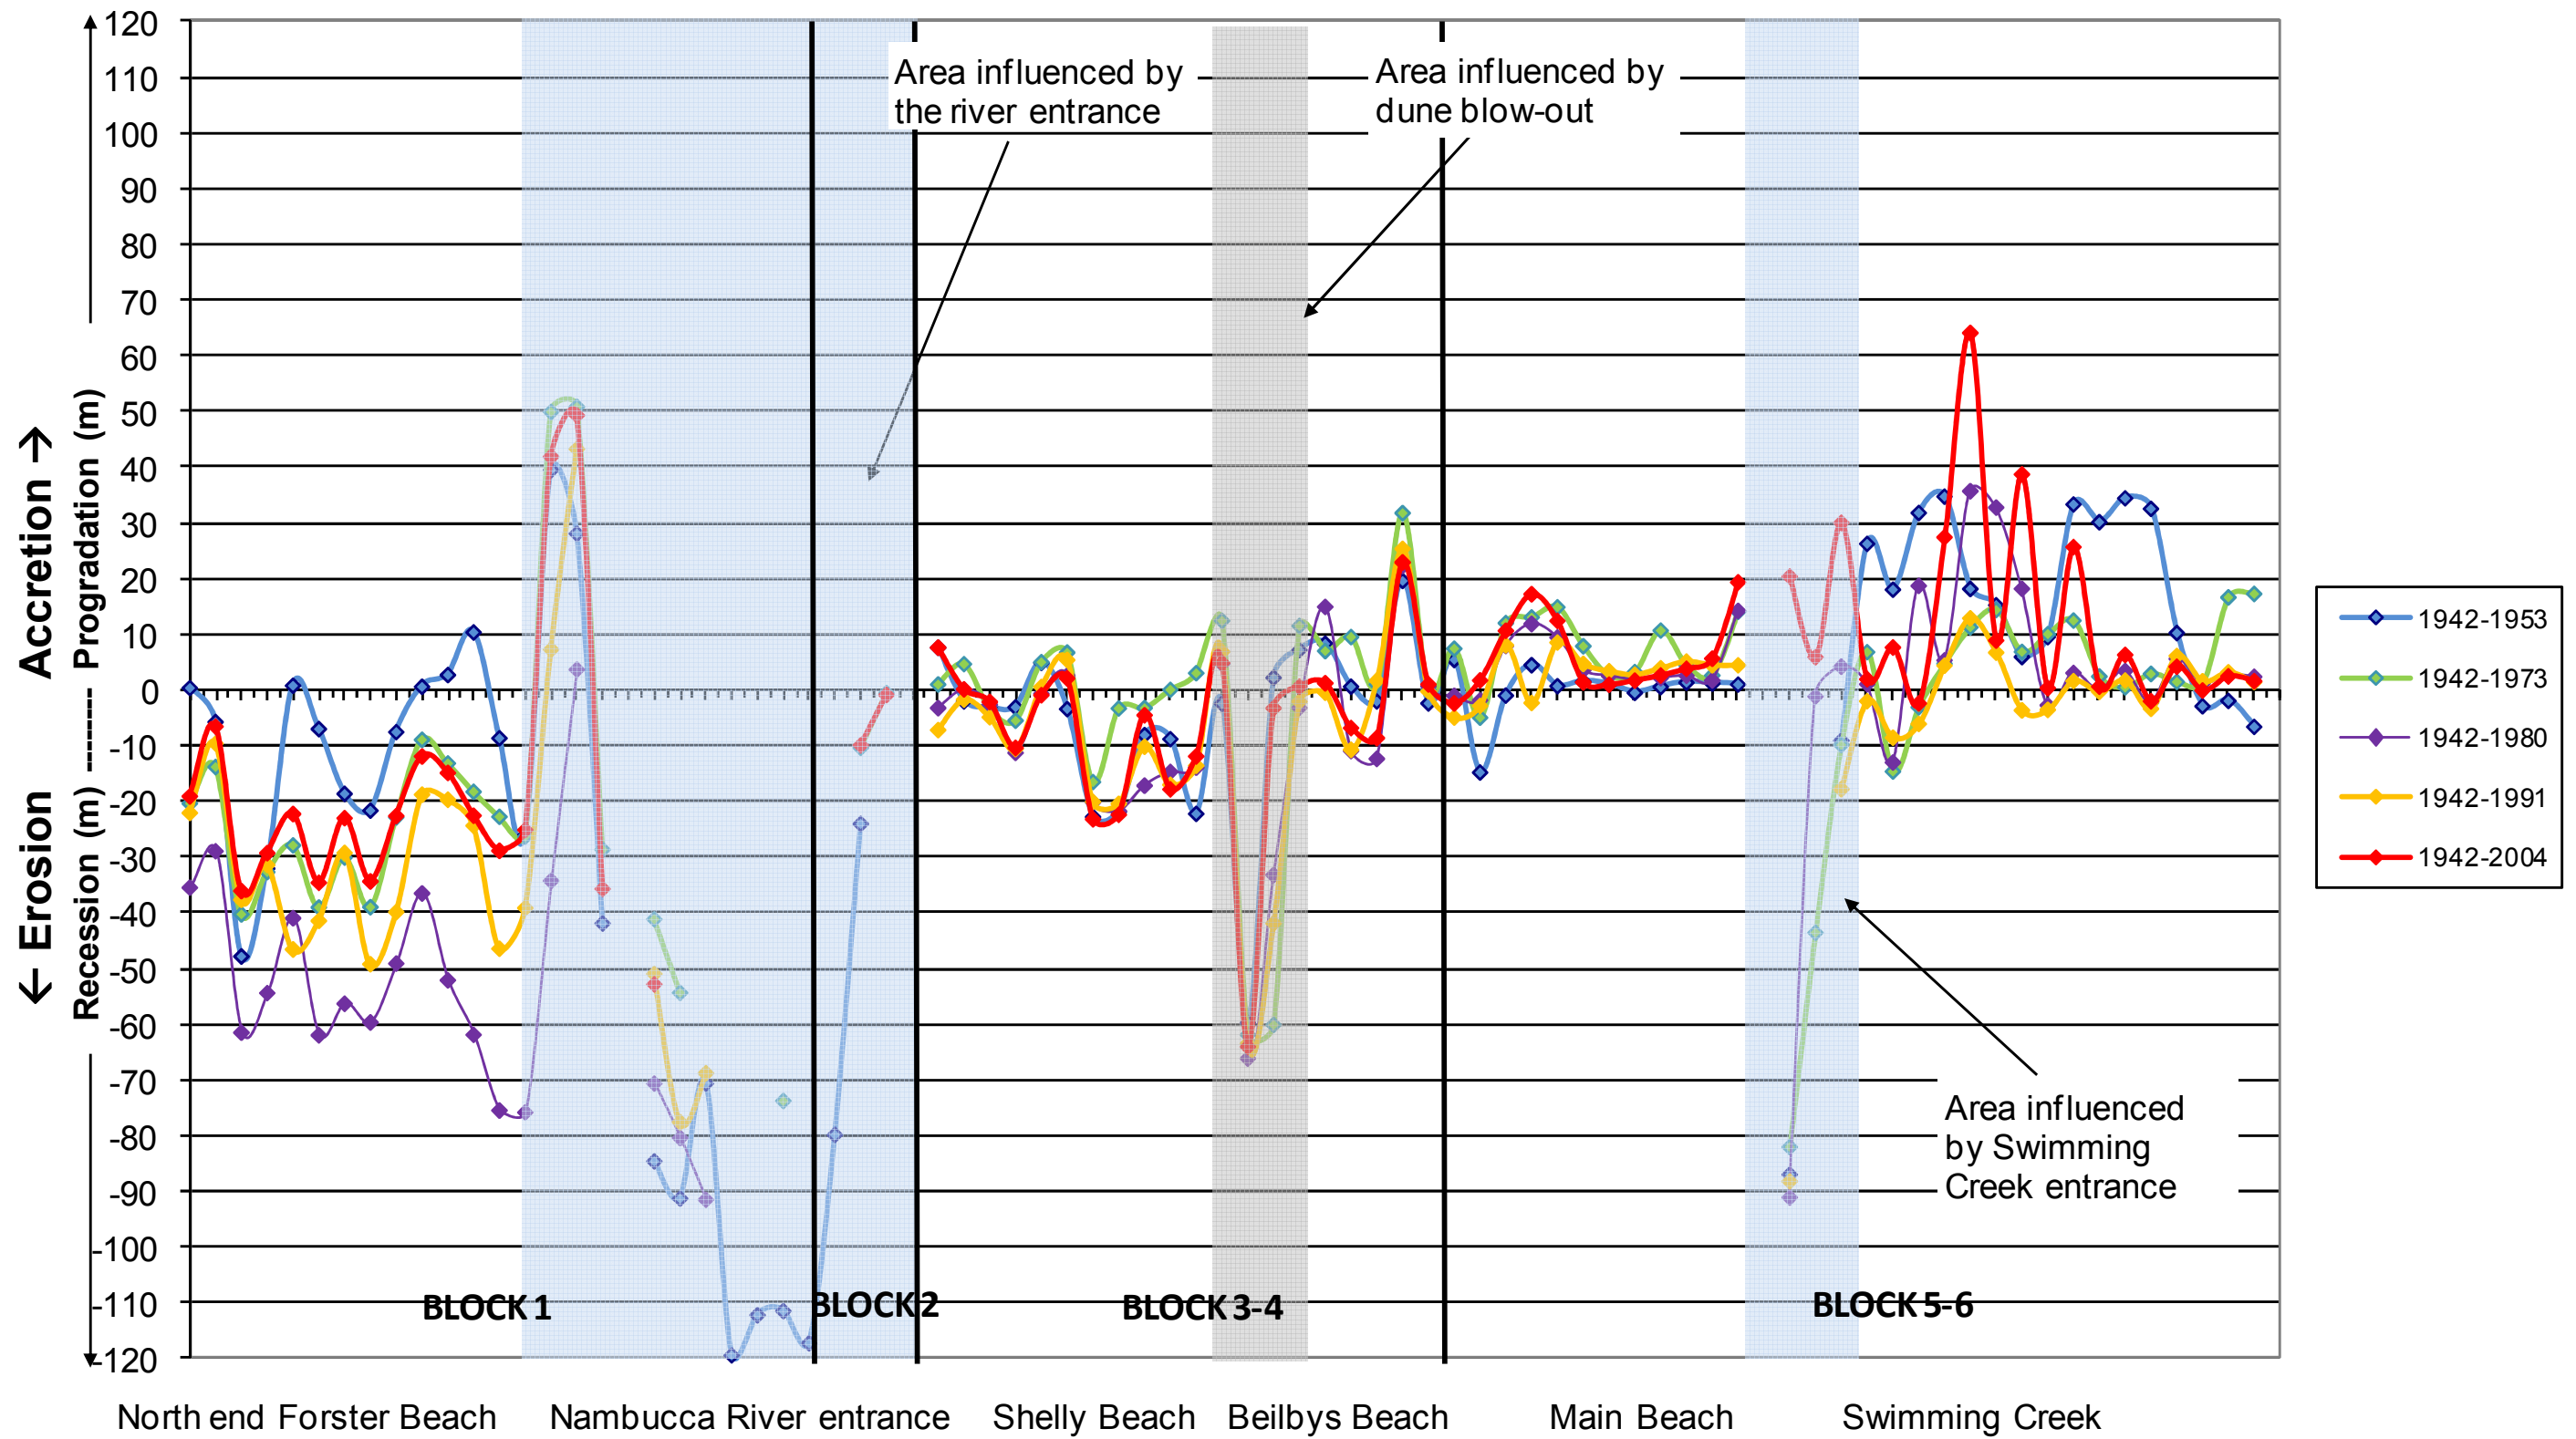
Figure A.35 – Movement of RL 4 contour along beach
