# Nambucca Ecohealth Project 2016-2017

# **Assessment of River and Estuarine Condition**

**Final Technical Report**

July 2018

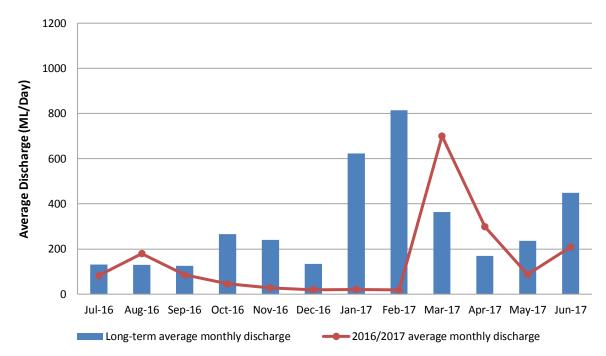
*Figure 2.6a* Average monthly discharge over the 2016-2017 study period (July 2016 to June 2017) in comparison to the long-term average monthly discharge of the Nambucca River at Bowraville (NOW gauge 205015).

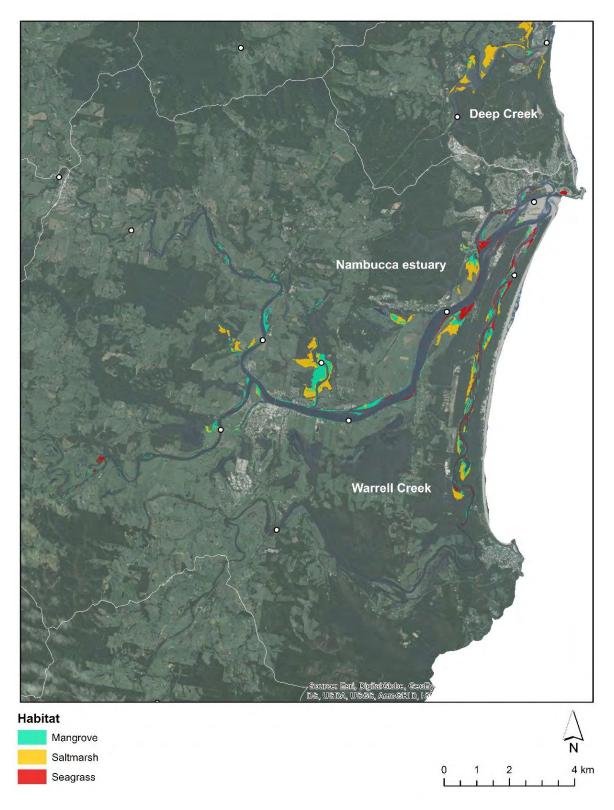
**Figure 3.4** Mangrove, seagrass and saltmarsh habitats in the Nambucca River Catchment estuaries (NSW Department of Industry and Investment – Primary Industries and Energy 2004). The estuaries are divided into three zones for more detailed temporal analysis.

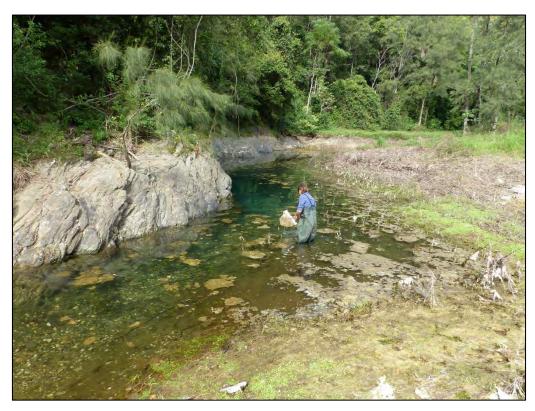
**Plate 3.1** Site NAMB8 in the upper freshwater Nambucca River (North Arm) upstream of Girralong (looking upstream).

The geomorphic River Style at Nambucca River 8 is a planform controlled, meandering, fine-grained channel in a partially confined valley setting. NAMB8 drains 20.3km of stream network, predominantly headwater streams in good geomorphic condition. However, NAMB8 is located midway in an 11km reach assessed as being in poor geomorphic condition overall (Alluvium 2012). The bed sediments at NAMB8 comprised an open framework of subangular cobbles with <5% fine sediments. There were small pockets of active bed erosion due to scour downstream of the causeway. Banks comprised fine sediments with gravel. There was moderate (5-10m) erosion on both banks, minor (<5m) undercutting on the left bank and minor (<5m) slumping on the right bank. There was significant (10-20m) of exposure of tree roots on both banks, but this was evenly distributed along both banks and comprised small proportions of each individual root mass immediately above the low flow channel. NAMB8 scored 84, a B for BANK CONDITION and 87, a B+, for BED CONDITION. The overall geomorphic condition for NAMB8 was 85, a grade of B+.

In summary, NAMB8 was assessed as being in good geomorphic condition, with scour immediately downstream the causeway the most significant issue for site-level geomorphic condition. The desktop GIS assessment of subcatchment geomorphic condition found the freshwater reaches of the Nambucca River (North Arm) to be in moderate condition with a grade of C-. The geomorphic condition at NAMB8 was above the subcatchment average.

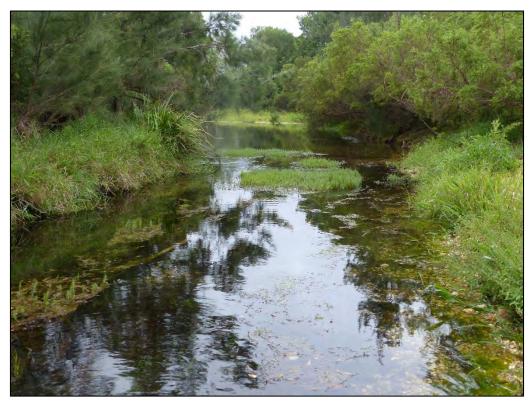
**Plate 3.2** Site NAMB7 in the freshwater Nambucca River (North Arm) upstream of the confluence with Missabotti Creek (looking downstream).

The geomorphic River Style at Nambucca River 7 is also a planform controlled, meandering, finegrained channel in a partially confined valley setting. NAMB7 drains 81.3km of stream network, with 24.7km of the dominant River Style (planform controlled, meandering, fine-grained channel) assessed as being in poor condition (Alluvium 2012). The bed sediments at NAMB7 comprised a contact framework of rounded pebbles filled with a matrix of 5-32% fine sediments. Pugging from cattle was very significant at NAMB7 (Plate 3.10). Banks comprised fine sediments. There were severe pugging, trampling and slumping (<20m) on both banks from heavy cattle access. NAMB7 scored 58, a D+ for BANK CONDITION and 60, a C-, for BED CONDITION. The overall geomorphic condition for NAMB8 was 59, a grade of D+.

In summary, NAMB7 was assessed as being in poor geomorphic condition, with cattle pugging and compaction of banks and the streambed the most significant current issue for site-level geomorphic condition. The geomorphic condition at NAMB7 (D+) was slightly below the subcatchment average of C-.

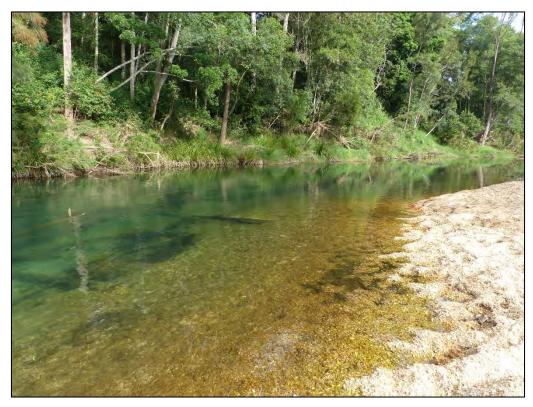
**Plate 3.3** Site NAMB6 in the lower freshwater Nambucca River (North Arm) upstream of Girralong (looking upstream).

The geomorphic River Style at Nambucca River 6 is a planform controlled, meandering, fine-grained channel in a partially confined valley setting. NAMB6 drains 129.2km of stream network, with 56.9km of the dominant River Style (planform controlled, meandering, fine-grained channel) assessed as being in poor condition (Alluvium 2012). The bed sediments at NAMB6 comprised a dilated framework of rounded pebbles with 32-60% fine sediments. Pugging from cattle was also significant at NAMB6 on the right bank and streambed (Plate 3.11). The reach contained significant quantities of large woody debris, including a cross-spanning trunk that comprises a significant geomorphic control, stabilizing the immediate upstream bed sediments. Scour around these large wood pieces also maintains topographic complexity and pool refugia for aquatic fauna. Banks comprised fine sediments. The right bank had significant (10-20m) slumping and moderate (5-10m) undercutting and active erosion from cattle tracks. NAMB6 scored 64, a C- for BANK CONDITION and 57, a D+, for BED CONDITION. The overall geomorphic condition for NAMB6 was 60, a grade of C-.

In summary, NAMB6 was assessed as being in moderate geomorphic condition, erosion from stock access on the right bank the most significant current issue for site-level geomorphic condition. The geomorphic condition at NAMB6 was equal to the subcatchment average.

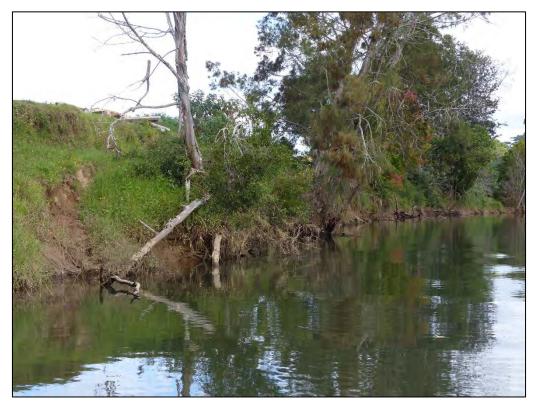
**Plate 3.4** Site NAMB5 in the upper Nambucca estuary downstream of the confluence with South Creek (looking upstream).

The geomorphic River Style at Nambucca River 5 is a planform controlled, tidal channel in a partially confined valley setting. NAMB5 drains 246.4km of stream network, with 103.1km of the dominant River Style (planform controlled, meandering, fine-grained channel) assessed as being in poor condition (Alluvium 2012). The bed sediments at NAMB5 comprised a framework of rounded pebbles dominated by a matrix of >60% fine sediments. Banks comprised fine sediments. There was severe (20-100m) undercutting and slumping on the left bank, and significant (10-20m) undercutting with severe (20-100m) slumping on the right bank. Both banks were grazed by cattle with erosion from cattle tracks particularly apparent on the left bank. Undercutting of banks was consistently present in the intertidal zone through the reach and likely due to tidal action. NAMB5 scored 48, a D-for BANK CONDITION. The overall geomorphic condition for NAMB5 was 48, a grade of D-.

In summary, NAMB5 was assessed as being in poor geomorphic condition, with cattle pugging and compaction of banks and the streambed the most significant current issue for site-level geomorphic condition. The geomorphic condition at NAMB5 (D-) was below the subcatchment average of C for the Nambucca estuary.

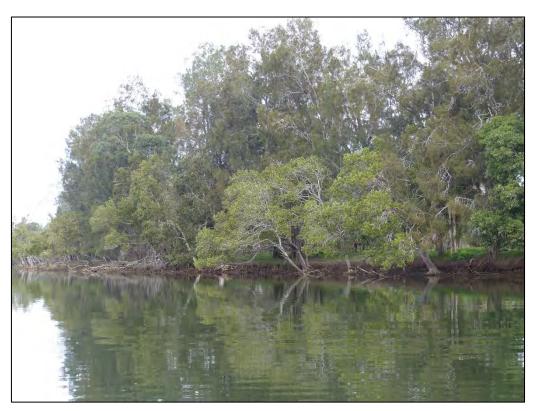
**Plate 3.5** Site NAMB4 in the mid Nambucca estuary upstream of the confluence with Taylors Arm (looking downstream).

The geomorphic River Style at Nambucca River 4 is a planform controlled, tidal channel in a partially confined valley setting. NAMB4 drains 256.6km of stream network. As well as the 103.1km of planform controlled, meandering, fine grained channel in poor condition, 14.8km of the upper estuary (planform controlled, tidal channel) upstream of NAMB4 is also considered to be in poor condition (Alluvium 2012). The bed and bank at NAMB4 comprised fine sediments (silty sand). There

was severe (20-100m) active erosion in the intertidal zone on the right bank, likely due to historic gravel extraction causing widespread bed lowering and bank incision, the combination of cattle trampling and grazing reducing vegetation cover, and wave wash on the fine bank sediments. The downstream end of the left bank comprised rock revetment. NAMB4 scored 74, a C+ for BANK CONDITION. The overall geomorphic condition for NAMB5 was 74, a grade of C+.

In summary, NAMB4 was assessed as being in moderate geomorphic condition, with cattle trampling and removal of vegetation cover on fine-grained bank sediments the most significant issue for site-level geomorphic condition. The geomorphic condition at NAMB4 (C+) was slightly above the subcatchment average of C for the Nambucca estuary.

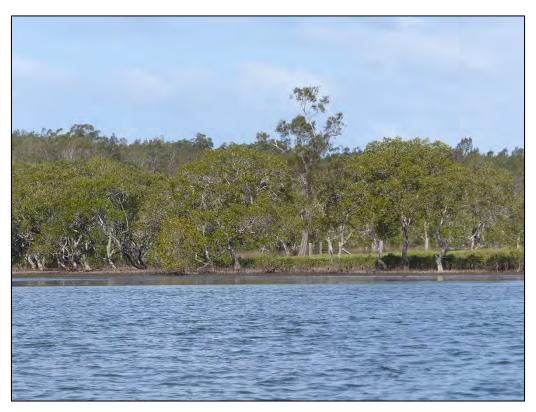
*Plate 3.6* Site NAMB3 in the lower Nambucca estuary downstream of the confluence with South Creek (looking upstream).

The geomorphic River Style at Nambucca River 3 is a planform controlled, tidal channel in a partially confined valley setting. NAMB3 drains 590.9km of stream network, of which 191.2km is considered to be in poor geomorphic condition (Alluvium 2012). The bed and bank at NAMB3 comprised fine sediments (silty sand). There was minor (<5m) active erosion and minor (<5m) exposed tree roots in the intertidal zone on the right bank, likely due to wave action on the fine bank sediments. NAMB3 scored 88, a B+ for BANK CONDITION. The overall geomorphic condition for NAMB3 was 88, a grade of B+.

In summary, NAMB3 was assessed as being in good geomorphic condition, with minor bank erosion in the intertidal zone from wave action the most significant issue for site-level geomorphic condition. The geomorphic condition at NAMB3 (B+) was above the subcatchment average of C for the Nambucca estuary.

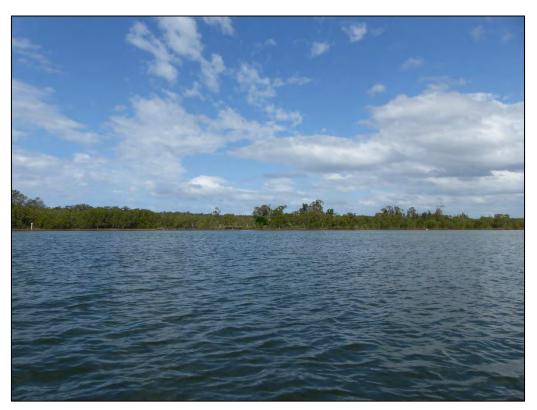
**Plate 3.7** Site NAMB2 in the mid Nambucca estuary upstream of the confluence with Taylors Arm (looking downstream).

The geomorphic River Style at Nambucca River 2 is a planform controlled, tidal channel in a partially confined valley setting. NAMB2 drains 604.4km of stream network, of which 191.5km is considered to be in poor geomorphic condition (Alluvium 2012). The bank at NAMB2 comprised fine sediments with the bed consisting of sand. There was moderate (5-10m) active erosion, minor (<5m) slumping and minor (<5m) exposed tree roots in the intertidal zone on the left bank, likely due to trampling and grazing of vegetation cover by cattle and wave action on the fine bank sediments. NAMB2 scored 82, a B for BANK CONDITION. The overall geomorphic condition for NAMB2 was 82, a grade of B.

In summary, NAMB2 was assessed as being in good geomorphic condition, with minor bank erosion in the intertidal zone from cattle trampling and wave action the most significant issue for site-level geomorphic condition. The geomorphic condition at NAMB2 (B) was above the subcatchment average of C for the Nambucca estuary.

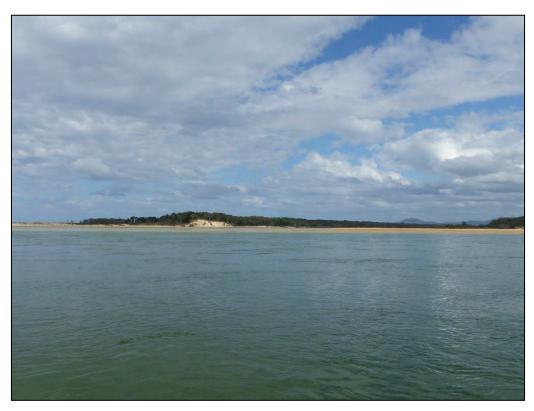
**Plate 3.8** Site NAMB1 in the lower Nambucca estuary upstream of the confluence with Warrell Creek (looking downstream).

The geomorphic River Style at Nambucca River 1 is a planform controlled, tidal channel in a partially confined valley setting. NAMB1 drains 801.6km of stream network (the entire Nambucca catchment), of which 202.5km is considered to be in poor geomorphic condition (Alluvium 2012). The left bank at NAMB1 comprised rock revetment and the right bank comprised marine sand with the bed consisting of marine sand. NAMB1 scored 88, a B+ for BANK CONDITION. The overall geomorphic condition for NAMB1 was 88, a grade of B+.

In summary, NAMB1 was assessed as being in good geomorphic condition, with rock revetment controlling erosion on the left bank the entire 100m length of the site. The soft sediments that comprise the right bank are constantly reworked but are primarily affected by depositional processes. The geomorphic condition at NAMB1 (B+) was above the subcatchment average of C for the Nambucca estuary.

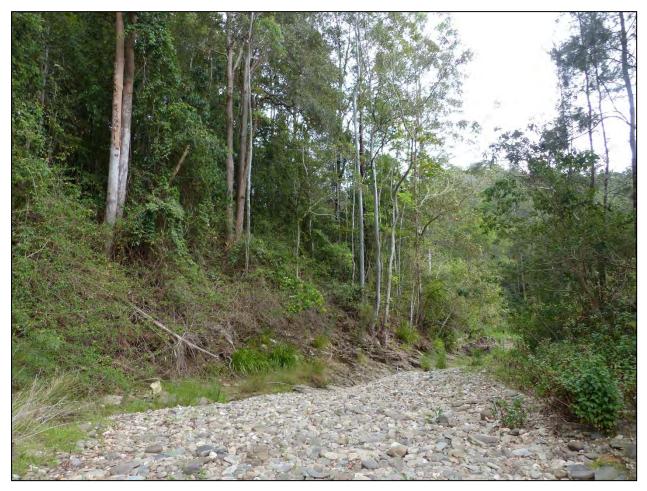
**Plate 3.9** Riparian vegetation condition at NAMB8 was considered to be a moderately disturbed system. This was primarily due to reduced riparian width and continuity, the dominance of weed and noxious weed species throughout the midstory and understory structural layers, low levels of large woody debris, historic land clearing and reduced habitat trees.

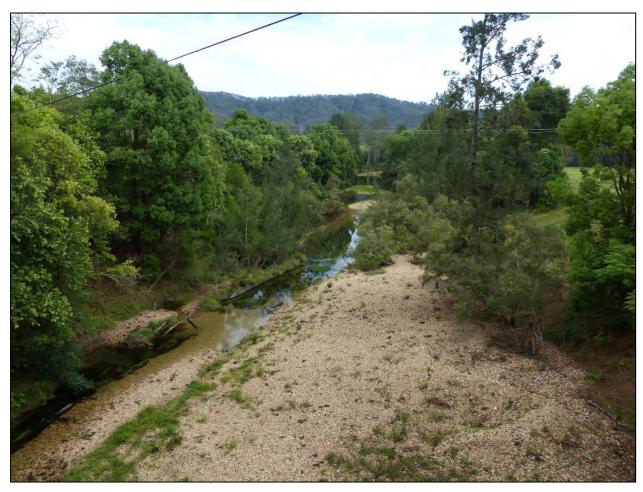
**Plate 3.10** Riparian vegetation condition at NAMB7 was low and considered to be highly disturbed. This was primarily due to poor habitat connectivity, the dominance of weed and noxious weed species throughout all structural layers and the presence of livestock throughout the riparian zone.

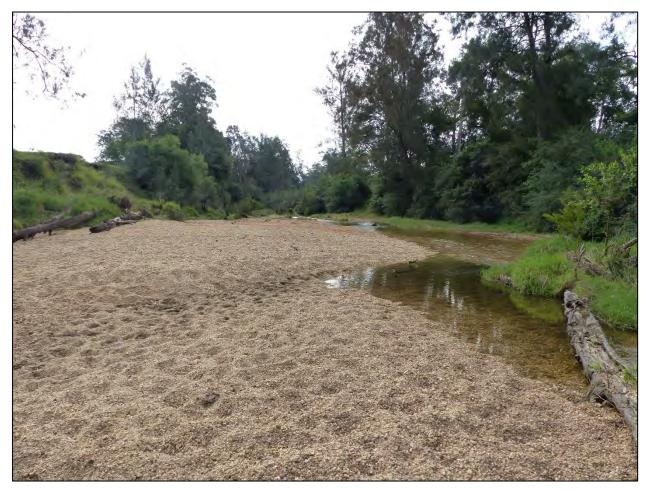
**Plate 3.11** Riparian vegetation condition at NAMB5 was low and considered to be a highly disturbed system. This was primarily due to poor riparian width, continuity and habitat connectivity, the dominance of weed and noxious weed species throughout all structural layers, reduced cover in the canopy and midstory and the presence of livestock throughout the riparian zone.

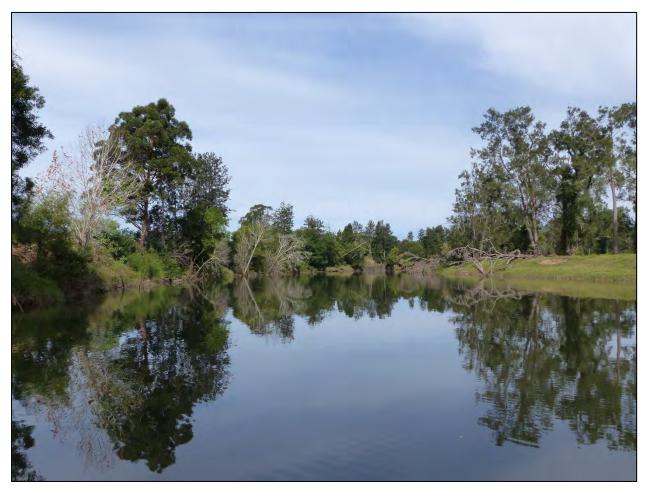
**Plate 3.12** Riparian vegetation condition at NAMB5 was considered to be a very highly disturbed system. This was primarily due to poor riparian width, continuity and connectivity, the dominance of weed and noxious weed species throughout several structural layers, reduced vegetation cover and the presence of livestock throughout the riparian zone.

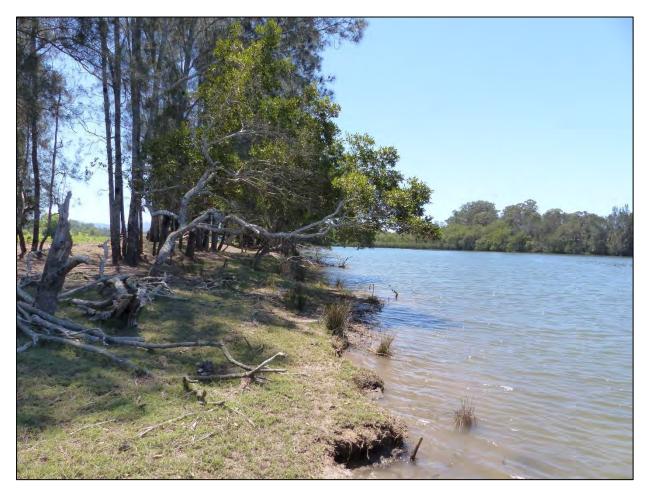
**Plate 3.13** Despite possessing some remnant canopy vegetation riparian vegetation at NAMB4 was highly disturbed. This was primarily due to poor riparian width, continuity and connectivity, reduced vegetation cover and the presence of livestock throughout the riparian zone.

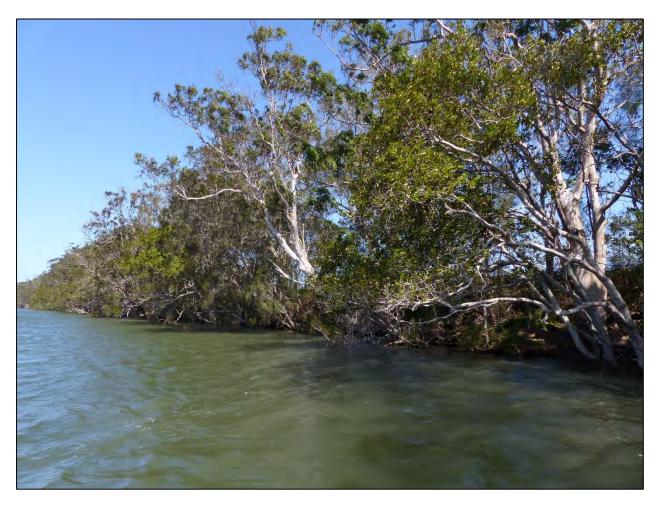
**Plate 3.14** Despite possessing good vegetation cover throughout all structural layers NAMB3 was considered to be a moderately disturbed riparian system primarily due to poor riparian width and connectivity and the presence of weed and noxious weed species.

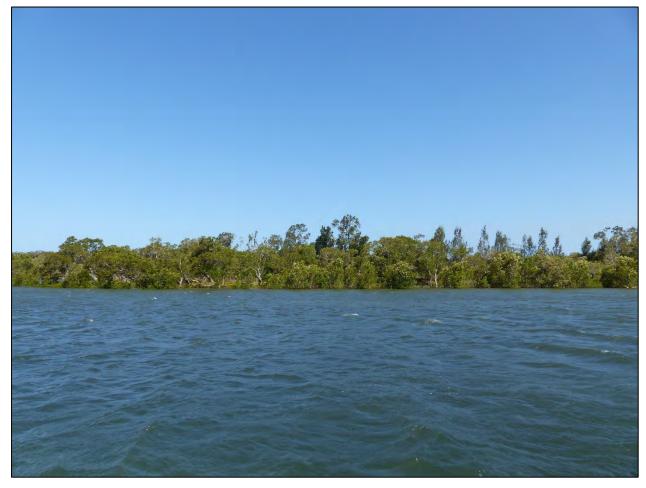
**Plate 3.15** Despite possessing good vegetation cover throughout the canopy and understory structural layers, NAMB2 was considered to be a mildly disturbed riparian system primarily due to poor riparian width and connectivity, the presence of weed and noxious weed species and inadequate riparian fencing.

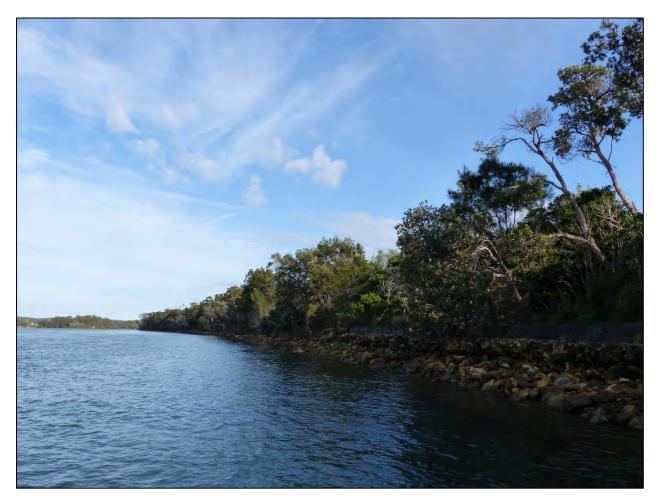
**Plate 3.16** Despite possessing good vegetation cover in the canopy and midstory layers with the removal of the original fringing riparian vegetation layer NAMB1 was considered to be a very highly disturbed riparian system.

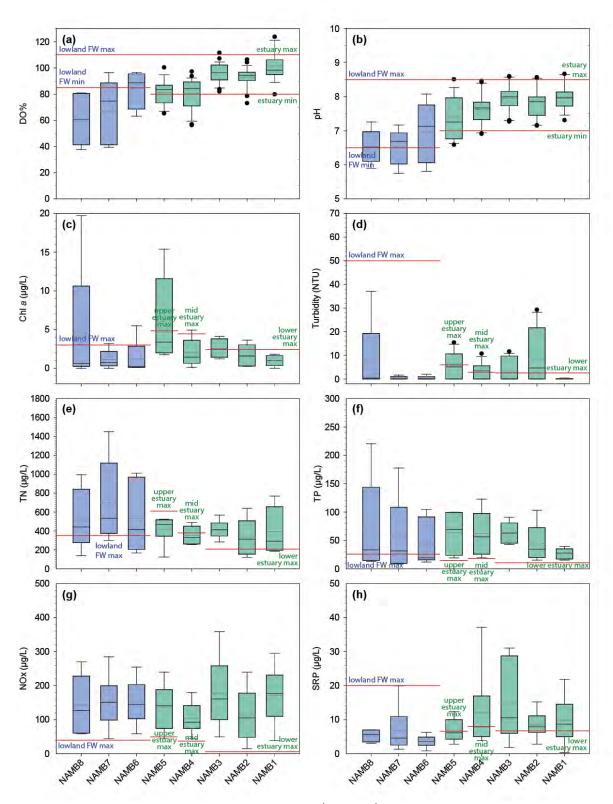
**Figure 3.7** Mean (grey line), median (black line), 25<sup>th</sup> and 75<sup>th</sup> percentiles, and range of water quality variables in the main stem of the Nambucca River from 2016-2017. Outliers are represented by black dots. Green and blue boxes represent estuary and freshwater sites, respectively. Red lines represent the relevant maximum or minimum guideline value for each type of system.

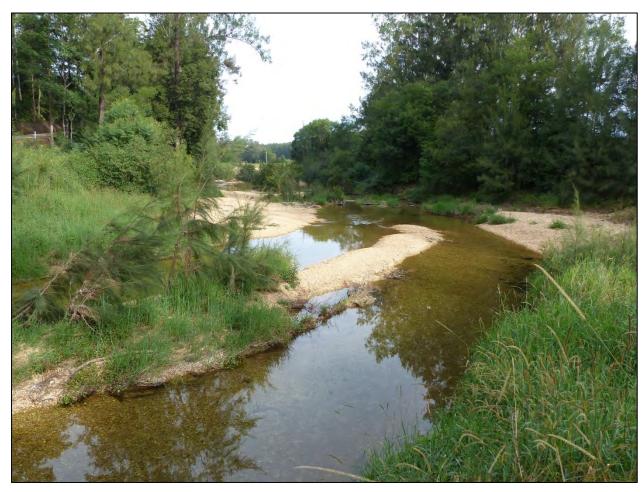
**Plate 3.24** Riparian vegetation condition at MISC1 was considered to be highly disturbed. This was primarily due to reduced riparian width and poor continuity and connectivity, the dominance of weed and noxious weed species throughout all structural layers, reduced cover in the canopy and midstory and the presence of livestock throughout the riparian zone.

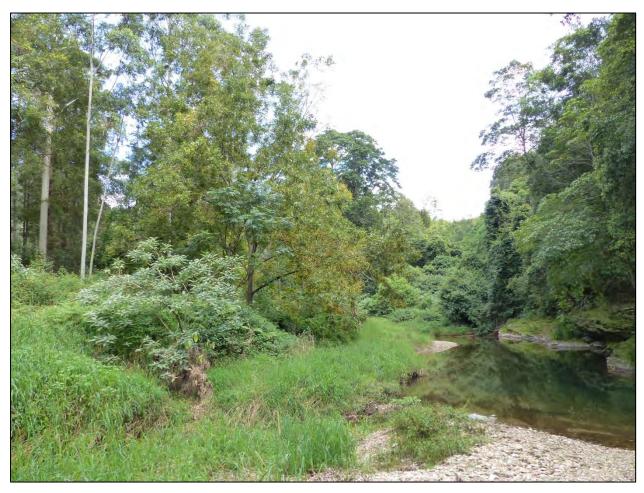
**Plate 3.25** Despite possessing good native vegetation cover in the forested areas adjacent to the riparian zone, riparian condition at BUCC2 was considered to be a highly disturbed system. This was primarily due to reduced riparian width and poor continuity, the dominance of weed and noxious weed species in the midstory and understory structural layers, reduced cover in the canopy and midstory structural layers and low levels of large woody debris.

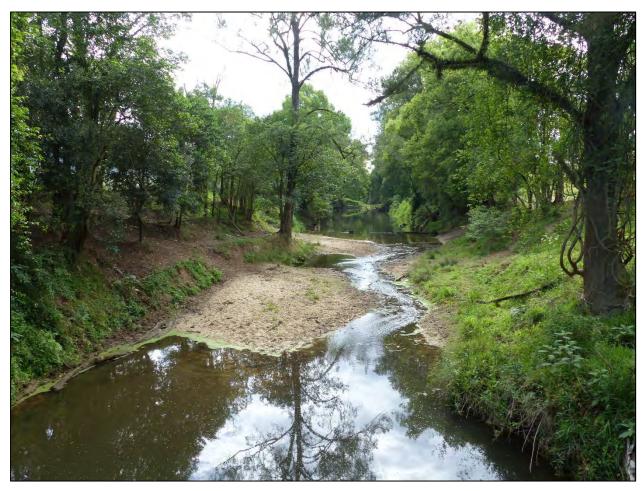
**Plate 3.26** Riparian vegetation condition at BUCC1 was poor and considered to be a very highly disturbed system. This was primarily due to poor habitat connectivity and reduced vegetation width and continuity, the dominance of weed and noxious weed species throughout all structural layers and the presence of livestock throughout the riparian zone.

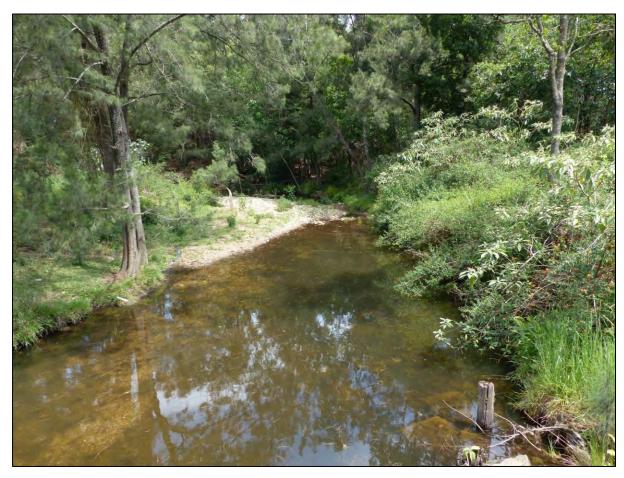
**Plate 3.27** Despite possessing good vegetation cover in the canopy layer riparian veetation at SOUC3 was low and considered to be a highly disturbed system. This was primarily due to reduced riparian vegetation width, the dominance of weed and noxious weed species, particularly in the midstory, reduced woody and non-woody debris and the presence of livestock throughout the riparian zone.

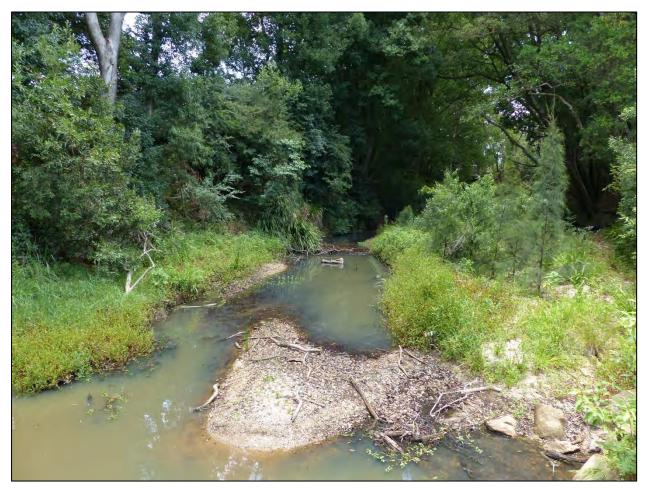
**Plate 3.28** Despite possessing good vegetation cover in the canopy and midstory layers riparian vegetation at SOUC2 was poor and considered to be a very highly disturbed system. This was primarily due to poor habitat connectivity, the dominance of weed and noxious weed species throughout all structural layers and the presence of livestock throughout the riparian zone.

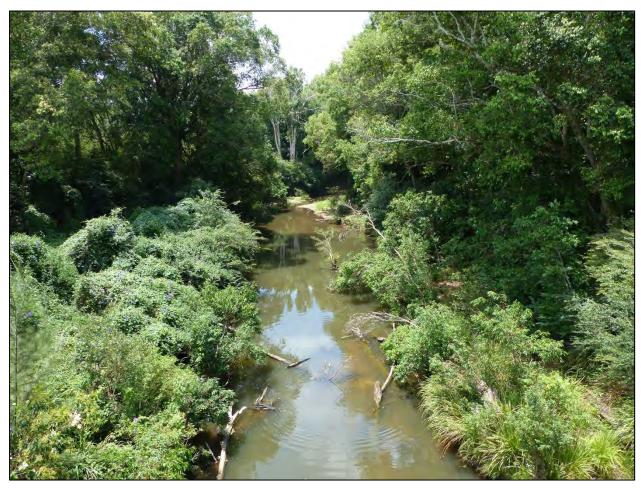
**Plate 3.29** Despite possessing good vegetation cover in the canopy and midstory layers riparian vegetation at SOUC1 was a highly disturbed system. This was primarily due to the dominance of weed and noxious weed species throughout all structural layers, poor habitat connectivity and the presence of livestock throughout the riparian zone.

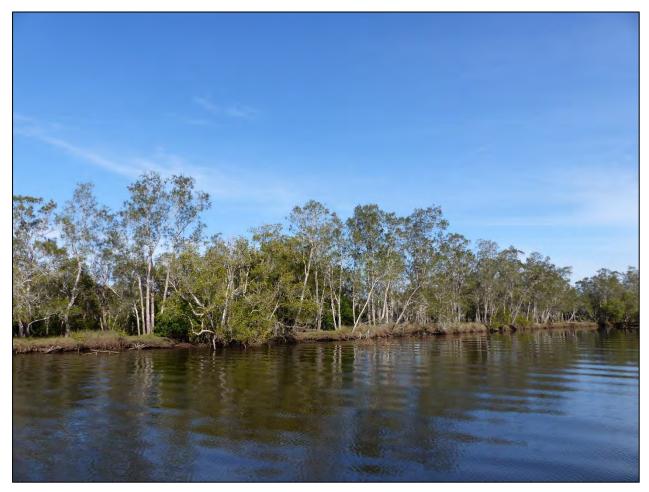
**Plate 3.30** Riparian vegetation condition at NEWC1 was very good and considered to be of low disturbance. This was mainly attributed to the dominance of native species throughout all structural layers and the presence of livestock in the riparian zone.

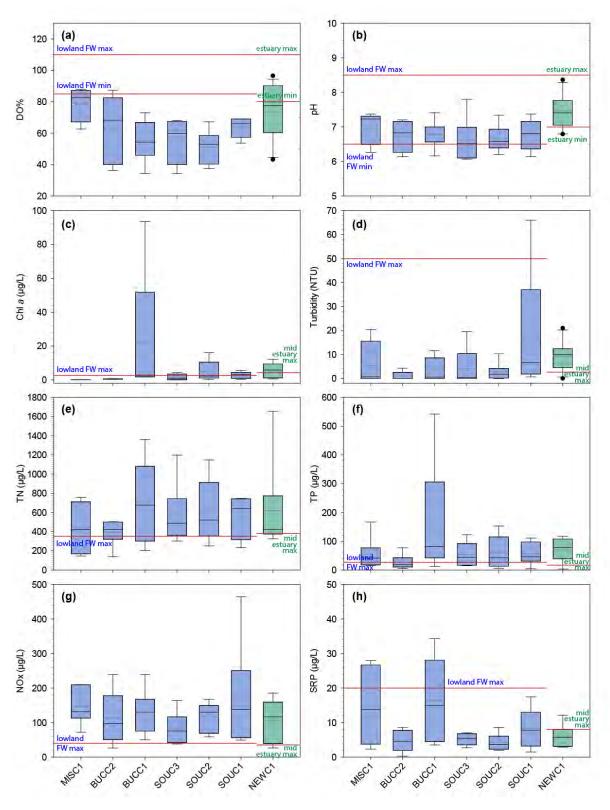
**Figure 3.11** Mean (grey line), median (black line), 25<sup>th</sup> and 75<sup>th</sup> percentiles, and range of water quality variables in the tributaries of the Nambucca River (North Arm) from 2016-2017. Outliers are represented by black dots. Green and blue boxes represent estuary and freshwater sites, respectively. Red lines represent the relevant maximum or minimum guideline value for each type of system.

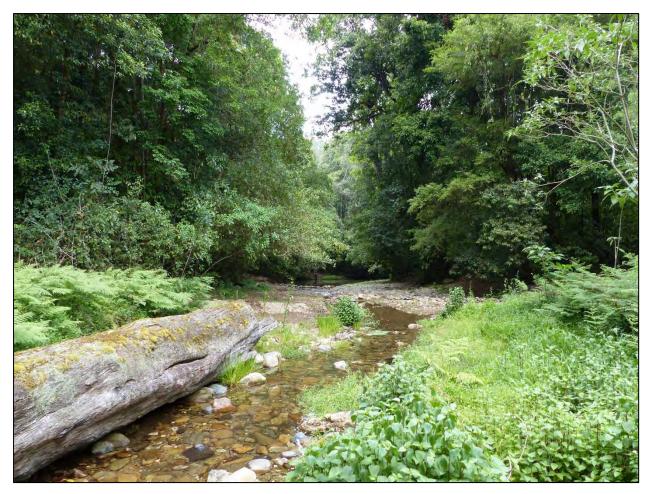
**Plate 3.36** Riparian vegetation condition at TAYL5 was very good and of low disturbance. This was mainly attributed to the presence of a remnant canopy and the dominance of native species throughout all structural layers, however the presence of weed and noxious weed species and low levels of large woody debris reduced riparian condition.

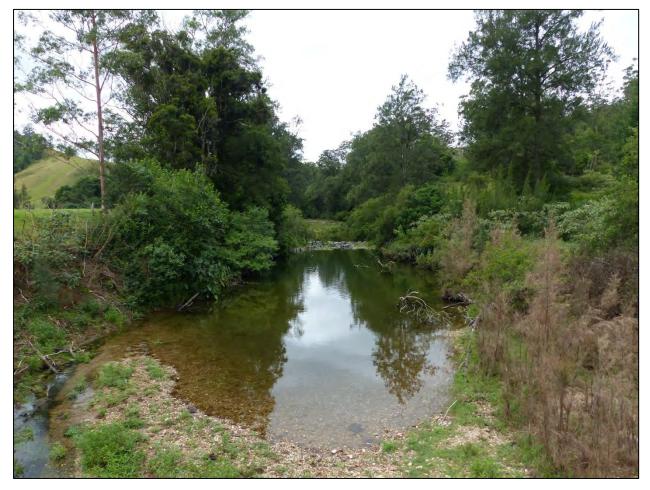
**Plate 3.37** Riparian vegetation condition at TAYL4 was considered to be highly disturbed. This was primarily due to reduced riparian vegetation width, disrupted continuity, poor habitat connectivity, the presence of weed and noxious weed species, reduced canopy and midstory cover, low levels of large woody debris, inadequate riparian fencing and the presence of livestock throughout the riparian zone.

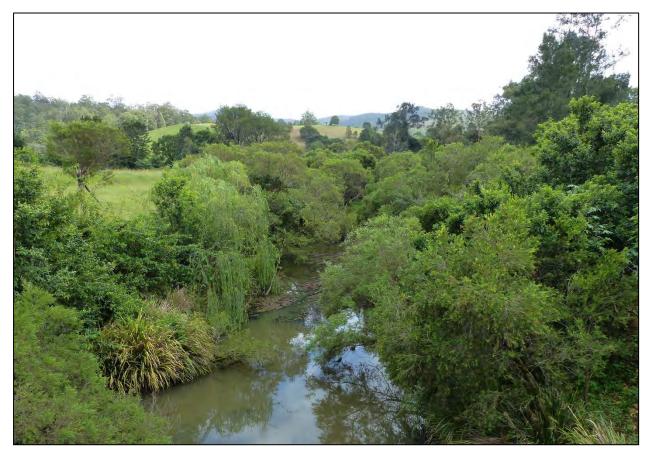
**Plate 3.38** Despite possessing good vegetation cover in the midstory layer, riparian vegetation at TAYL3 was highly disturbed. This was primarily due to reduced riparian vegetation width, disrupted continuity, poor habitat connectivity, the presence of weed and noxious weed species, reduced canopy cover, low levels of large woody debris, inadequate riparian fencing and the presence of livestock throughout the riparian zone.

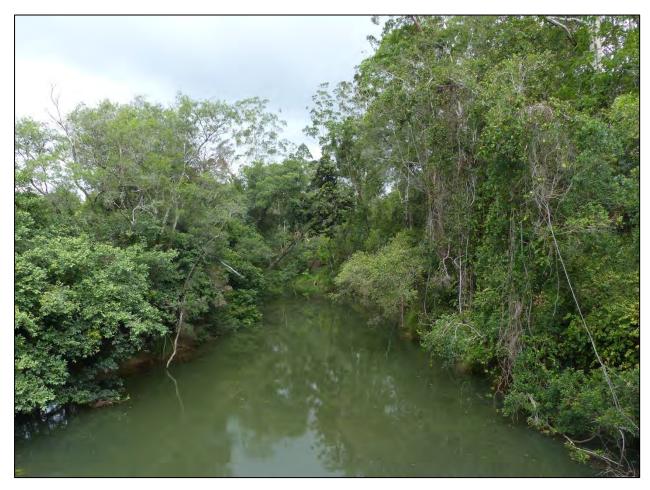
**Plate 3.39** Despite possessing relatively good vegetation cover in the canopy and midstory layers, riparian vegetation at TAYL2 was considered to be a moderately disturbed system. This was primarily due to reduced riparian width and continuity and cover, the presence of weed and noxious weed species, particularly in the midstory structural layer, low levels of large woody debris and inadequate riparian fencing and livestock presence.

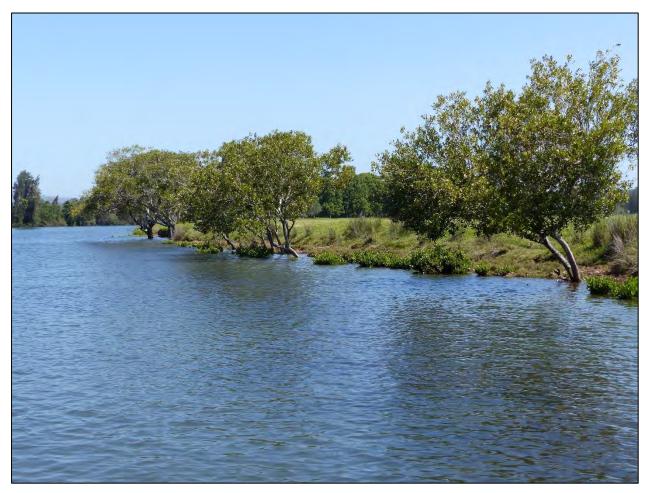
**Plate 3.40** Riparian vegetation condition at TAYL1 was low and considered to be a very highly disturbed system. This was primarily due to poor riparian width and continuity, the presence of weed and noxious weed species and livestock impacts throughout the riparian zone.

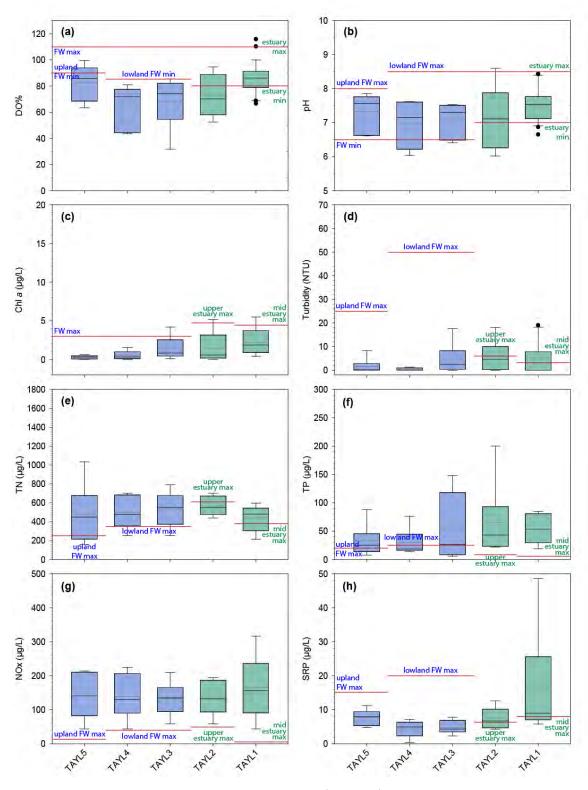
**Figure 3.13** Mean (grey line), median (black line), 25<sup>th</sup> and 75<sup>th</sup> percentiles, and range of water quality variables in Taylors Arm from 2016-2017. Outliers are represented by black dots. Green and blue boxes represent estuary and freshwater sites, respectively. Red lines represent the relevant maximum or minimum guideline value for each type of system.

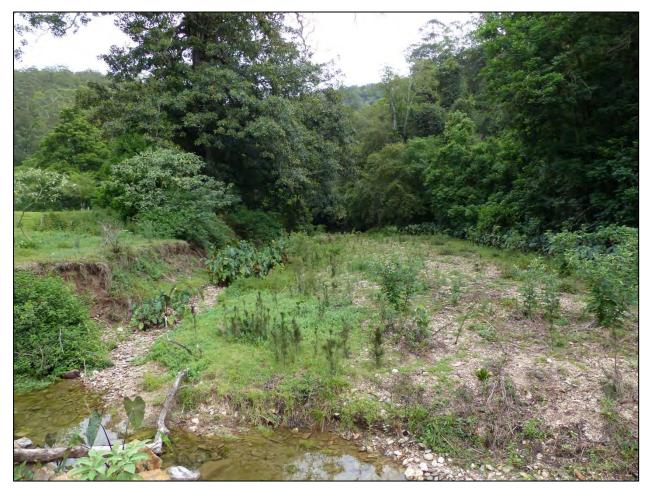
**Plate 3.44** Riparian vegetation condition at THUM1 was considered to be highly disturbed. This was primarily due to disrupted continuity, the presence of weed and noxious weed species, reduced canopy and midstory cover, low levels of large woody debris, inadequate riparian fencing and the presence of livestock throughout the riparian zone.

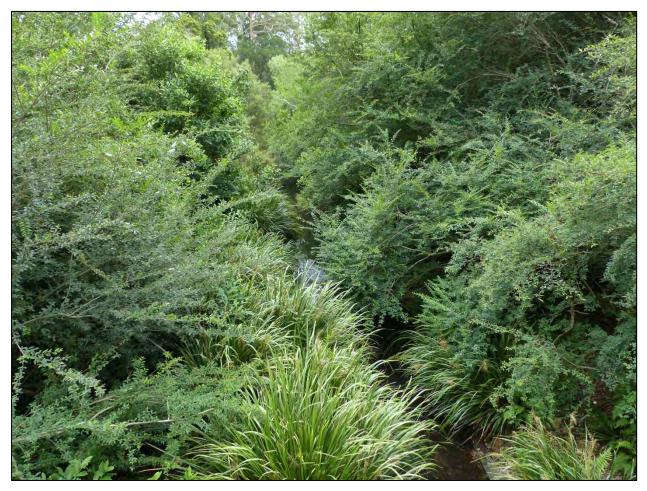
**Plate 3.45** Despite possessing good vegetation cover, particularly in the midstory, riparian vegetation at BAKE1 was highly disturbed. This was primarily due to poor riparian habitat connectivity, the dominance of weed and noxious weed species throughout all structural layers, and inadequate riparian fencing and the presence of livestock throughout the riparian zone.

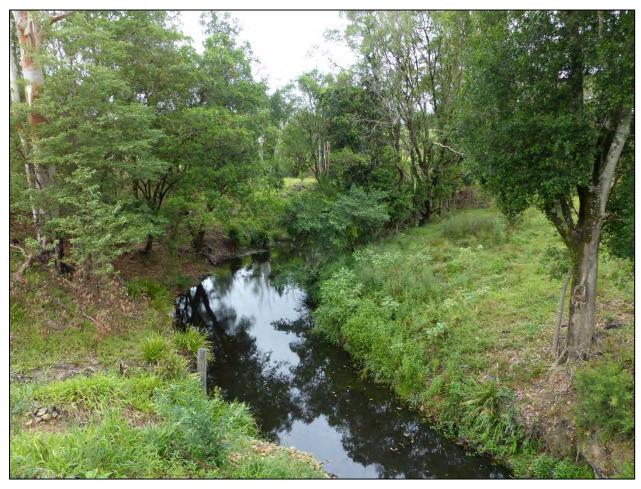
**Plate 3.46** Riparian vegetation condition at TOMC1 was highly disturbed. This was primarily due to poor riparian width and habitat connectivity, reduced connectivity, the presence of weed and noxious weed species, inadequate riparian fencing and the presence of livestock throughout the riparian zone.

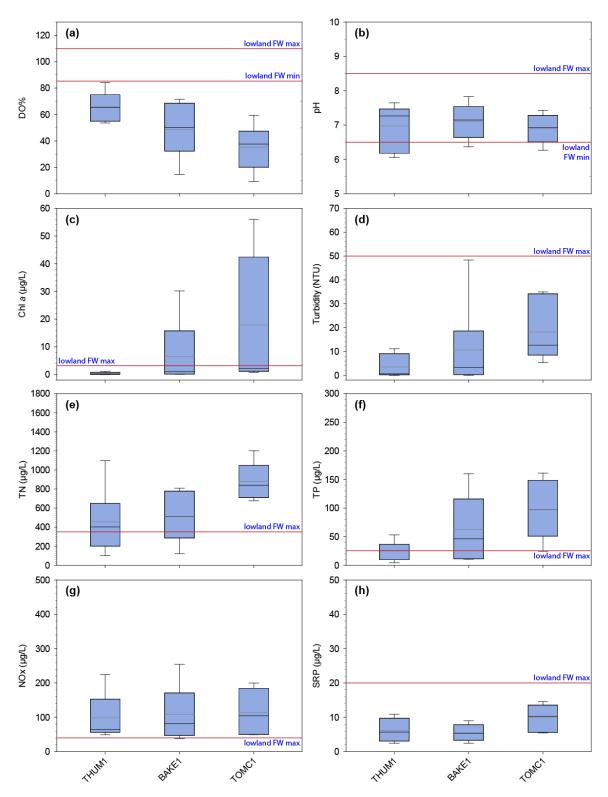
**Figure 3.14** Mean (grey line), median (black line), 25<sup>th</sup> and 75<sup>th</sup> percentiles, and range of water quality variables in freshwater tributaries of Taylors Arm from 2016-2017. Outliers are represented by black dots. Green and blue boxes represent estuary and freshwater sites, respectively. Red lines represent the relevant maximum or minimum guideline value for each type of system.

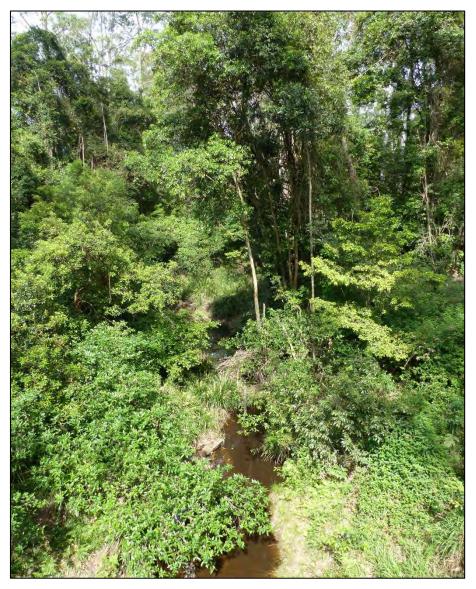
**Plate 3.51** Despite possessing good vegetation cover in the canopy and midstory layers, riparian vegetation at EUNC1 was considered to be mildly disturbed. This was primarily due to presence and regeneration of weed and noxious weed species, particularly in the midstory and understory structural layers, reduced levels of cover in the canopy and a reduction in levels of woody debris and native non-woody debris.

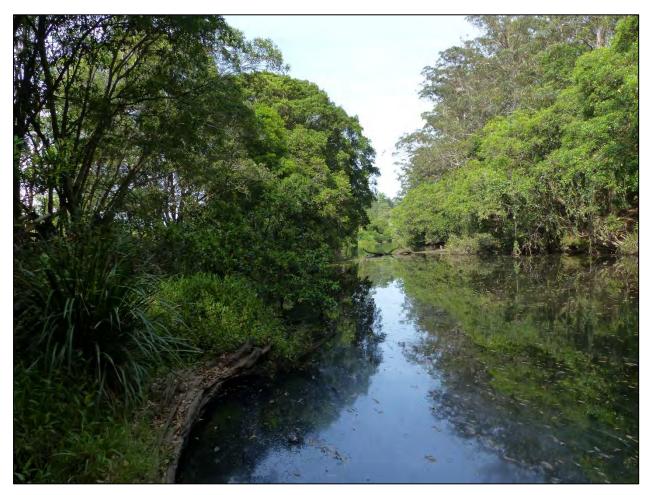
**Plate 3.52a** Riparian vegetation condition at WARR3 was considered to be moderately disturbed. This was primarily due to poor riparian vegetation width, habitat connectivity and disrupted continuity, the presence of weed and noxious weed species in the midstory and understory, reduced canopy and midstory cover, low levels of large woody debris and the presence of livestock throughout the riparian zone.

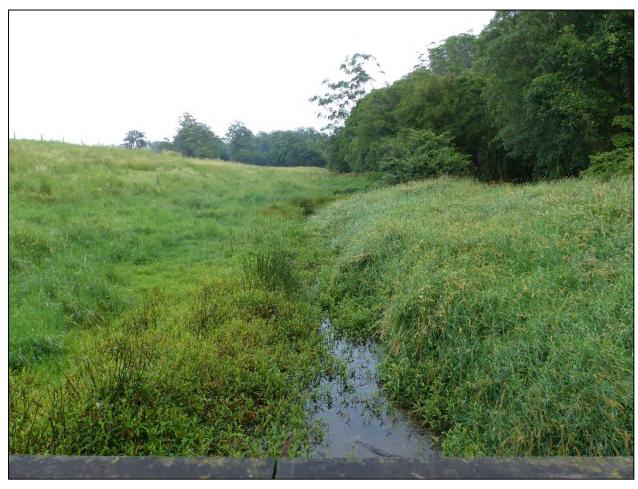
Plate 3.52b WARR3 also comprised a Knotweed wet meadow at the upstream part of the site.

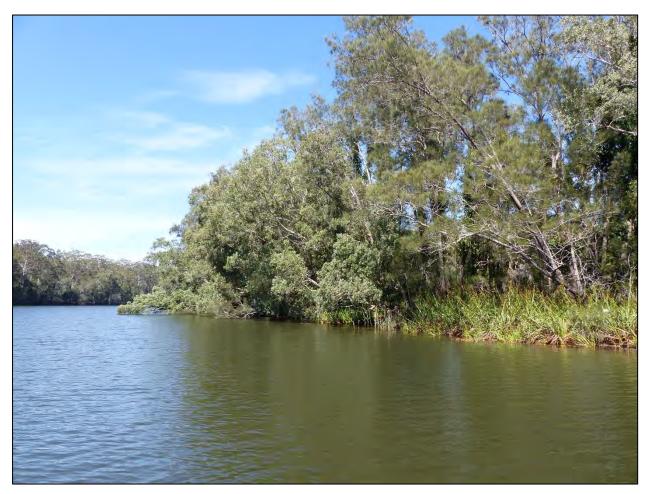
**Plate 3.53** Riparian vegetation condition at WARR2 was good yet mildly disturbed. This was primarily due to reduced riparian width and habitat connectivity, the presence of weed and noxious weed species, low levels of large woody debris and inadequate riparian fencing.

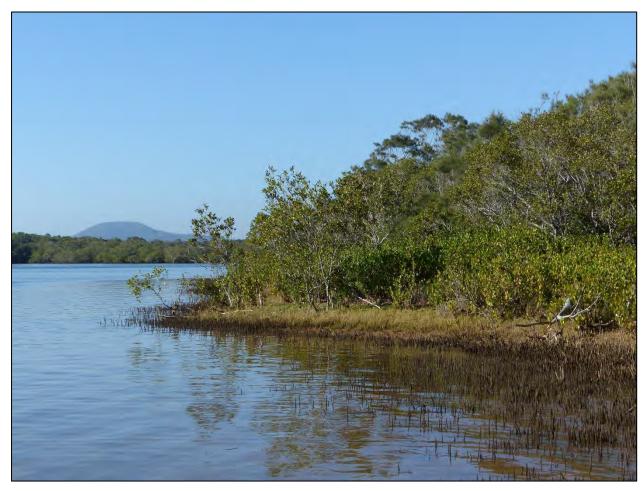
**Plate 3.54** Riparian vegetation condition at WARR1 was very good and considered to be of low disturbance. This was mainly attributed to the presence of a remnant canopy and the dominance of native species throughout all structural layers. Improvements could be made through the control and removal of weed and noxious weed species.

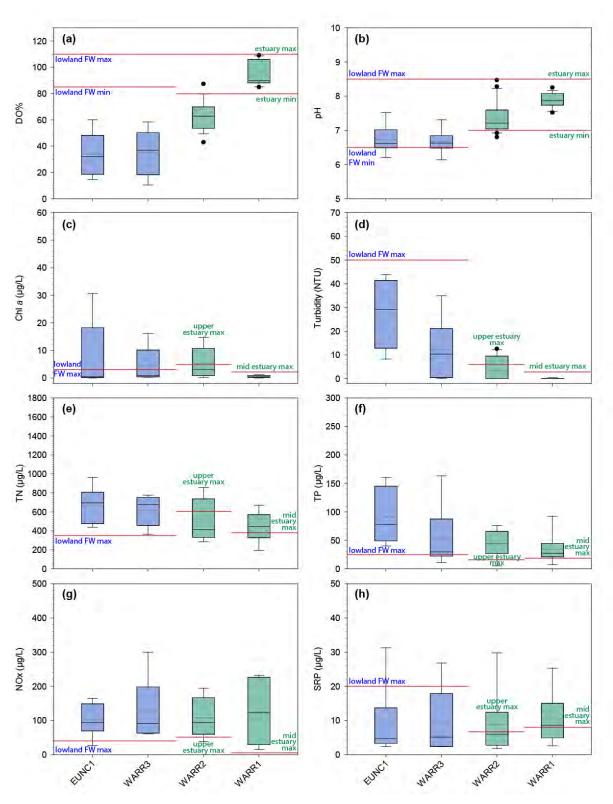
**Figure 3.16** Mean (grey line), median (black line), 25<sup>th</sup> and 75<sup>th</sup> percentiles, and range of water quality variables in Eungai and Warrell Creeks from 2016-2017. Outliers are represented by black dots. Green and blue boxes represent estuary and freshwater sites, respectively. Red lines represent the relevant maximum or minimum guideline value for each type of system.

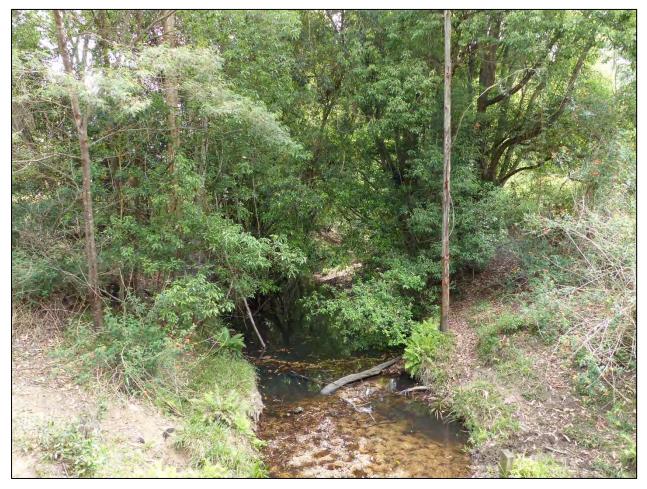
**Plate 3.59** Riparian vegetation condition at DEEP4 was considered to be highly disturbed. This was primarily due to the prevalence and regeneration of weed and noxious weed species, reduced cover, limited habitat trees, a reduction in large woody and native non-woody debris and inadequate riparian fencing and subsequent animal impact.

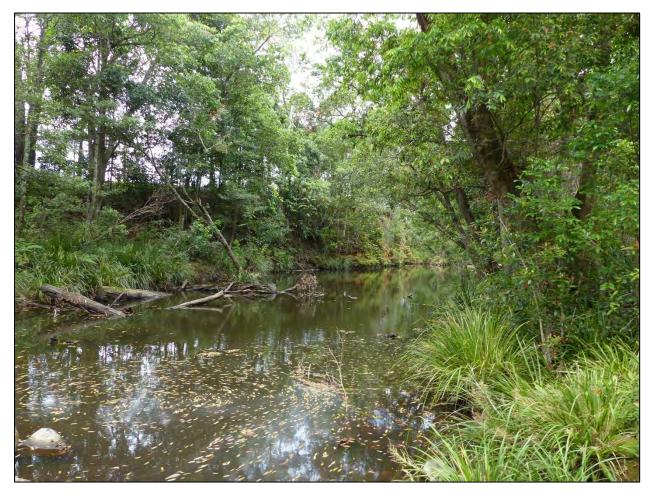
**Plate 3.60** Riparian vegetation condition at DEEP3 was considered to be a mild disturbance system. This was primarily due to reduced riparian vegetation width, disrupted continuity, poor habitat connectivity and the presence and regeneration of weed and noxious weed species, reduced cover and a reduction in large woody debris and native non-woody debris.

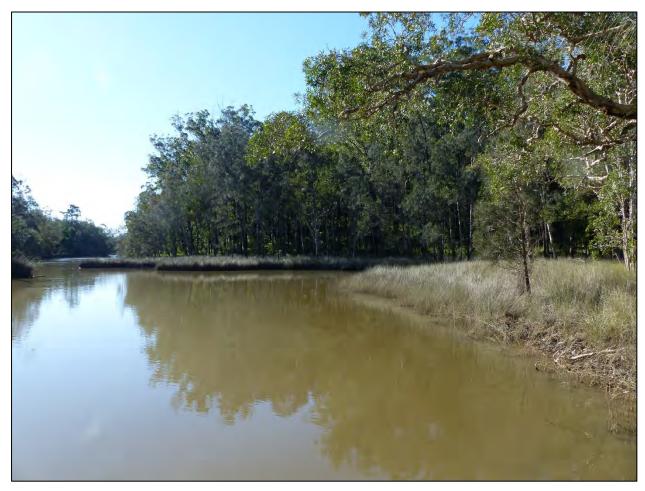
**Site:** The original riparian vegetation community at Deep Creek 2 (DEEP2, Plate 3.61) was described as 'Broad-leaved Paperbark – Bare Twig Rush swamp sclerophyll open forest of coastal swamps' (NAM\_ForW06) and 'Swamp Oak – Broad-leaved Paperbark – Willow Bottlebrush floodplain forested wetland' (NAM\_ForW02), both listed TEC's, grading into 'Blackbutt – Red Mahogany – Bloodwood dry open forest on infertile sandy soils of low coastal rises and hills' (NAM\_DOF04) (OEH 2015). DEEP2 received an excellent riparian condition score of 91.5 a grade of A- (Table 3.72).

**Summary:** Deep Creek 2 was a relatively undisturbed open-swamp/closed-forest system with an intact remnant canopy and all structural layers dominated by native species in a predominantly forested/partially cleared rural-coastal landscape. The immediate surrounding landuse was state forest, beyond which was agricultural grazing country, transport networks and urban settlement. Significant remnant stands of vegetation surround the site in the form of Nambucca State Forest and wetland areas that have previously been recognised as 'suitable vegetation for environmental protection' (BMT WBM 2008). Representative elements of the remnant vegetation communities were retained in all structural layers, with DEEP2 scoring full marks for the Native Species subindex and well for Habitat, Cover, Debris and Management subindices (Table 3.72). Riparian condition was affected by a small disruption to vegetation continuity and reduced levels of woody debris.

**Plate 3.61** Riparian vegetation condition at DEEP2 was exemplary and considered to be relatively undisturbed. This was mainly attributed to the presence of a remnant canopy and the dominance of native species throughout all structural layers.

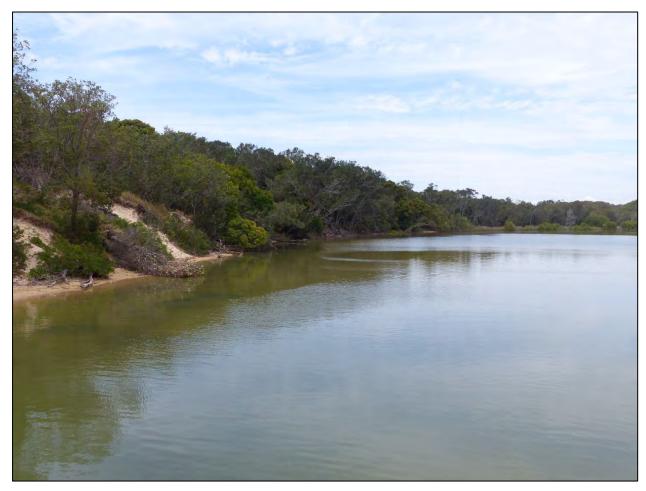
**Noxious weed species**: Noxious weed species observed on-site were Bitou Bush (*Chrysanthemoides monilifera* subsp. *rotundata*), Senna (*Senna pendula* var. *glabrata*), Asparagus Ferns (*Asparagus* spp.) and Coastal Morning Glory (*Ipomoea cairica*).

**Summary:** Deep Creek 1 was a mildly disturbed closed-forest system with a mixed-aged canopy and a mix of native and exotic species throughout all structural layers, in a predominantly forested, partially cleared urban-coastal landscape. The immediate surrounding landuse was Crown Land, forestry and Nature Reserve beyond which was urban settlement. Significant remnant stands of vegetation surround the site in the form of Crown Land and Nambucca State Forest to the south and Valla Nature Reserve to the North. Representative elements of the remnant vegetation communities were retained in all structural layers, with DEEP1 scoring well for subindices Habitat, Native Species and Cover and moderately for Debris and Management subindices (Table 3.73). Riparian condition was affected by contracted riparian vegetation width and the presence and regeneration of weed and noxious weed species, particularly in the midstory and understory structural layers. A reduction in seagrass cover, limited habitat trees and large woody debris and exposed tree roots due to bank erosion also contributed to the reduction in riparian grade at this site.

**Plate 3.62** Despite possessing good vegetation cover throughout all structural layers, DEEP1 was considered to be a mildly disturbed riparian system primarily due to the presence of weed and noxious weed species, reduced riparian width and low levels of large woody debris.
