Nambucca River Estuary Management Study

FINAL REPORT

Prepared For: Nambucca Shire Council

Prepared By: WBM (member of the BMT group of

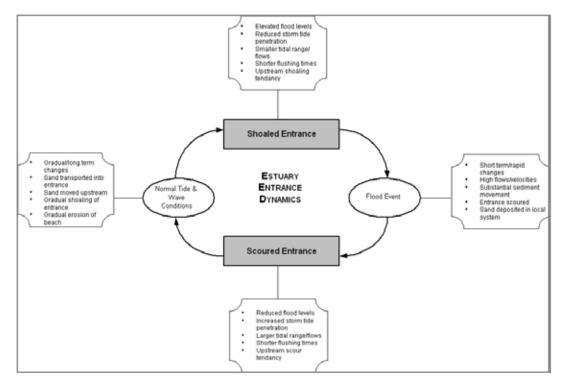
Figure 7-1 Flow chart showing the typical cycle of entrance conditions

Wave-dominated barrier estuaries typically have a tidal inlet that is naturally constricted by wave-deposited beach sand. These types of estuaries are often associated with larger rivers whose discharges tend to counteract the flux of wave-transported beach sand in the estuary mouths and occur behind sand barriers on the exposed sections of the coast. It is these natural processes occurring around the entrances of estuaries, up and down the coast of NSW, which are commonly believed to be in need of management, due to their often-constricted state.

In considering the influences and management options of the entrance to an estuary, it is essential to have an understanding of the complex interactions of the prevailing processes. The lower reaches of an estuary are typically in a form of dynamic equilibrium between the controlling forces of the tidal and fluvial activity of the river and the littoral processes of the adjacent beaches. As such, the configuration of the river and entrance channels as well as the adjacent coastline is continually changing under the natural variability of the prevailing conditions. As these changes occur, the associated hydraulic, water quality, sedimentation and erosion characteristics of the estuary also change in response. Figure 7-1 illustrates a typical cycle of entrance conditions and the influences of the various processes.

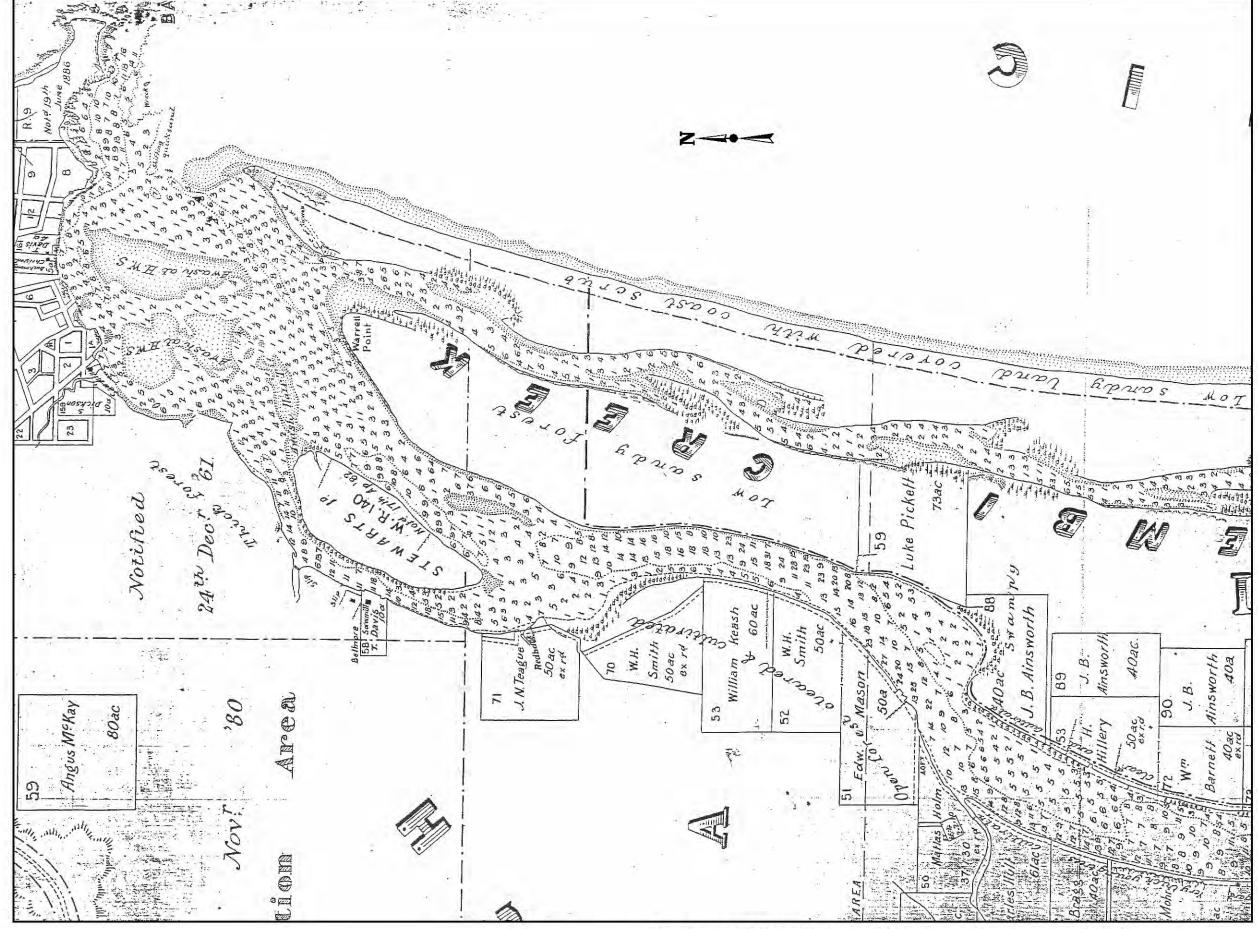
Figure 7-2

Nambucca River Estuary Hydrographic Survey - 1891

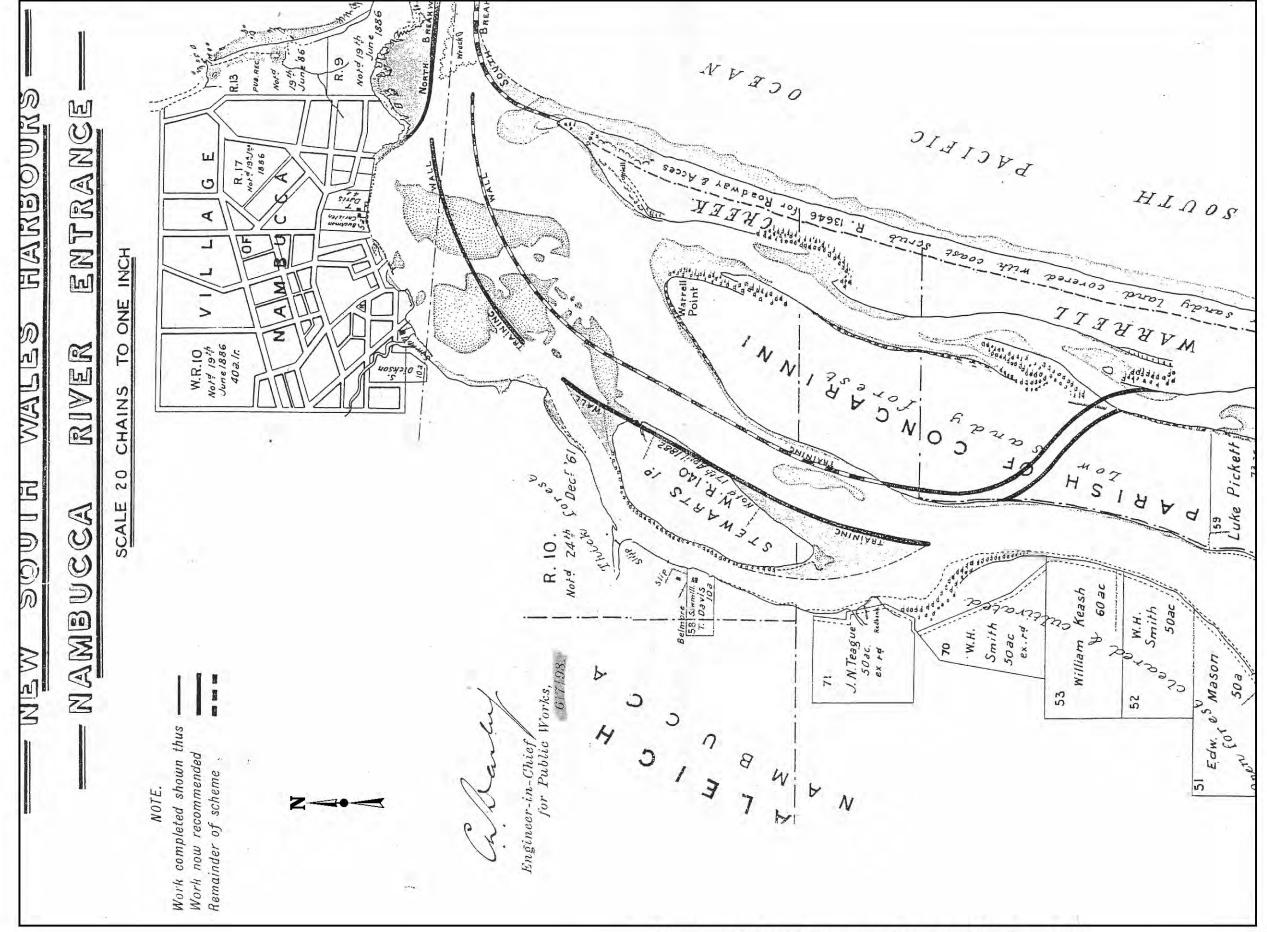
Figure 7-3

Nambucca River Entrance Training Works - 1898

- Northern breakwater:
- Northern training walls up to Stuarts Island; and
- Diversion of Warrell Creek to the upstream end of Stuarts Island.

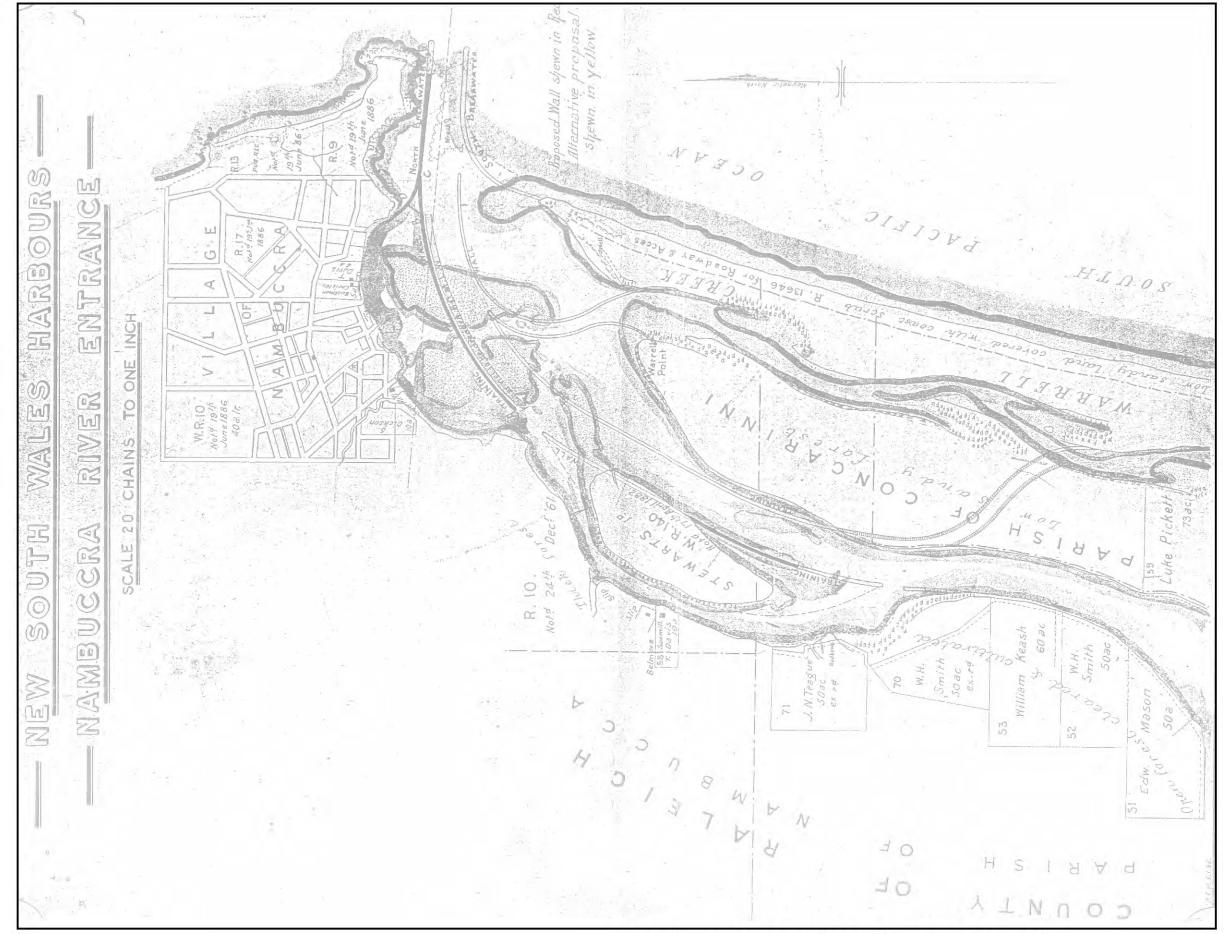
Figure 7-4

Nambucca River Entrance Training Works - 1903

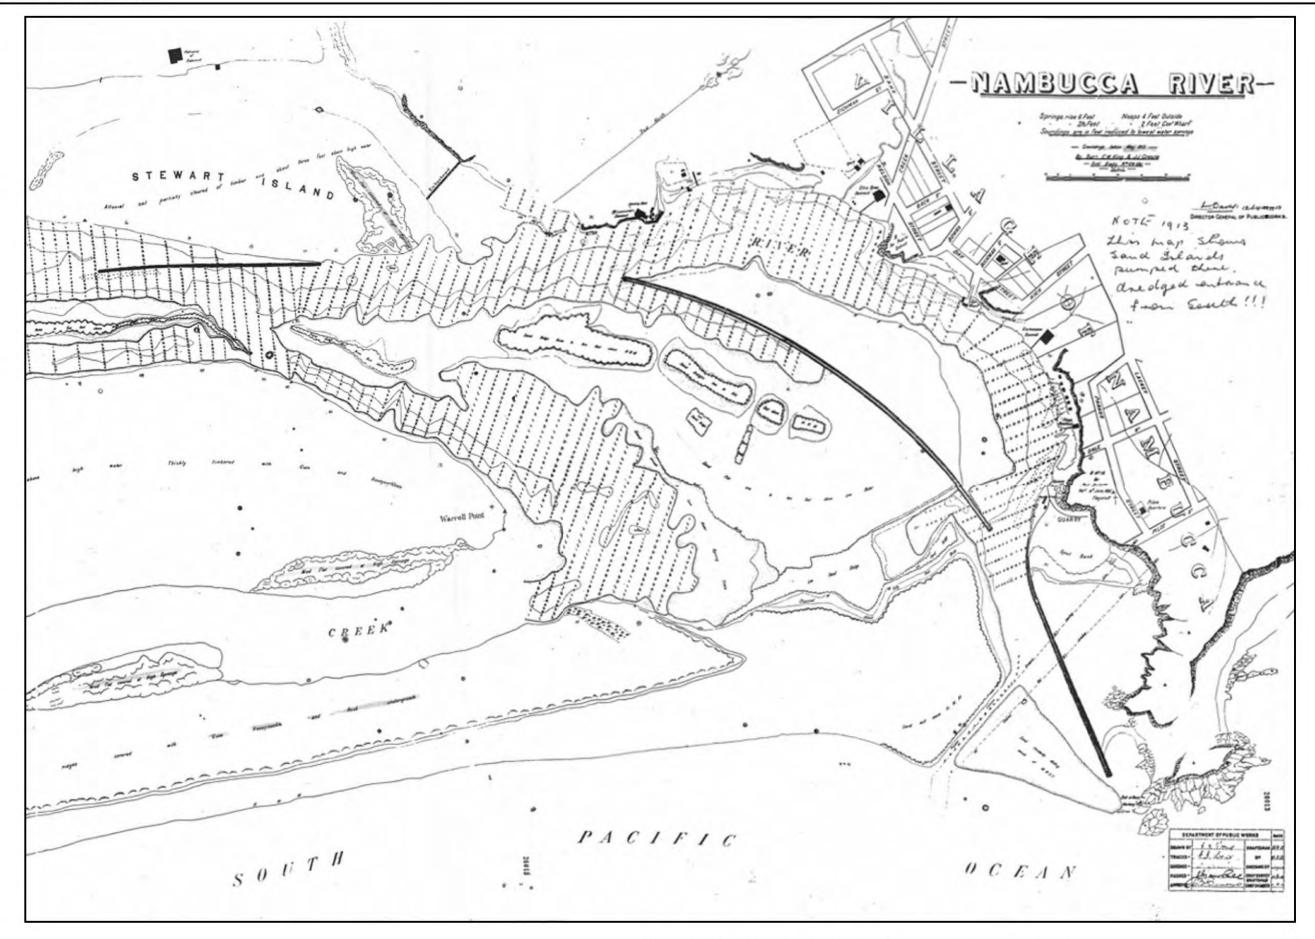
Nambucca River Entrance Training Works - 1913

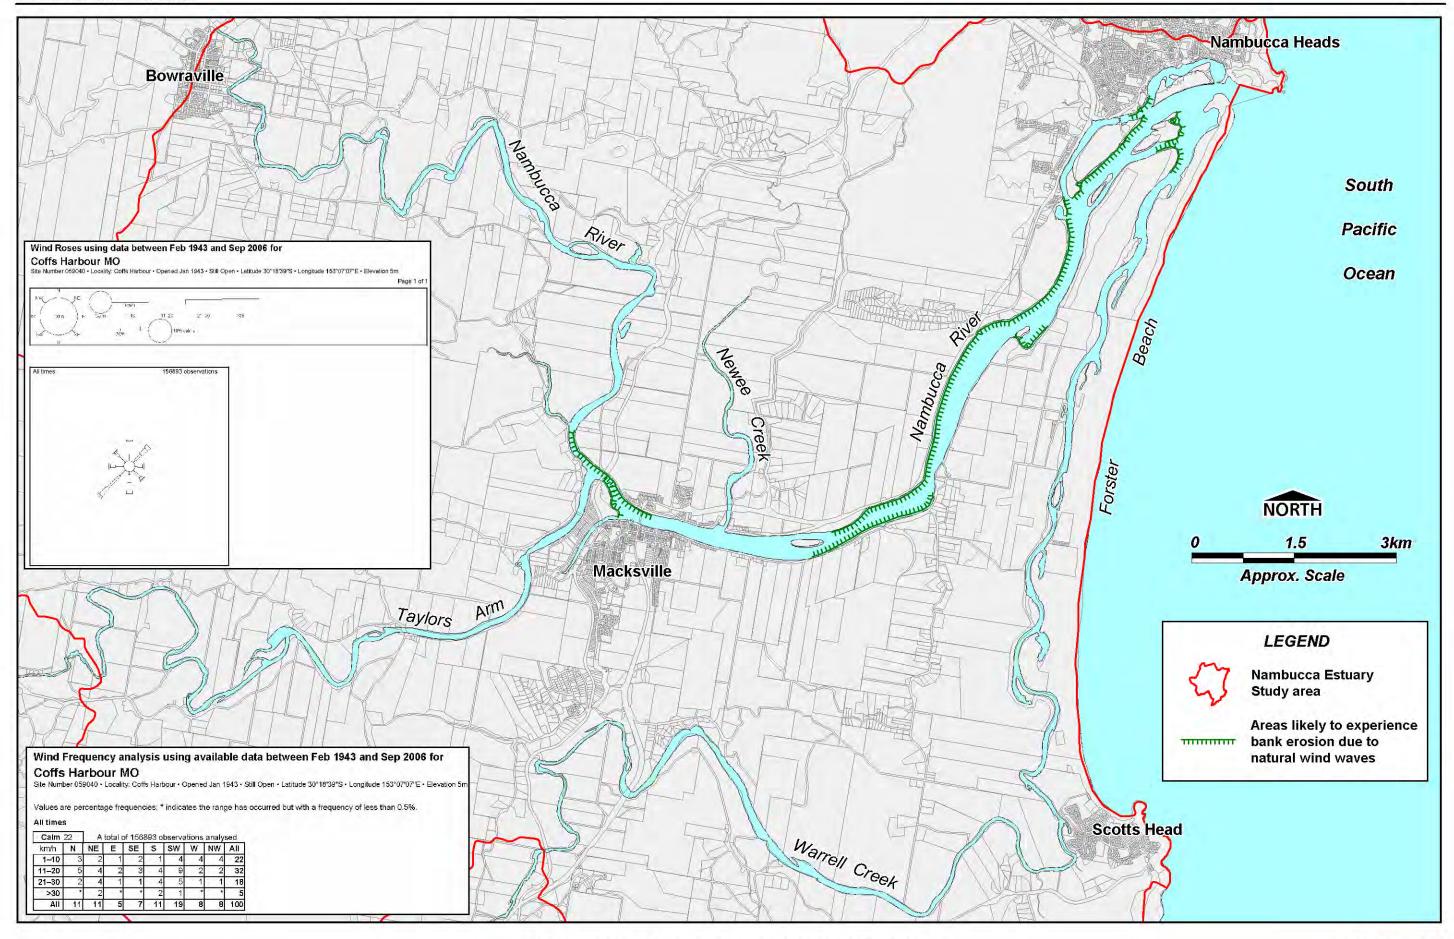
Figure 8-11

Bank Erosion Stress due to Natural Wind Waves

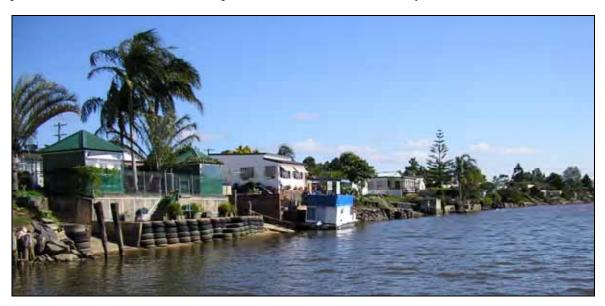
Figure 8-14 Private Foreshore Structures on Taylors Arm at Macksville

All private foreshore structures observed were found to exist on the lower Taylors Arm and Tilly Willy Creek and have been used to protect the foreshore against bank erosion. Figure 8-14 is a picture taken in 2004 of some of the private foreshore structures on Taylors Arm.

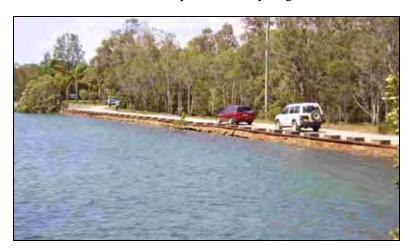
Figure 9-1 Stuarts Island Causeway

The causeway is approximately 120m long and about 7m wide at the top and approximately 11m wide at the base. The road across the causeway is effectively single lane.

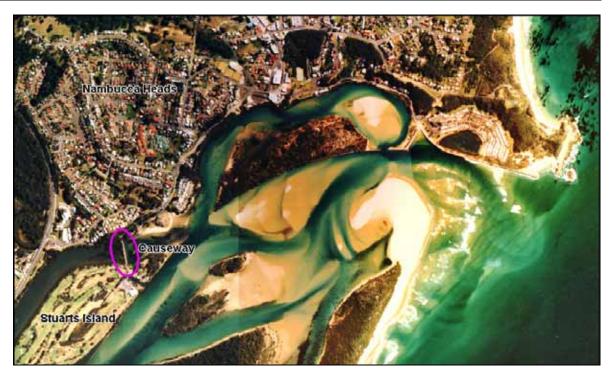
Figure 9-2 Stuarts Island Causeway in relation to estuary and entrance

Figure 9-2 shows the proximity of the causeway to the entrance. This region of the estuary is part of the active coastal system and is dominated by ocean influences as well as local estuary conditions.

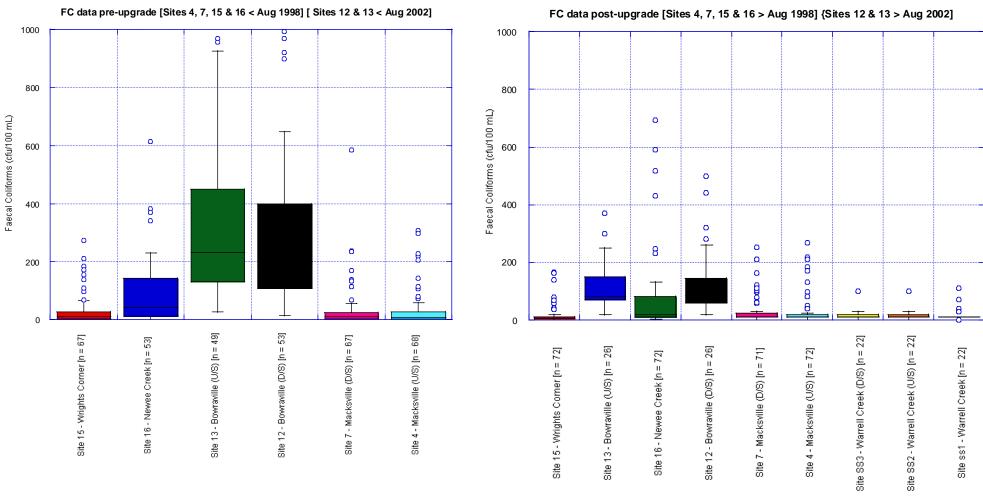
Figure 15-4 Faecal Coliform Box and Whisker Plots (Pre- and post-upgrade scenarios)

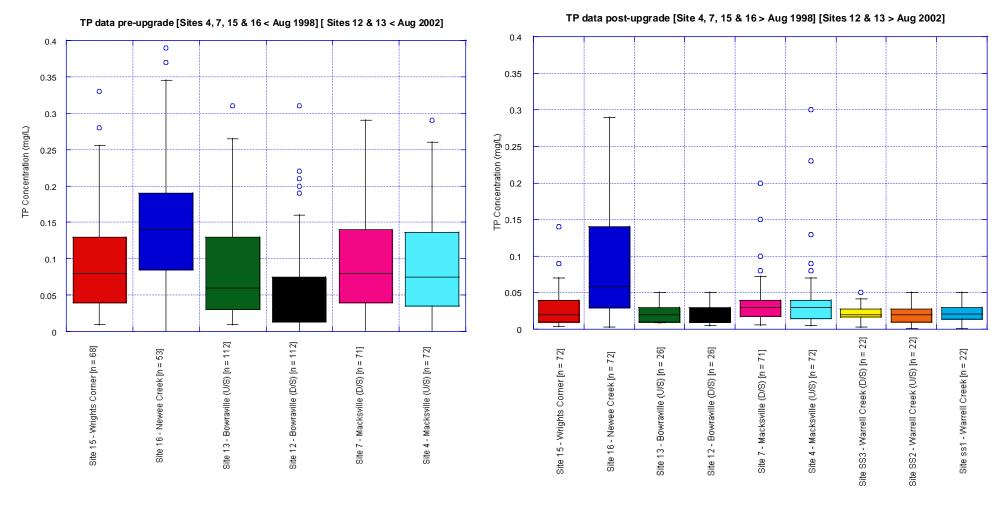
Figure 15-5 TP Box and Whisker Plots (Pre- and post-upgrade scenarios)

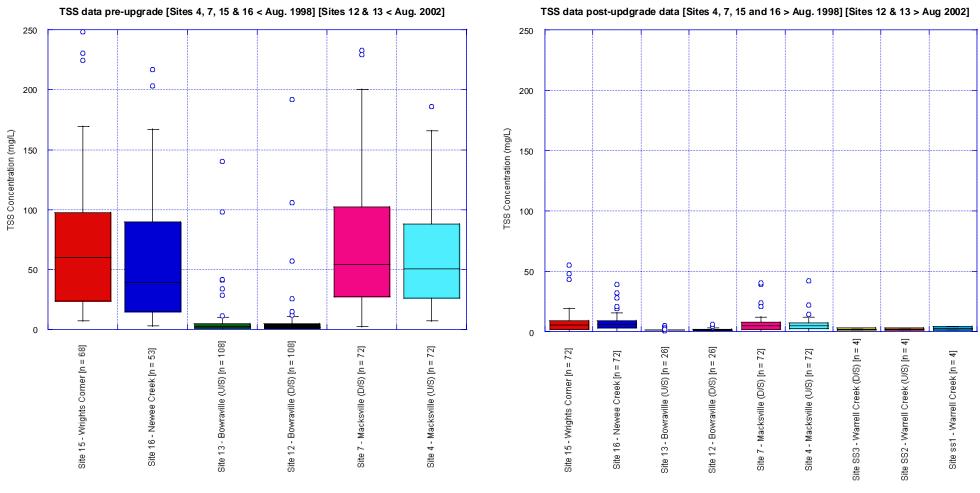
Figure 15-6 TSS Box and Whisker Plots (Pre- and post-upgrade scenarios)

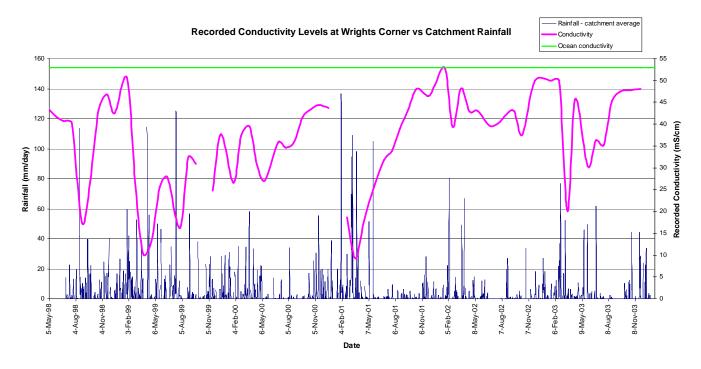
Figure 15-7 Conductivity data at Wrights Corner for period mid-1998 to end-2003

Whilst, the infilling which causes a gradual reduction in the cross-sectional area of the entrance will restrict the resultant tidal range and hence flushing of the estuary. Water quality data presented in Section 15.5.2 shows that water quality over the past several years have significantly improved. Further, Figure 15-7, shows a plot of recorded rainfall (averaged between Bowraville and Macksville) versus recorded electrical conductivity at Wrights Corner (site 15) over the past several years. From this plot is can be seen that at Wrights Corner, the electrical conductivity is near that of oceanic waters and there does appear to have been any significant decreases as a result of entrance infilling.

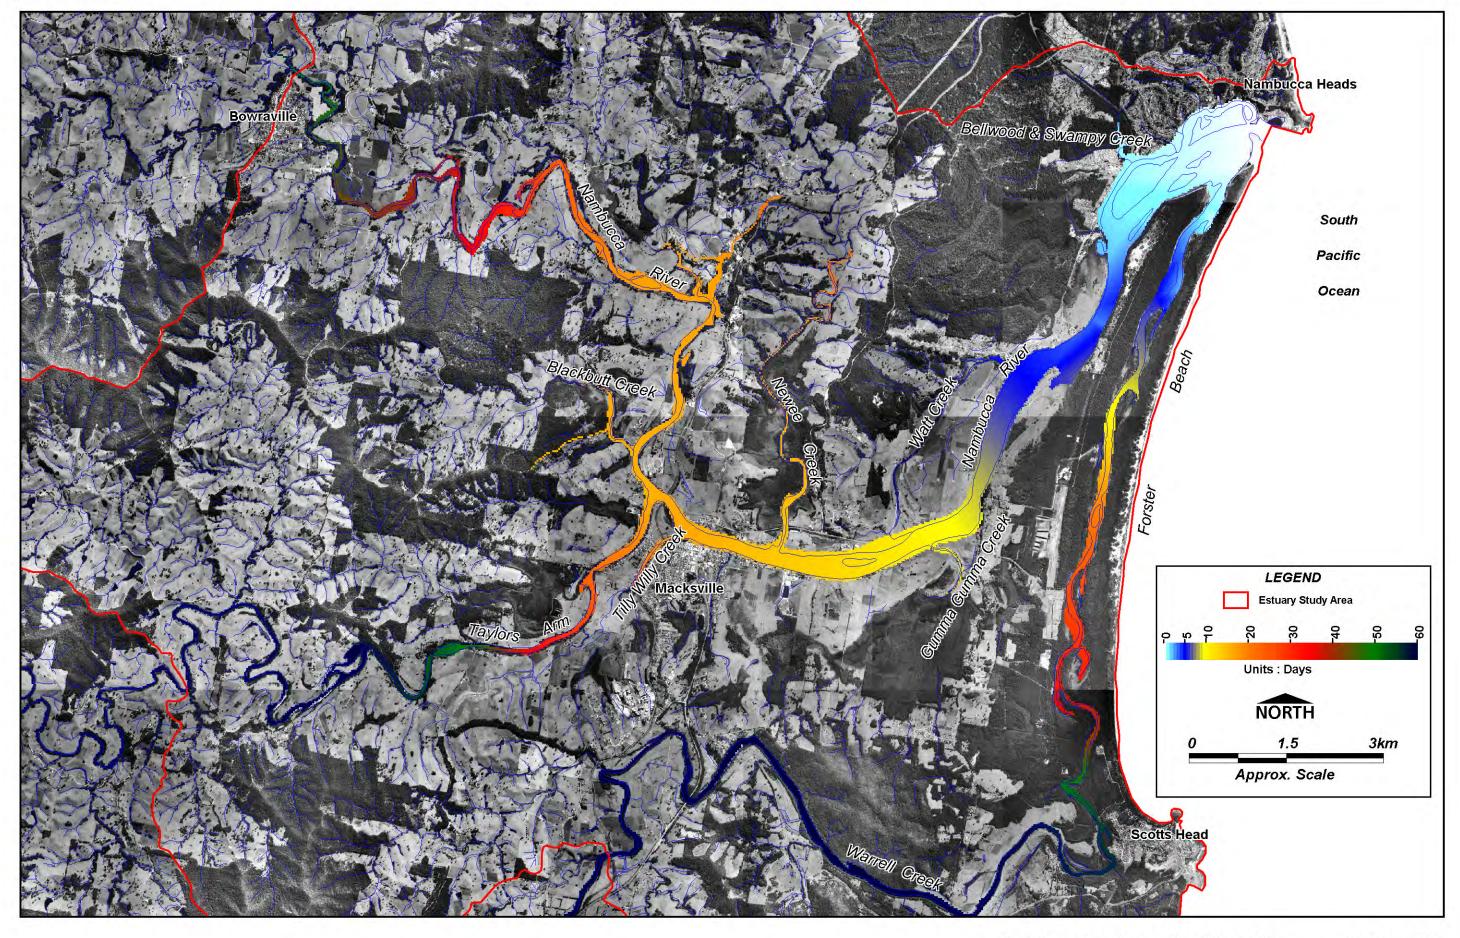
Predicted Estuary Flushing Plot

Figure 15-9 shows estuarine flushing (WBM, 2000) within the estuary. While there is no definitive information regarding the ability of certain flushing times to reduce water quality issues, it is considered that flushing times over about 2 weeks may present a higher risk of issues with water quality. Locations with lower flushing times are at a lower risk of developing associated water quality issues due to the increased tidal flushing at that location.

High-risk locations are locations from wehere runoff will enter portions of the estuary with lower tidal flushing, and consequently present higher risks for the development of water quality issues. Other high-risk locations are those where discharges enter directly into sensitive receiving waters, such as oyster harvest zones. Stormwater and other discharges from high-risk zones need to have a high level of control implemented to ensure receiving water quality is not adversely impacted.

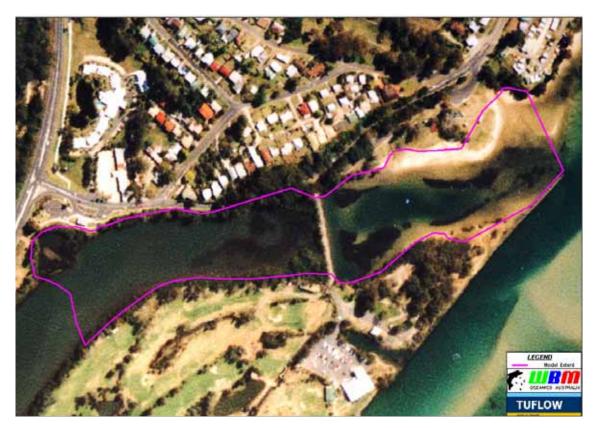
Figure E-18-1 Extent of TUFLOW Model

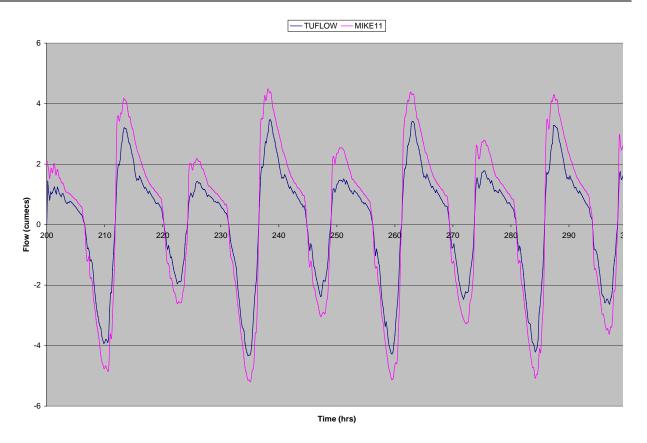
Figure E-18-4 - MIKE11 vs. TUFLOW - Flow Through Culvert

A comparison of the flow through the culvert was made between the 1D MIKE-11 model and the 2D TUFLOW model in order to verify the 2D model. The results are presented in Figure E-18-4 below. As can be seen the match in timing / shape is quite good and the match of flow magnitude was adequate. Differences in the magnitude of the flow are believed to be a result of more accurate representation of the bathymetry in the TUFLOW model. Overall, this was deemed to be a satisfactory verification of the 2D model performance.

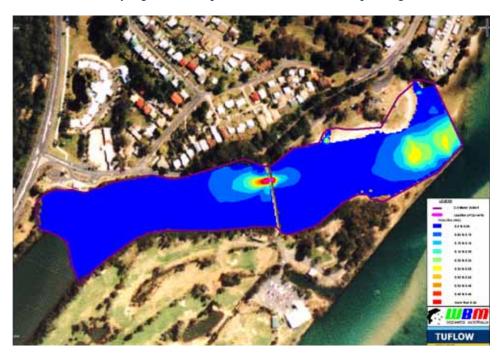
Figure E-18-5 – Maximum Predicted Velocities in Estuary After Installation of Culvert

There is potential for this redistribution of tidal flows to result in changes to the sediment transport regime of the river. However, the main branch of the Nambucca River conveys a peak flow of $240\text{m}^3/\text{s}$ on the ebb tide and $420\text{m}^3/\text{s}$ on the flood tide (during the spring tide assessed). The peak flow through the culverts is in the order of $4\text{m}^3/\text{s}$ (refer to Figure E-18-4). Hence, it is concluded that the culverts will not have any significant impact on the sediment transport regime of the river.

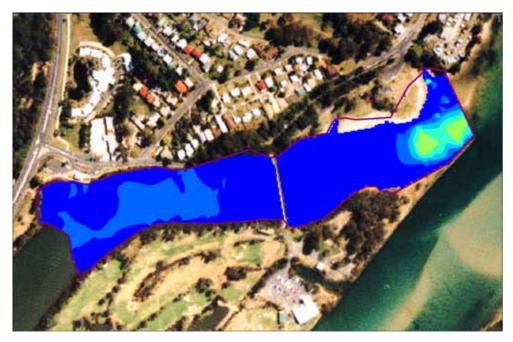
Figure E-18-6 - Maximum Predicted Velocities in Estuary Under Existing Conditions

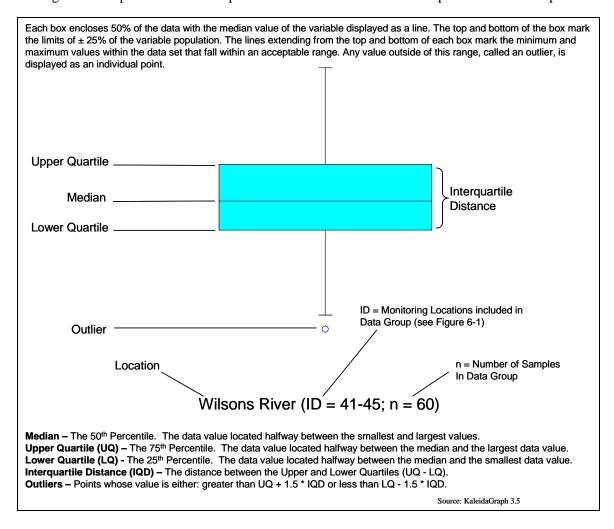
The figure below provides further explanation of how a box and whisker plot should be interpreted.
