Final Report

Nambucca Shire

Coastal Hazard Study

December 2009

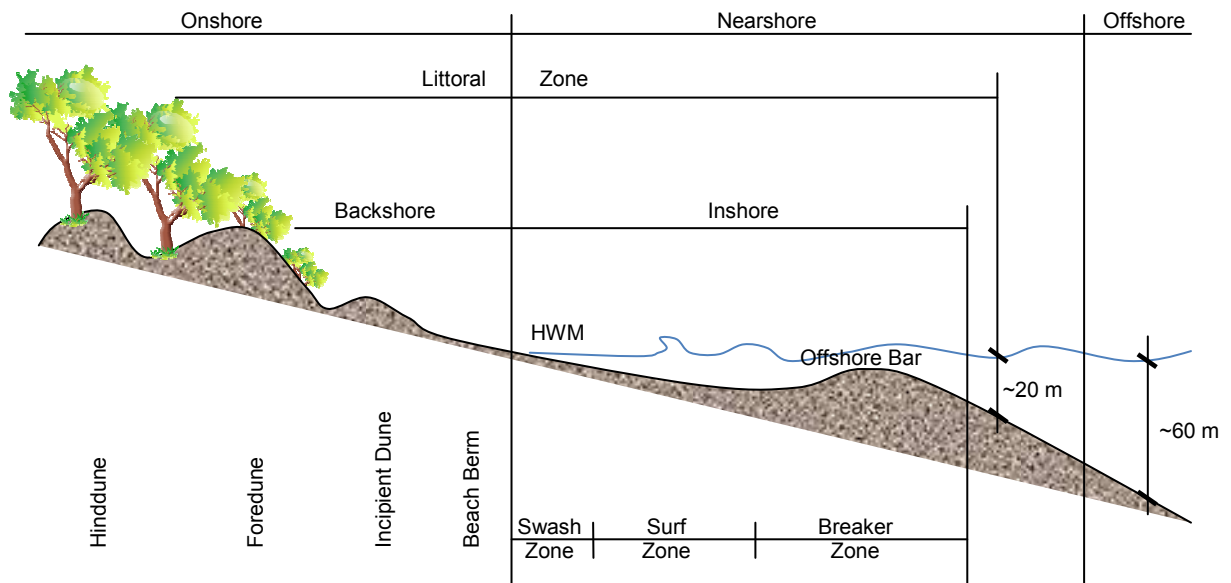
Figure 2.1 - Beach definition sketch (open coast beaches)

The beach is often perceived to be the sandy area between the waterline and the dunes. It includes the beach berm, where sand-binding grasses may exist, and any incipient foredune formations. Typically, however, on an open coast the overall beach system extends from some several kilometres offshore, in water depths of around twenty metres to the back beach dune or barrier region, which may extend up to several hundred metres inland (Figure 2.1). When examining the coastal processes of a beach system often it is necessary to consider this wider definition.

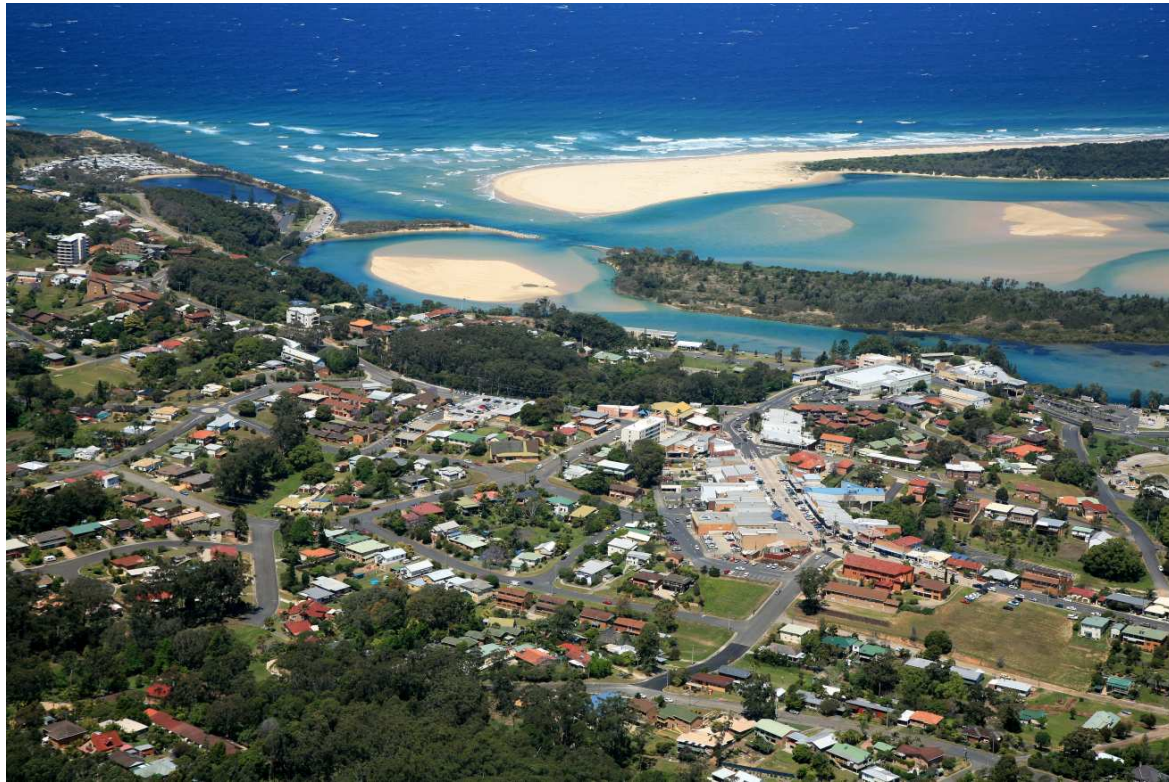
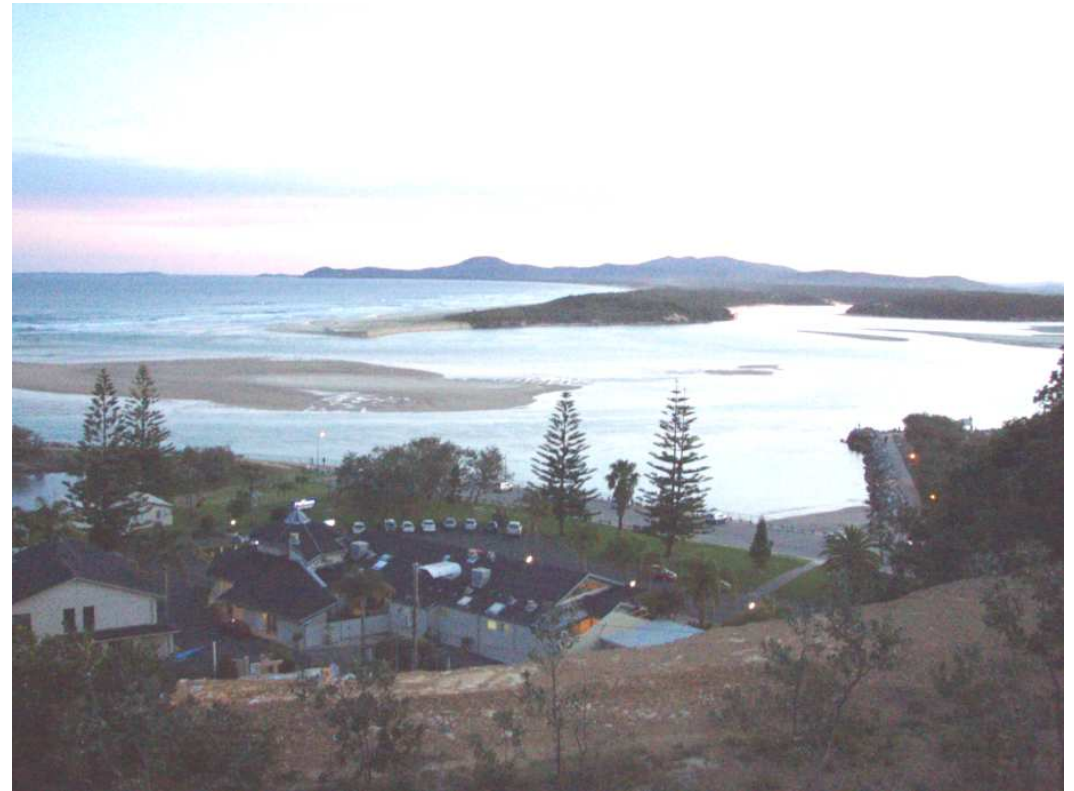
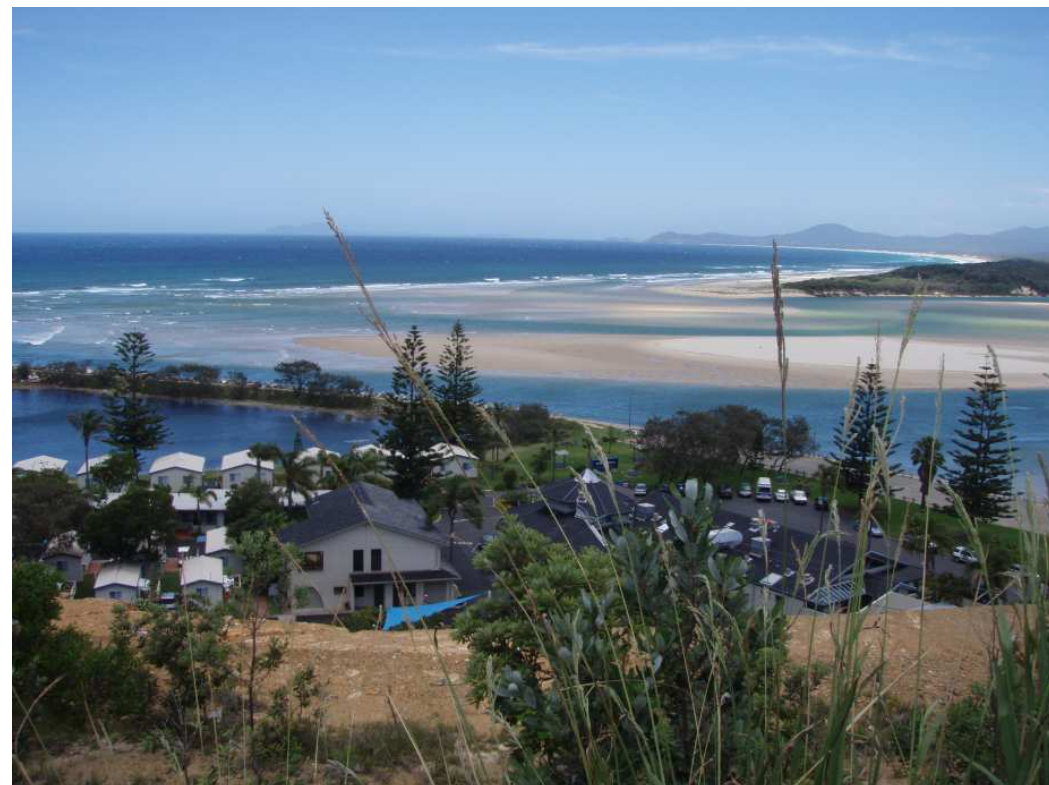
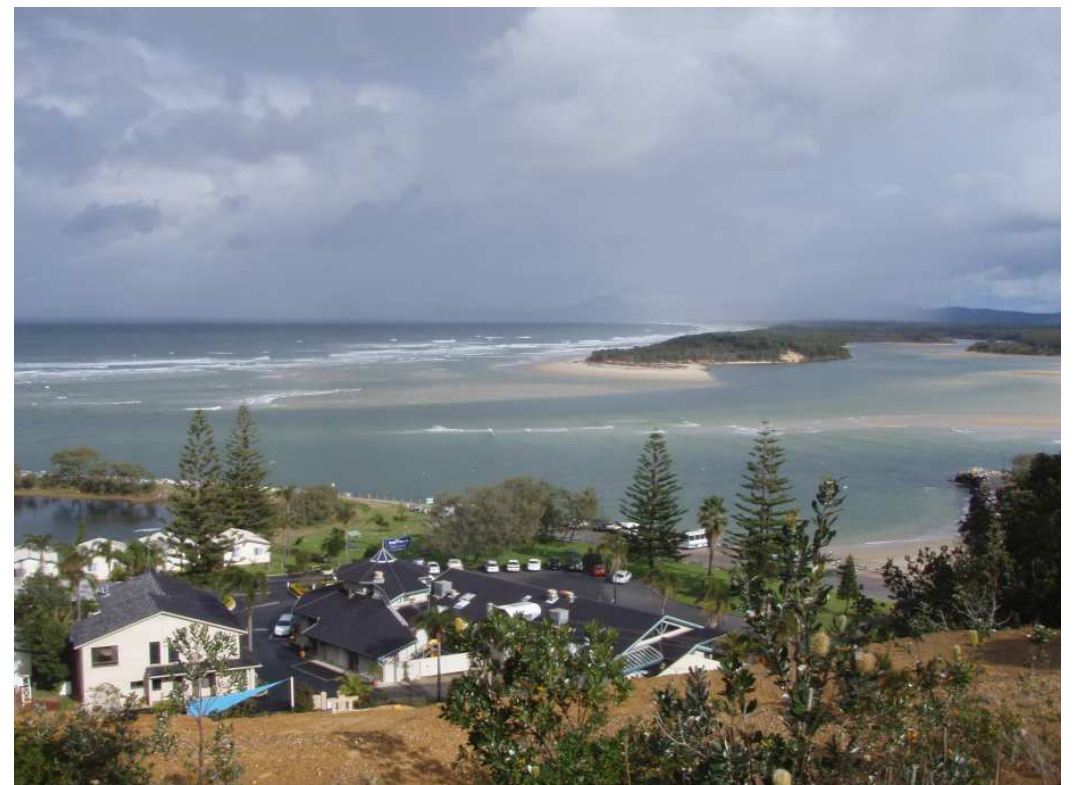
Entrance October 2006

Entrance partially open July 2008

Entrance partially open December 2008

Entrance completely open July 2009

Figure 2.3 – Extremes of entrance behaviour, Nambucca River entrance

Breakthrough of the berm at the northern end of Forster Beach can occur on a regular basis, due to the combined effects of river floods and wave action. Such breakthroughs can cause undermining of the dune and dune vegetation at the southern end of the river entrance. However, no development is at risk as a result of these breakthroughs, and longshore drift can restore the sand spit at the southern end of the river entrance after several months. This is essentially a natural process, and the river entrance behaves like a natural, untrained river entrance at this location.

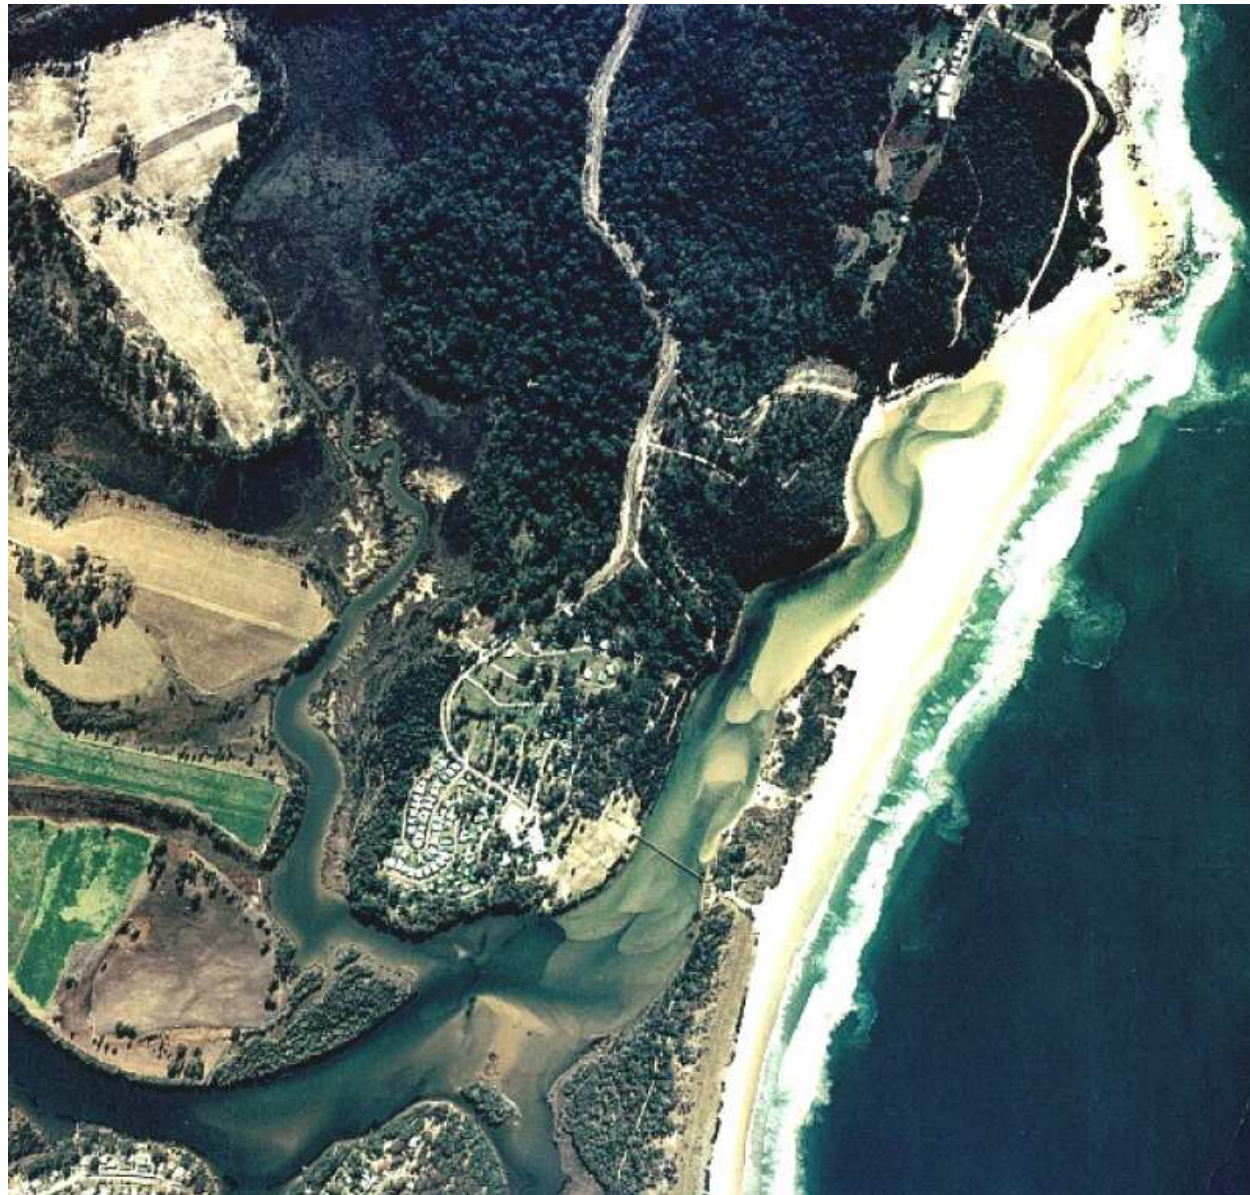
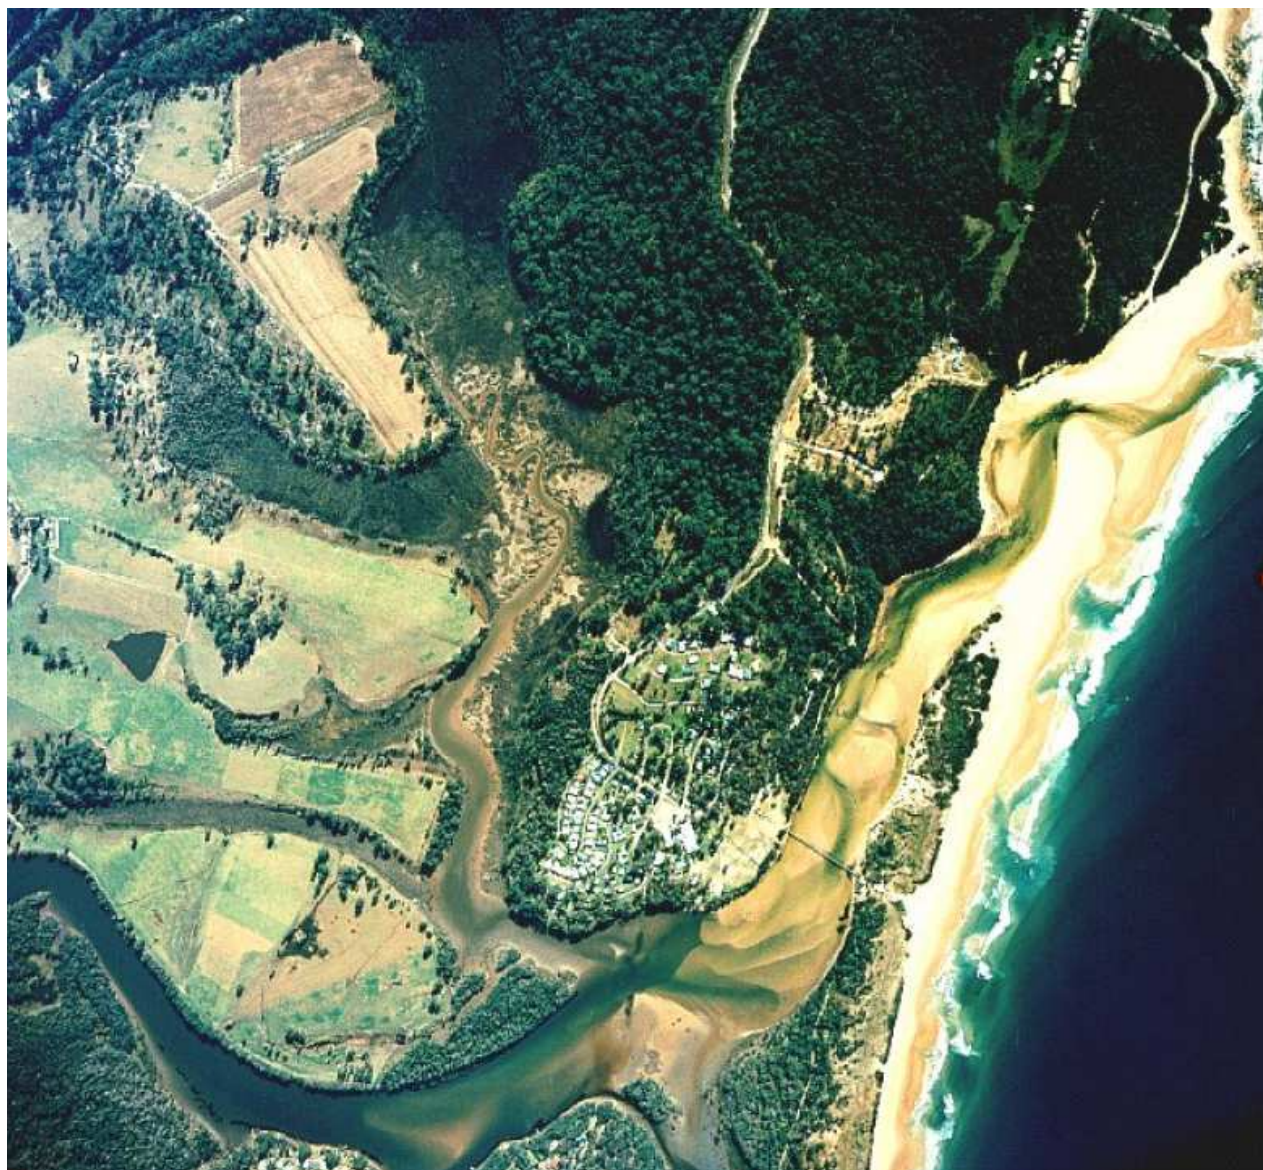
Deep Creek – Entrance Closed 17/6/93

Deep Creek – Entrance Open 28/6/96

Figure 2.4 – Extremes of entrance behaviour, Deep Creek (NSW Department of Land and Water Conservation, 2000)

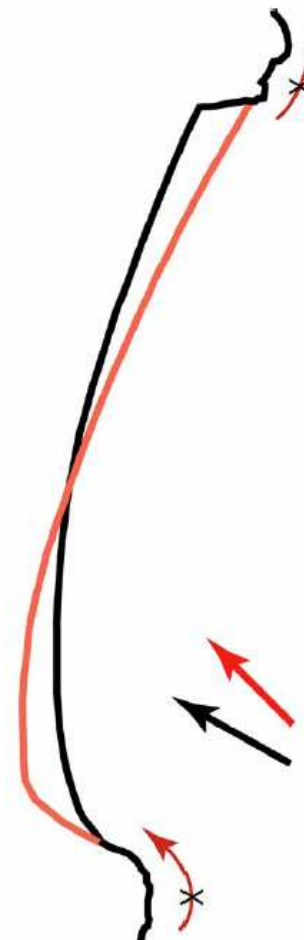
Mean state shift to more easterly mean wave direction (120°T)
Decreased mean wave height and power
Increased storm wave frequency from East Coast Lows and Tropical Cyclones
High regional sea-level anomalies
Increased frequency of storm surge, dune overwash and Dune transgression
Shoreline recession and anticlockwise rotation

Figure 2.7 – Wave rotation caused by *El-Niño* or *La-Niña* mean states (after Goodwin et al. 2007)

These beach rotations were considered to be caused by changes to both the mean direction and magnitude of wave energy flux, the signature of which is reflected in the SOI. The larger magnitude of wave energy flux induced greater onshore/offshore sand transport whereas changes in direction affected also alongshore transport rates and directions.

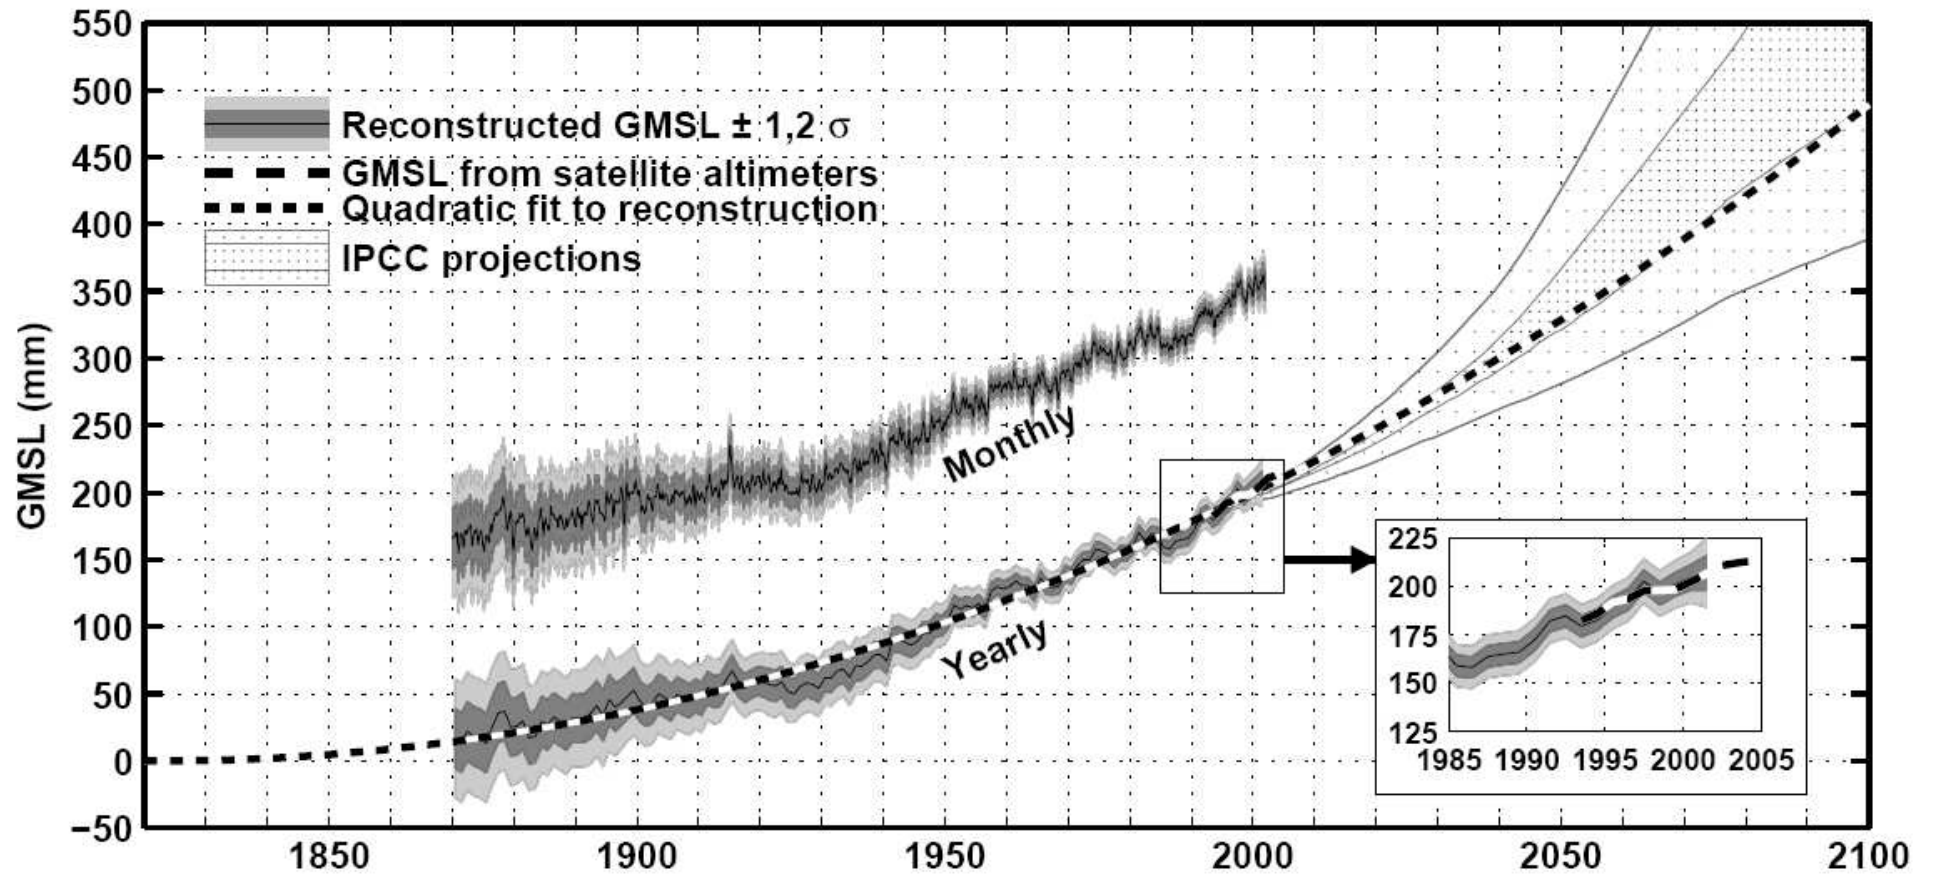
Figure 2.9 – Measured global mean sea level 1870 – 2002 (White and Church, 2006)

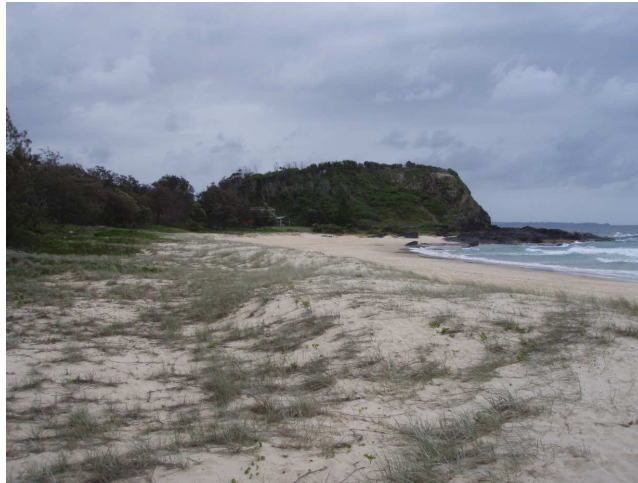
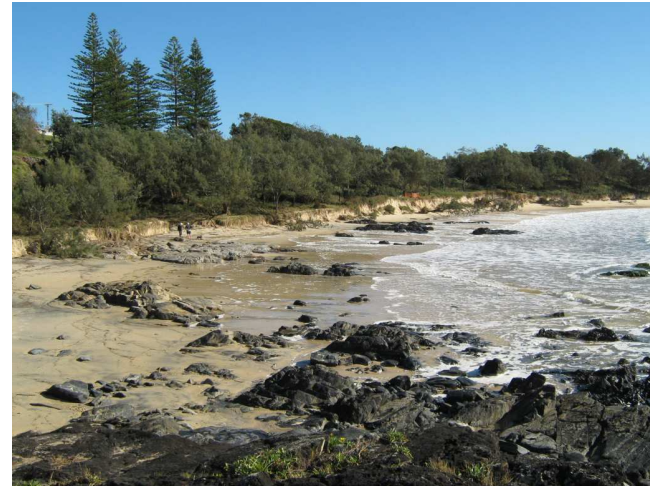
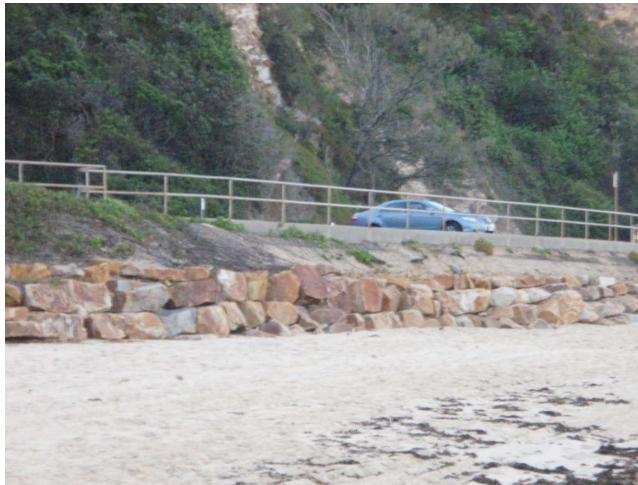
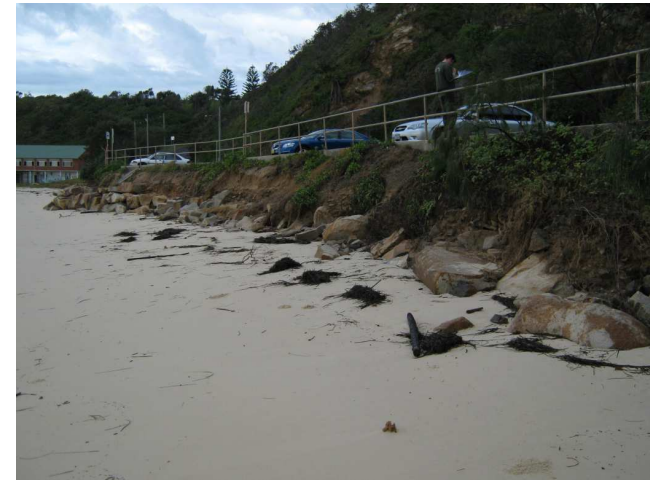
Little Beach, Scotts Head December 2008

Little Beach, Scotts Head May 28 2009

Carpark seawall, Main Beach October 2008

Carpark seawall, Main Beach May 28 2009

Figure 2.15 – Storm erosion and damage caused by East Coast Low, May 2009

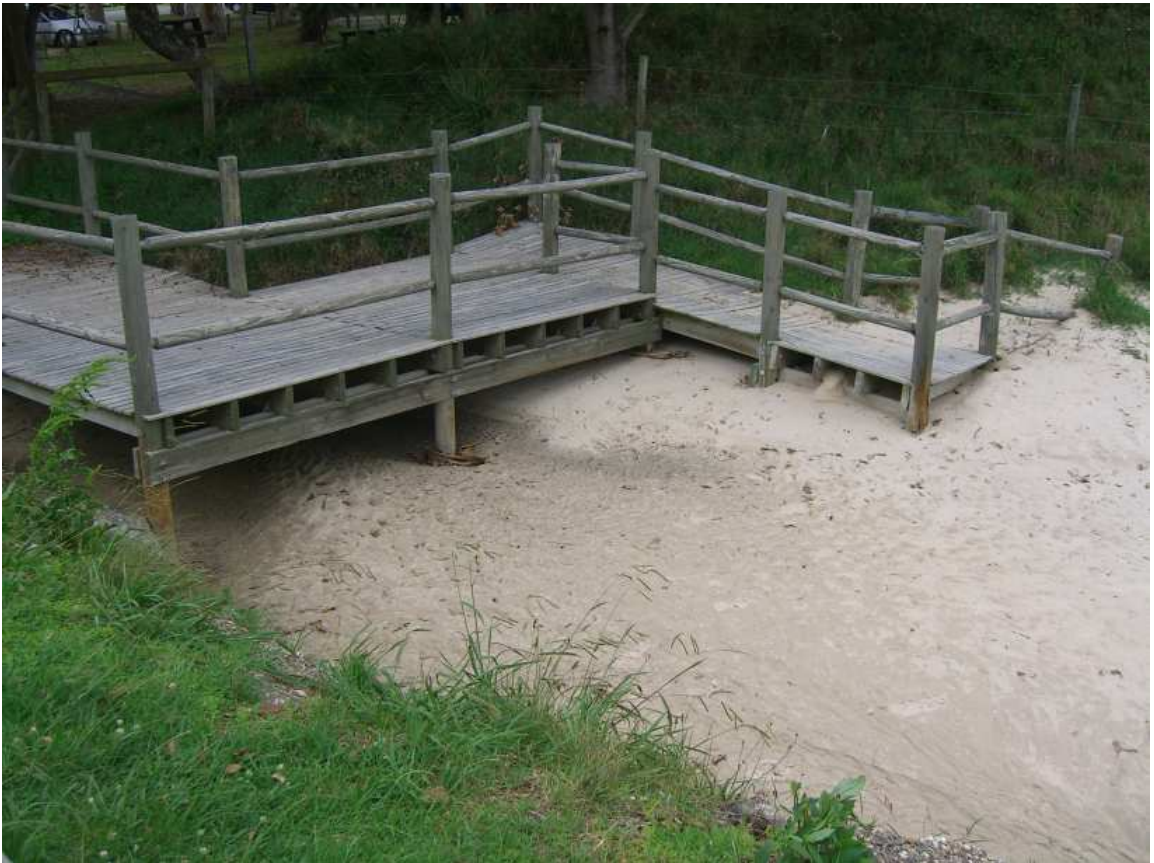
Figure 3.2 – Stormwater drain adjacent to carpark, southern end Forster Beach

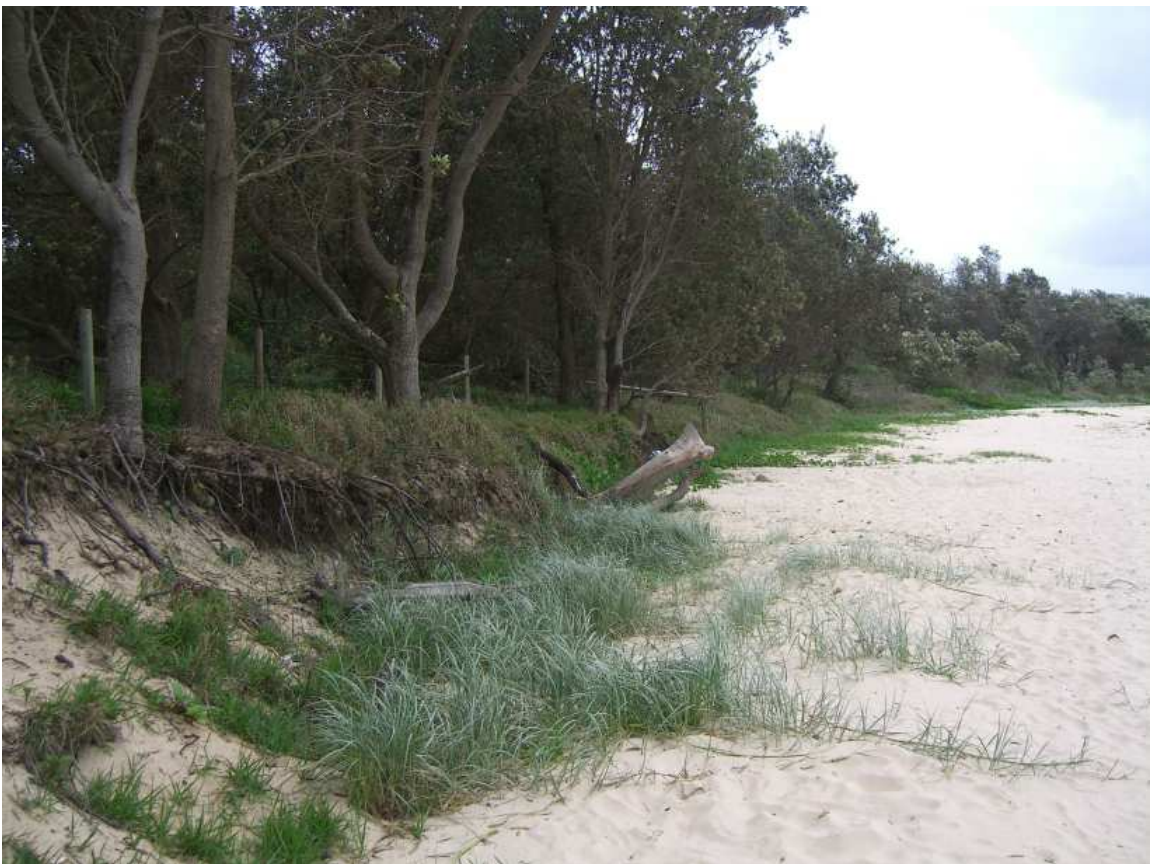
Figure 3.3 – Dune erosion, southern end Forster Beach

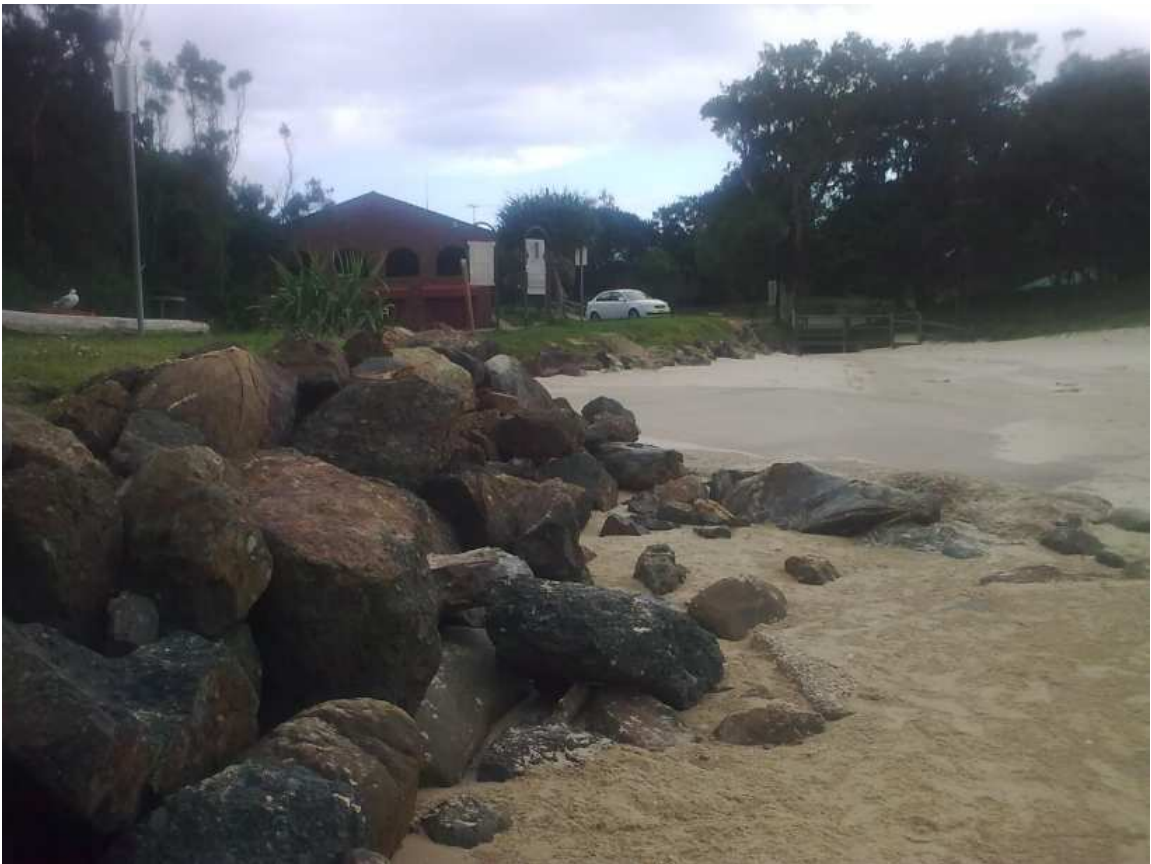
Figure 3.4 – Seawall adjacent to surf club, Forster Beach

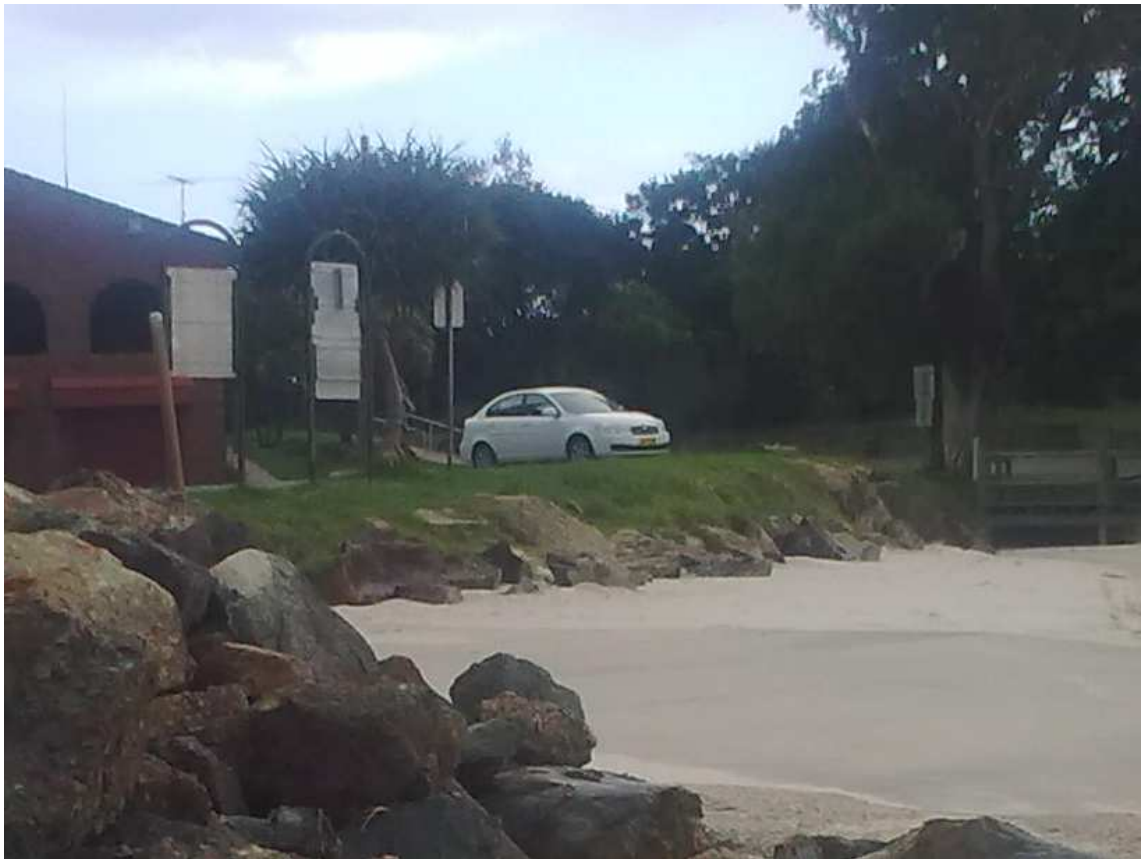
Figure 3.5 – Poorly built section of seawall, Scotts Head surf club

It is suggested that the seawalls be reconstructed at the carpark to provide better protection against storm erosion. As the existing armour stones appear to be of sufficient size and quality to withstand the wave climate experienced at the site, they may be able to be re-used in the reconstruction. The carpark would be overtopped by storm waves, though the paving of the carpark would help prevent failure of the seawall due to overtopping. Construction of the wall at a slope of around 1:1.5 would assist in absorption of wave energy, and provision of a geotextile layer would prevent loss of fine sediment through the primary armour of the wall.

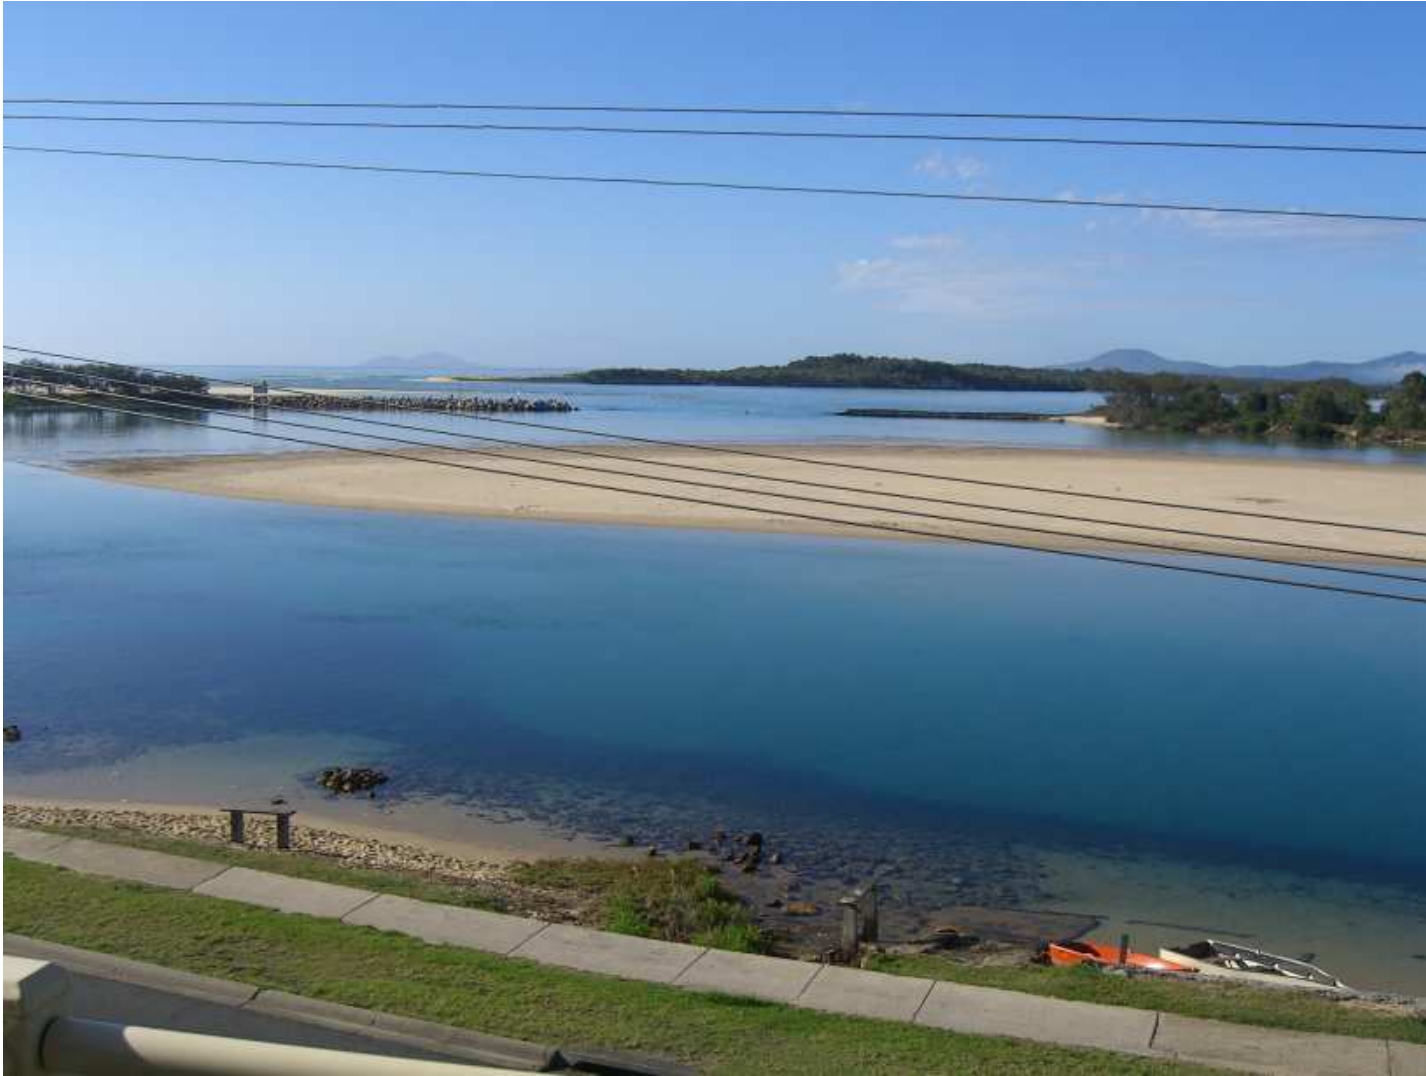
Figure 3.7 – Gap in the northern breakwall, Nambucca Heads

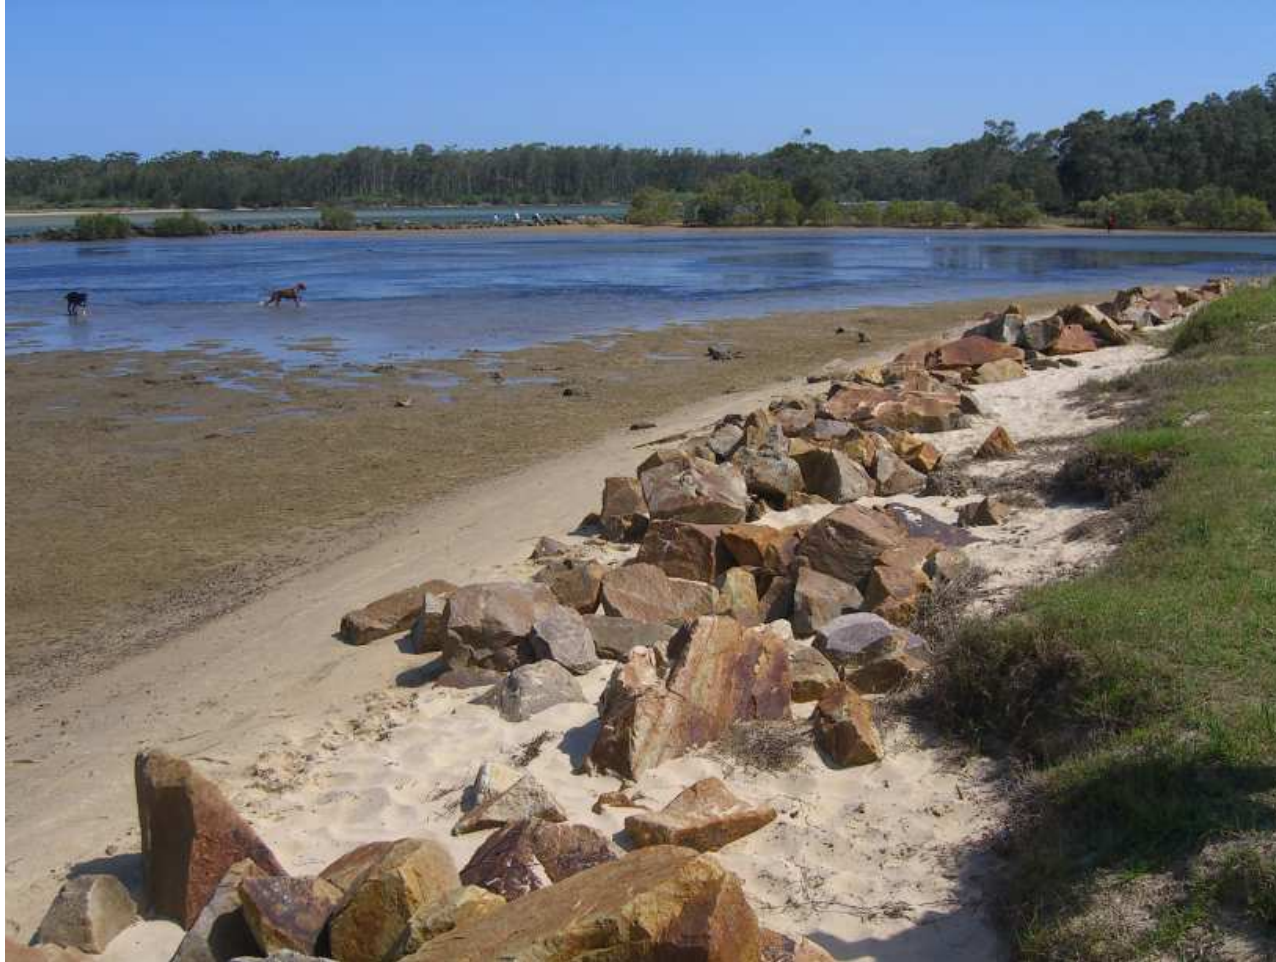
Figure 3.8 – Remnants of seawall, Bellwood Park

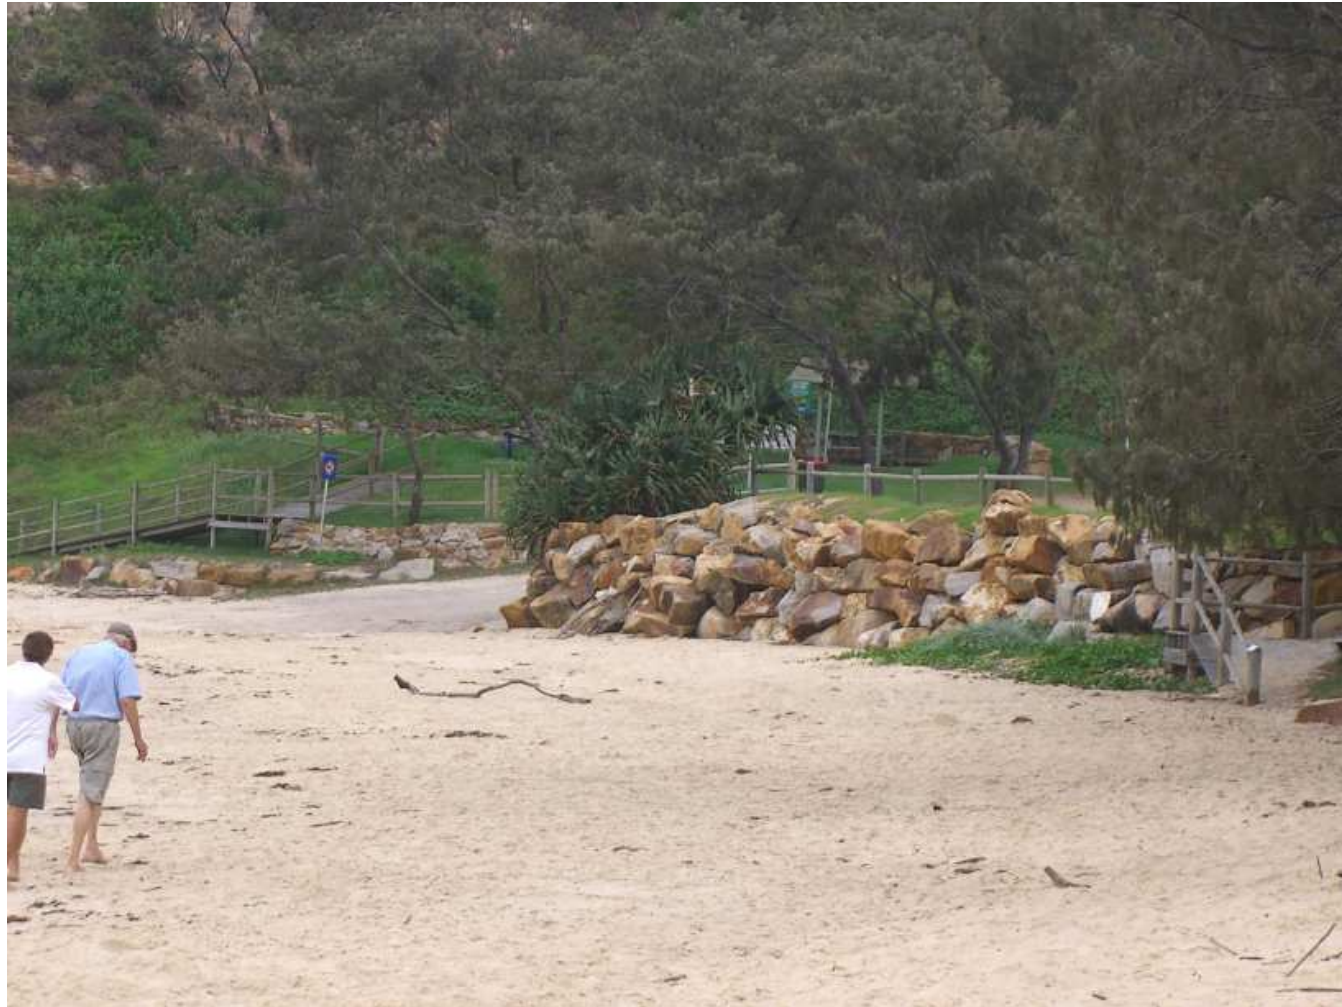
Figure 3.10 – Seawall and boat ramp, Shelly Beach

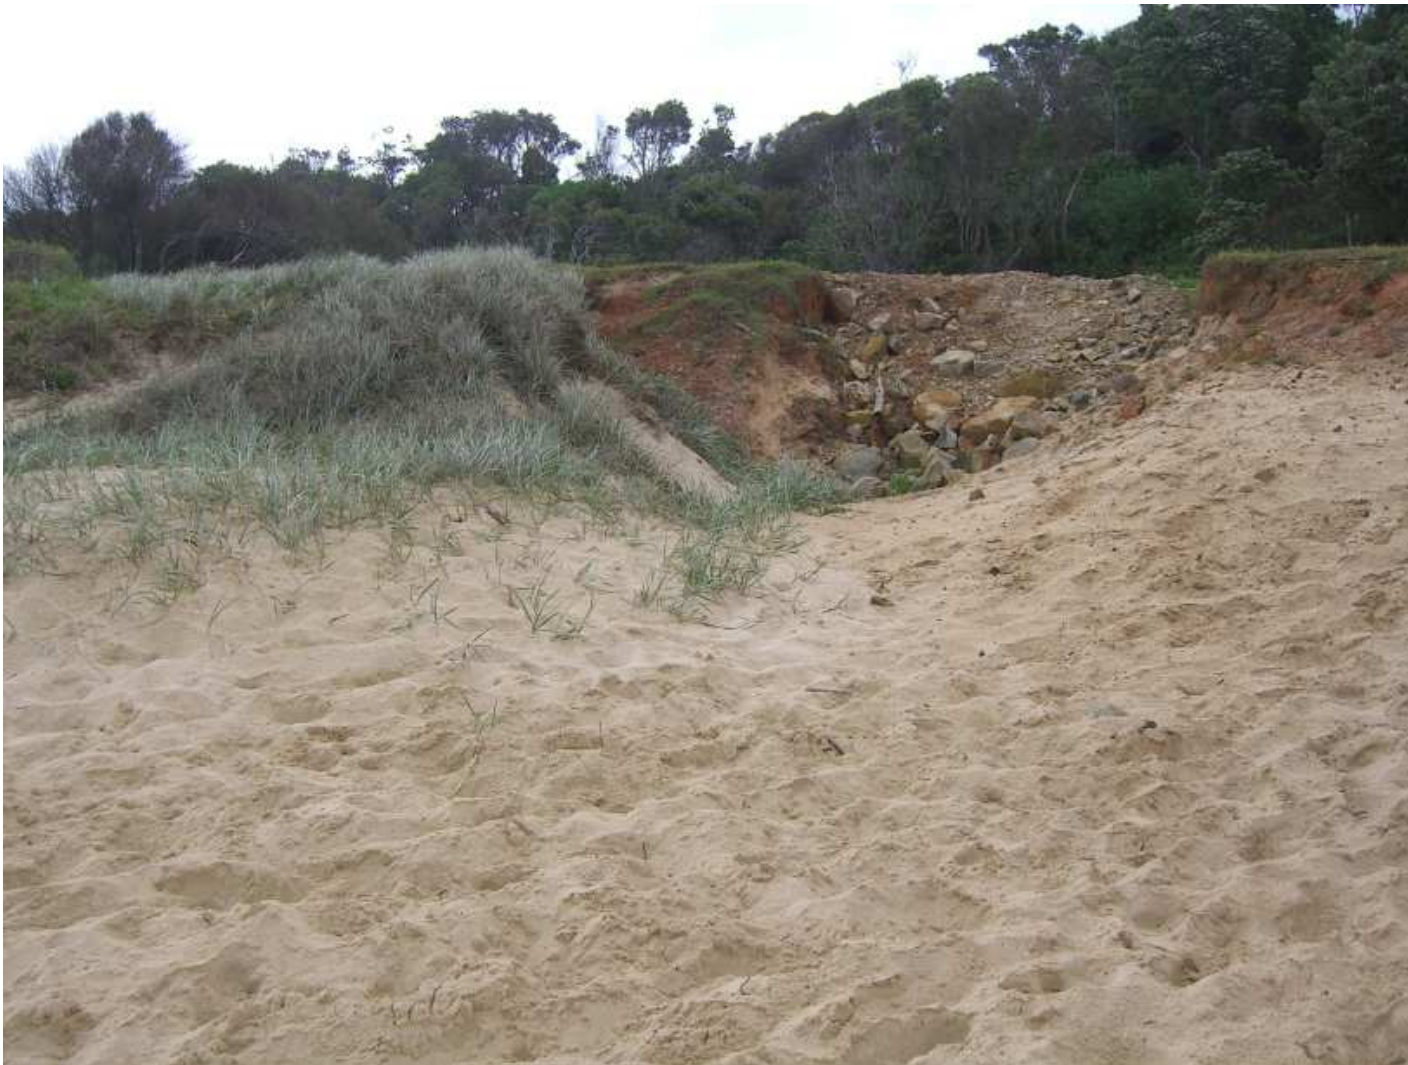
Figure 3.11 – Erosion at Beilbys Beach carpark

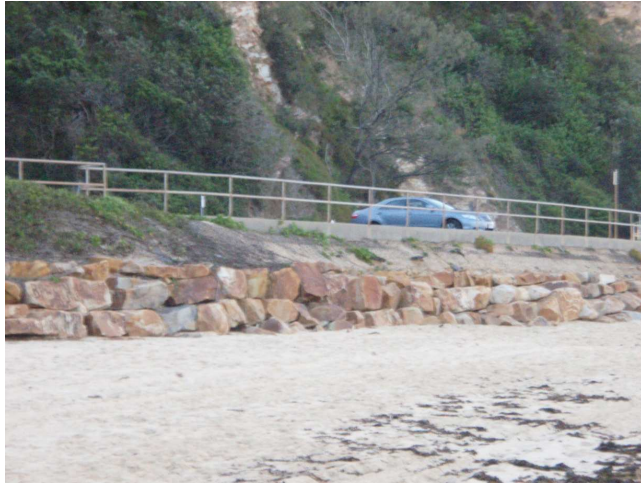
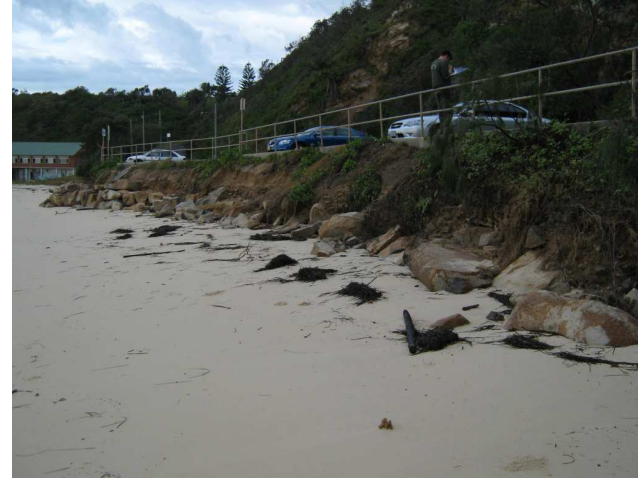
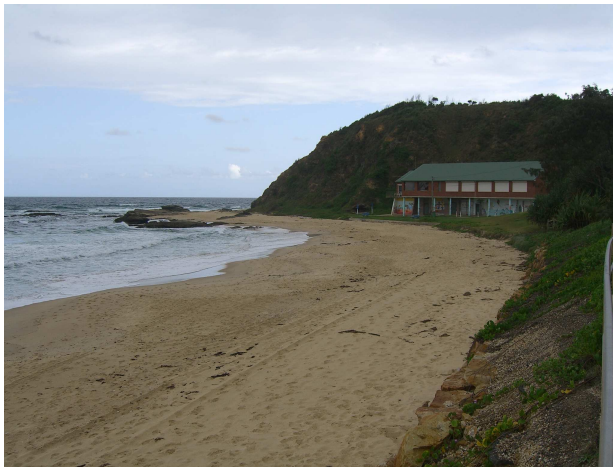
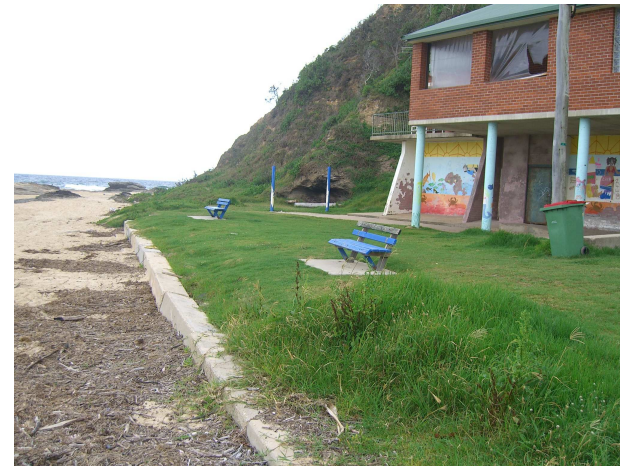
Carpark seawall, Main Beach October 2008

Carpark seawall, Main Beach May 28 2009

Main Beach looking south, surf club in background

Main Beach surf club with concrete retaining wall in foreground

Figure 3.12 – Main Beach
