Final Report

Nambucca Shire

Coastal Hazard Study

December 2009

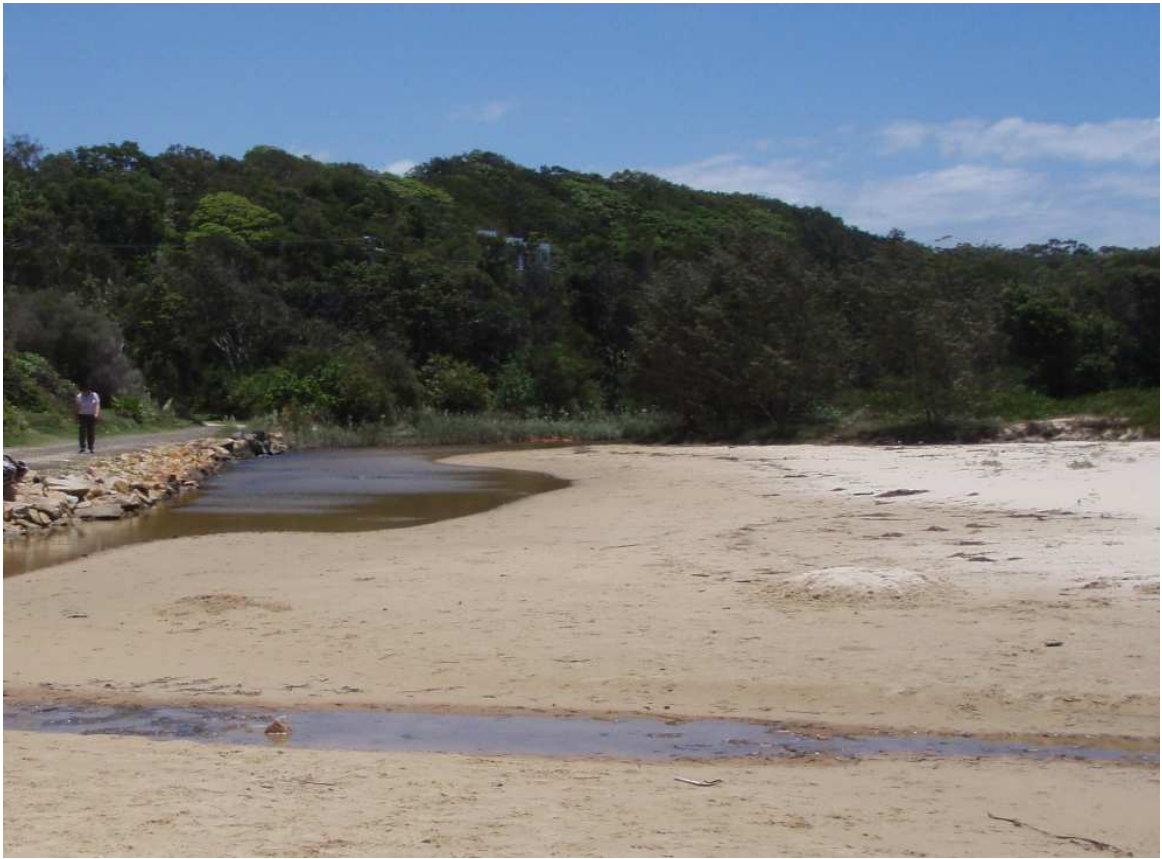
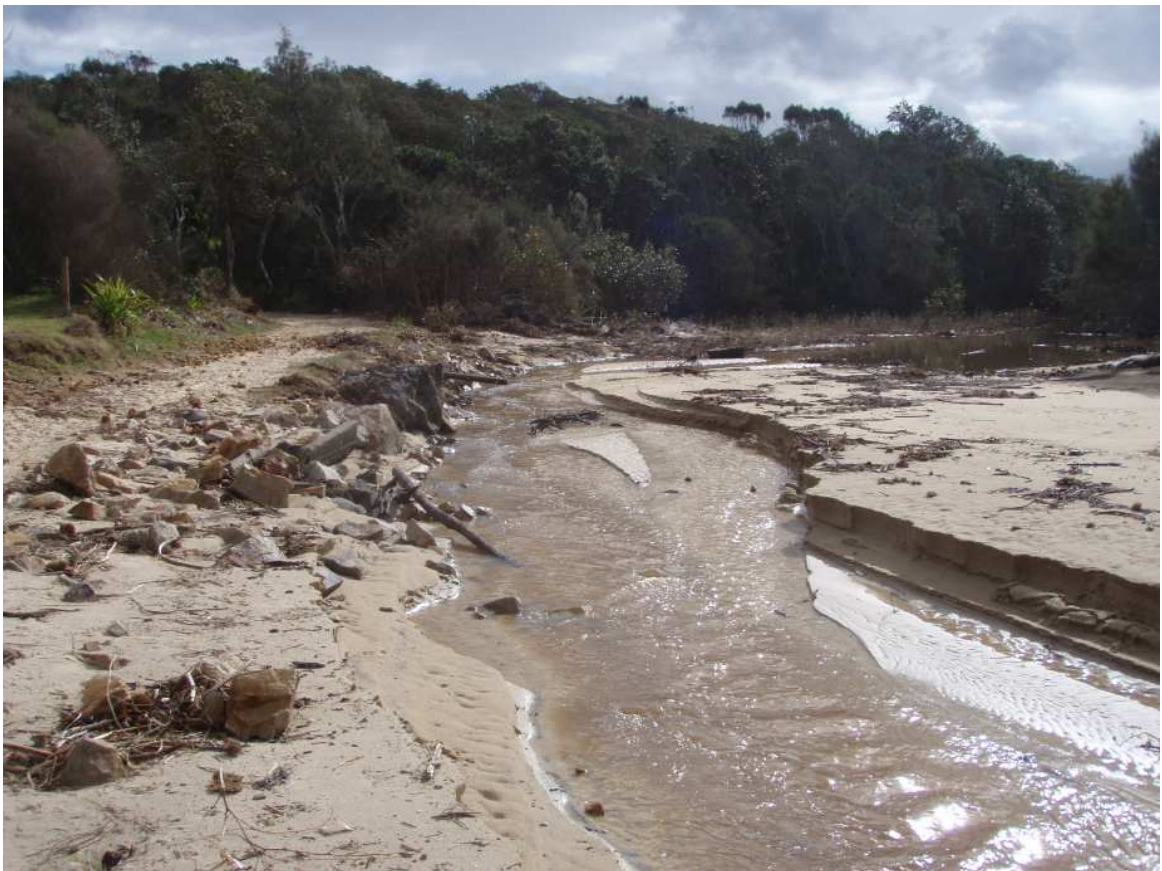
Figure 3.13 – Swimming Creek – Top December 2008, Bottom July 2009

Swimming Creek has very low flows and remains largely stagnant for the majority of the year. In June 2008, the creek entrance required opening to lower water levels so that work could be done on the sewage pipes located near the caravan park. A small retaining wall built with small rocks (0.1-0.4m in diameter) has been placed on the southern side of the creek entrance that leads onto the beach (Figure 3.13). This retaining wall suffered damage during the East Coast Low of May 2009 (Figure 3.13).
