3.4 Valla Beach

4 Coastal Hazard Assessment

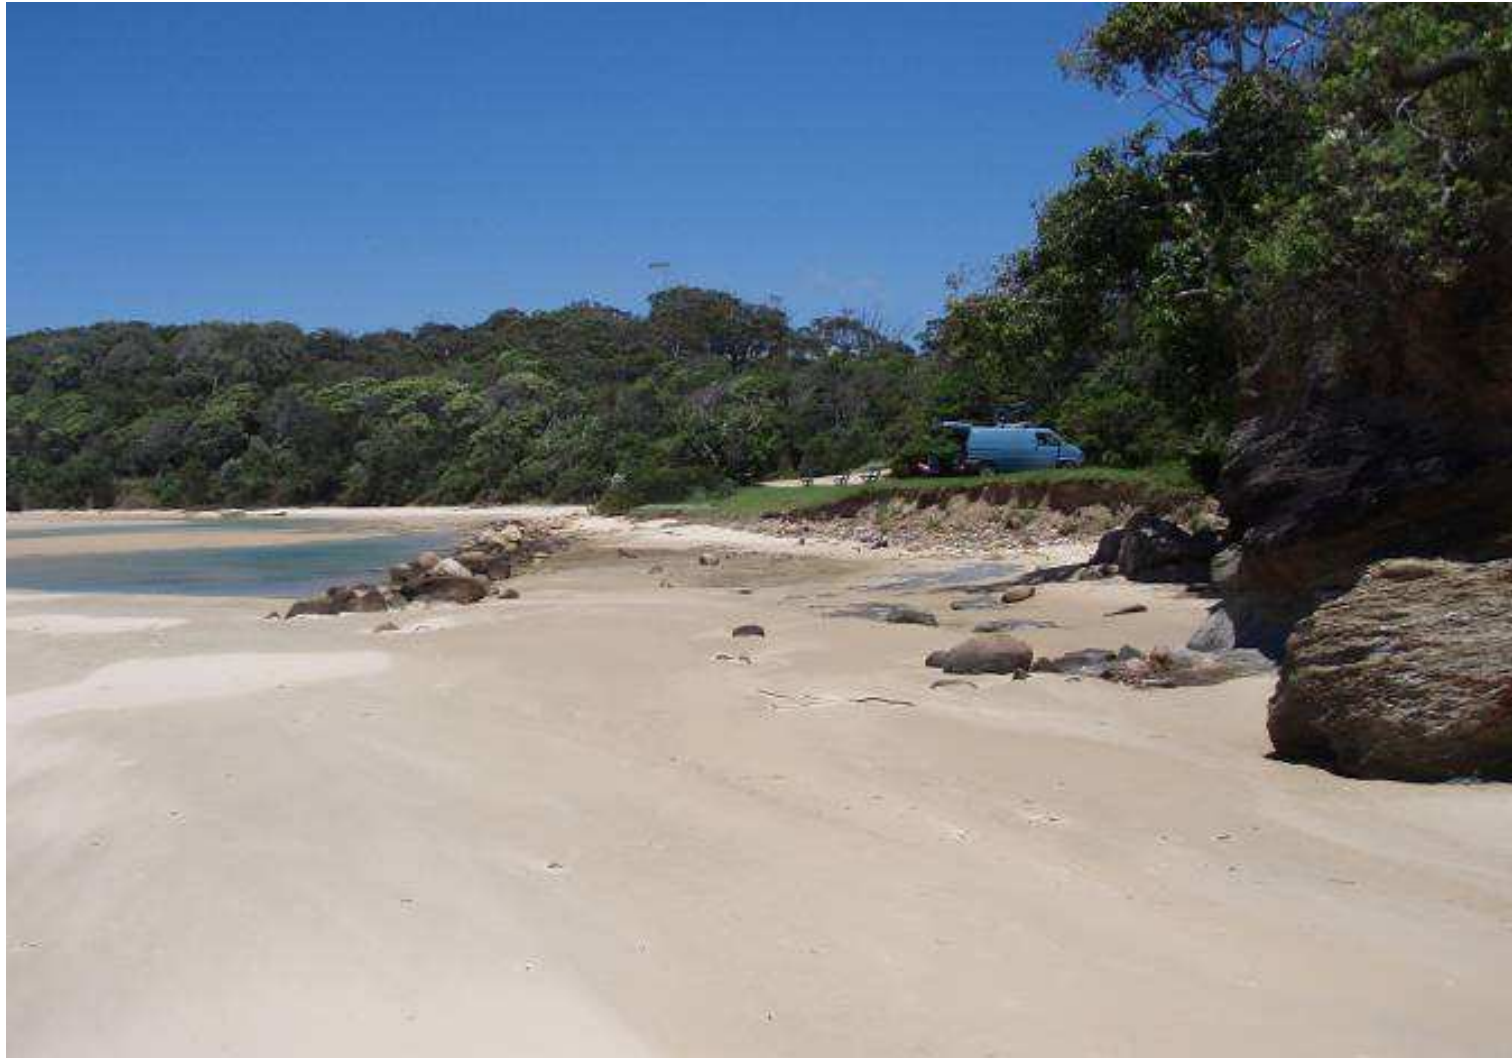
Figure 3.14 – Erosion at South Valla Beach carpark caused by creek entrance dynamics, December 2008

South Valla Beach is separated from North Valla Beach by a rock platform. A carpark located close to the foredune is protected by a vertical rock wall approximately 1.5 - 2m high, similar to those constructed at Shelly and Main Beaches. In December 2008, the beach berm was over 100m in breadth. However, evidence of past erosion caused by creek entrance dynamics was seen (Figure 3.14).

Consideration could be given to reconstruction of the rock wall here, to provide greater protection to the carpark and amenities block from erosion caused by re-alignment of the creek entrance. Evidence of a previous seawall at the eroded picnic area indicated that there was no geotextile layer, allowing fine material to wash through the wall and erosion to continue landward of the wall. Reconstruction of the existing wall should include a layer of large armour, underlain by smaller armour stones and a geotextile layer to prevent failure via this mechanism. Reconstruction of the rock wall could follow a standard design as shown in Figure 3.6.

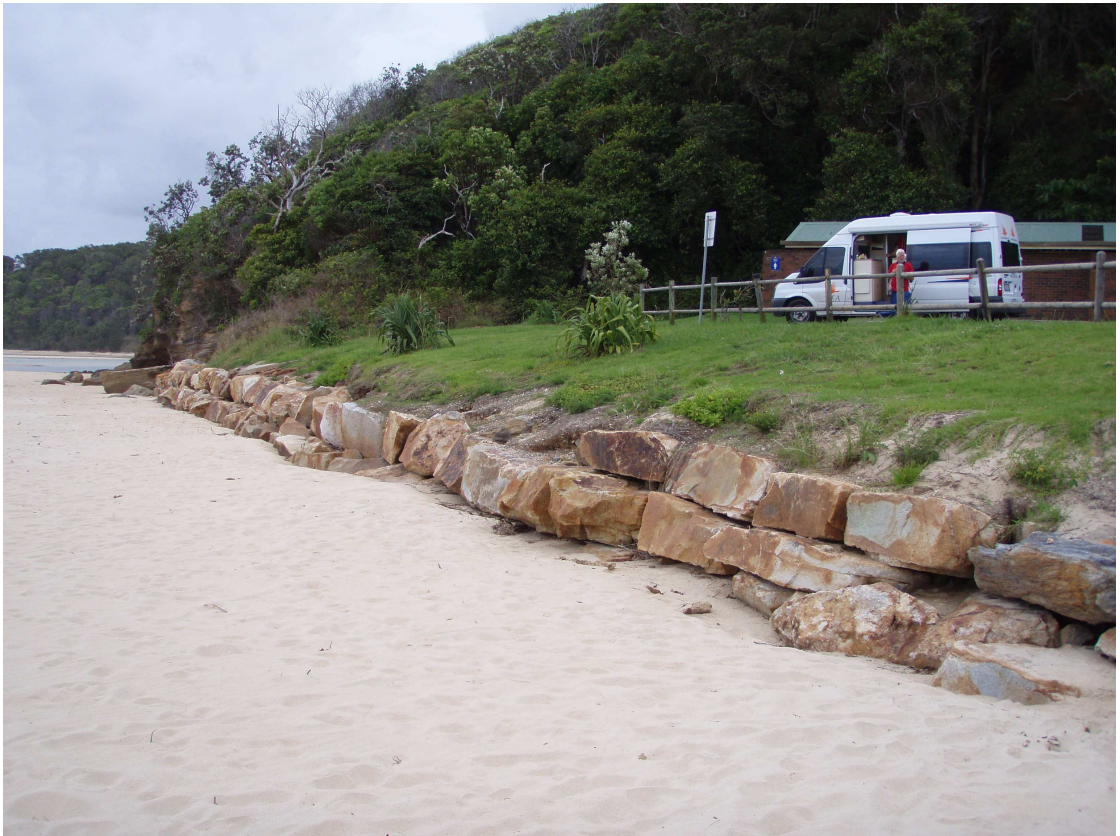
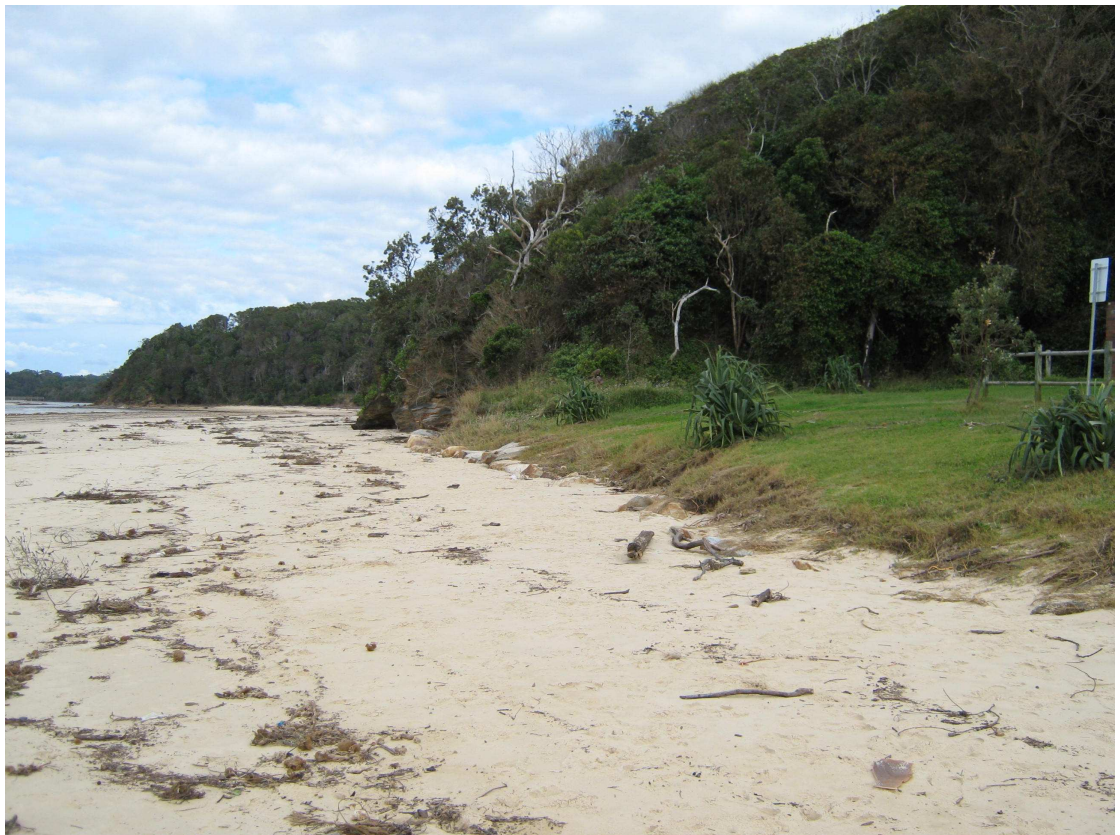
Figure 3.15 – South Valla Beach – December 2008 (Top), May 2009 (Bottom)

Following the storm event of May 2009, the existing vertical rock wall had been buried in sand, and evidence of wave runup at the carpark was seen (Figure 3.15).

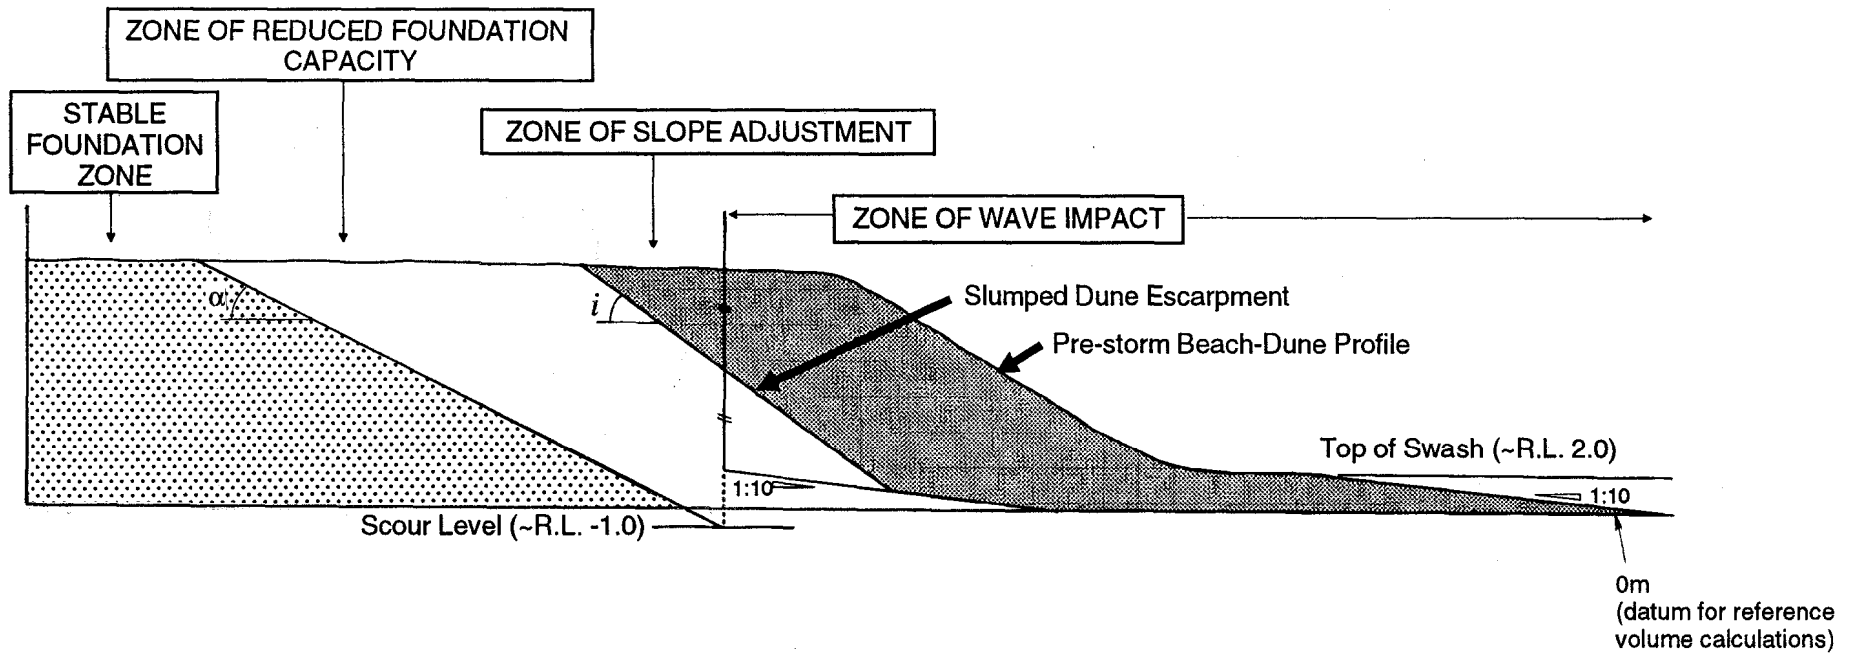
Angle of repose of dune sand: $i \sim \phi \approx 34^\circ$

Safe angle of repose of dune sand: $\alpha = \tan^{-1}\{(\tan \phi)/1.5\} \approx 24^\circ$

All levels to AHD

Figure 4.1 - Dune stability schema (after Nielsen et al., 1992)

Design storm erosion volumes for Scotts Head are calculated in Appendix A. An analysis of equivalent storm erosion volumes resulting from the 1995 storms followed the schema of Nielsen *et al.* 1992 (see Figure 4.1). The values were derived at the local maxima of the landward movement of the RL 4.0 m contour, as measured between the 1988 and 1995 photogrammetric data and applied to the whole beach, to take account of the formation of rip-heads and to arrive at a conservative estimate of storm erosion demand for the beach.

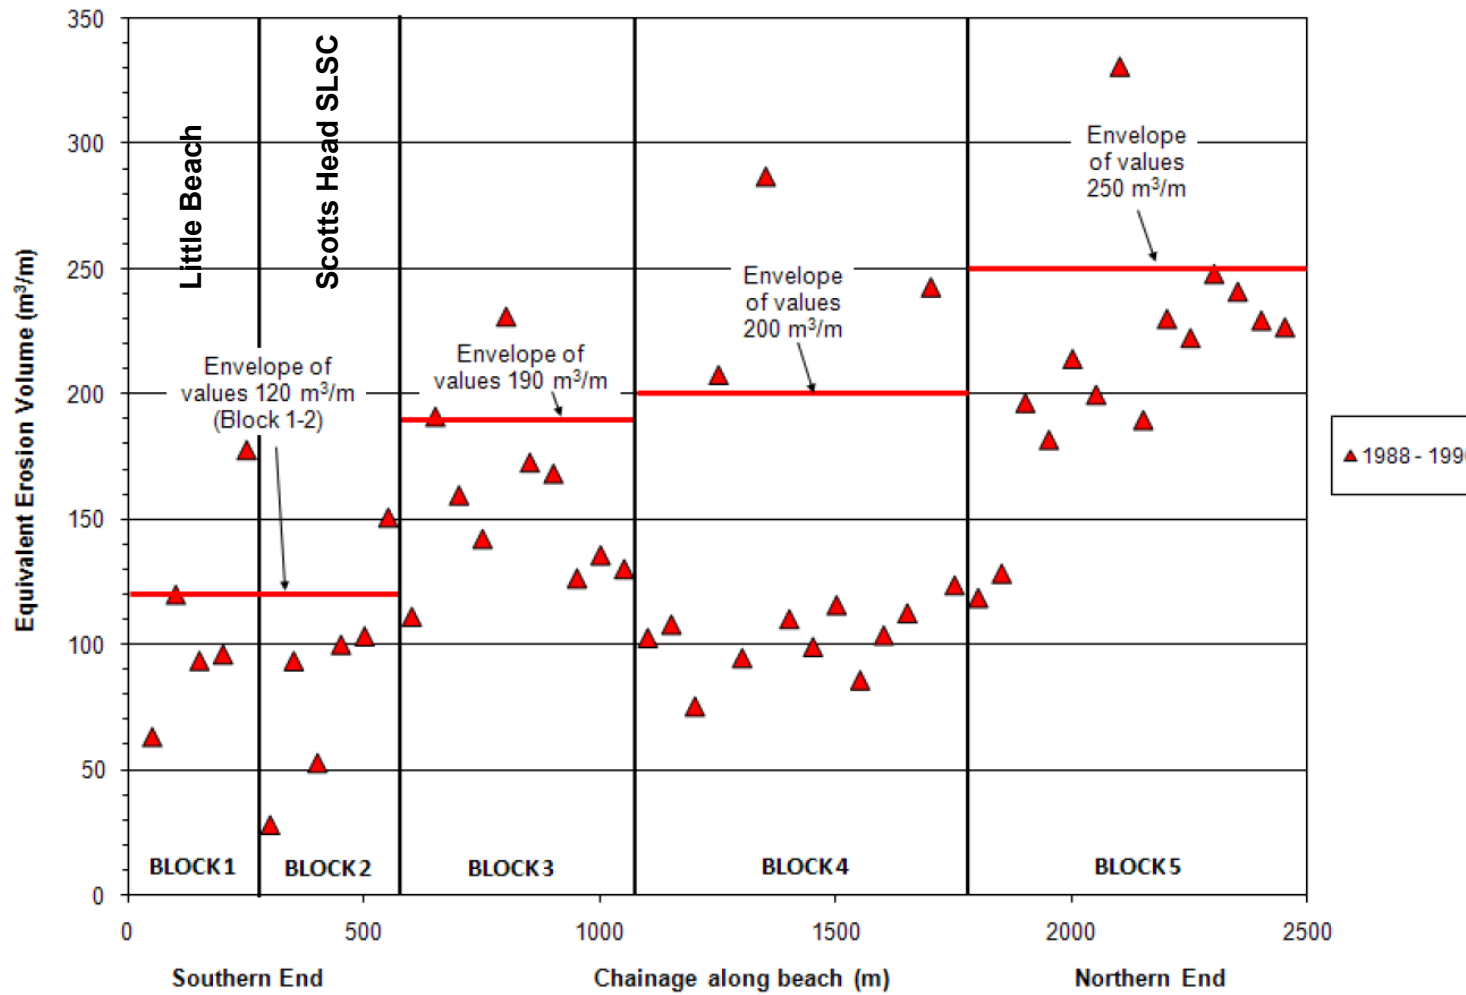
Figure 4.2 – Measured Equivalent Storm Erosion, Scotts Head 1988 - 1996

Equivalent storm erosion volumes were obtained from the analysis of the beachfront areas along the entire Scotts Head coastline. Analysis of the photogrammetric data between 1988 and 1996 showed that up to 250 m³/m of erosion (representing a landward translation of the dune of around 20 m) for the March 1995 storm at Scotts Head had occurred over this time period, with a maximum value of 330 m³/m (or around 26 m landward dune face translation). An envelope value of erosion volume between 1988 and 1996 was assessed for the various locations at Little Beach and Scotts Head. These values are also presented as a *storm erosion distance*, which represents the landward movement of the main beach dune as a result of the storm.

The lack of sufficient data immediately before and after storm events meant that it was not possible to perform a statistical analysis and assign a design encounter probability to the recommended storm erosion demand value. However, it is considered that a storm that would lead to the design storm erosion demand would have a very low risk of being exceeded over the next 50 years, given that the measured storm erosion demand was based on the combined effects of several storms and one cyclone of 1995. The estimated storm erosion demand from the 1995 storms for various locations along the coast at Scotts Head is plotted in Figure 4.2.

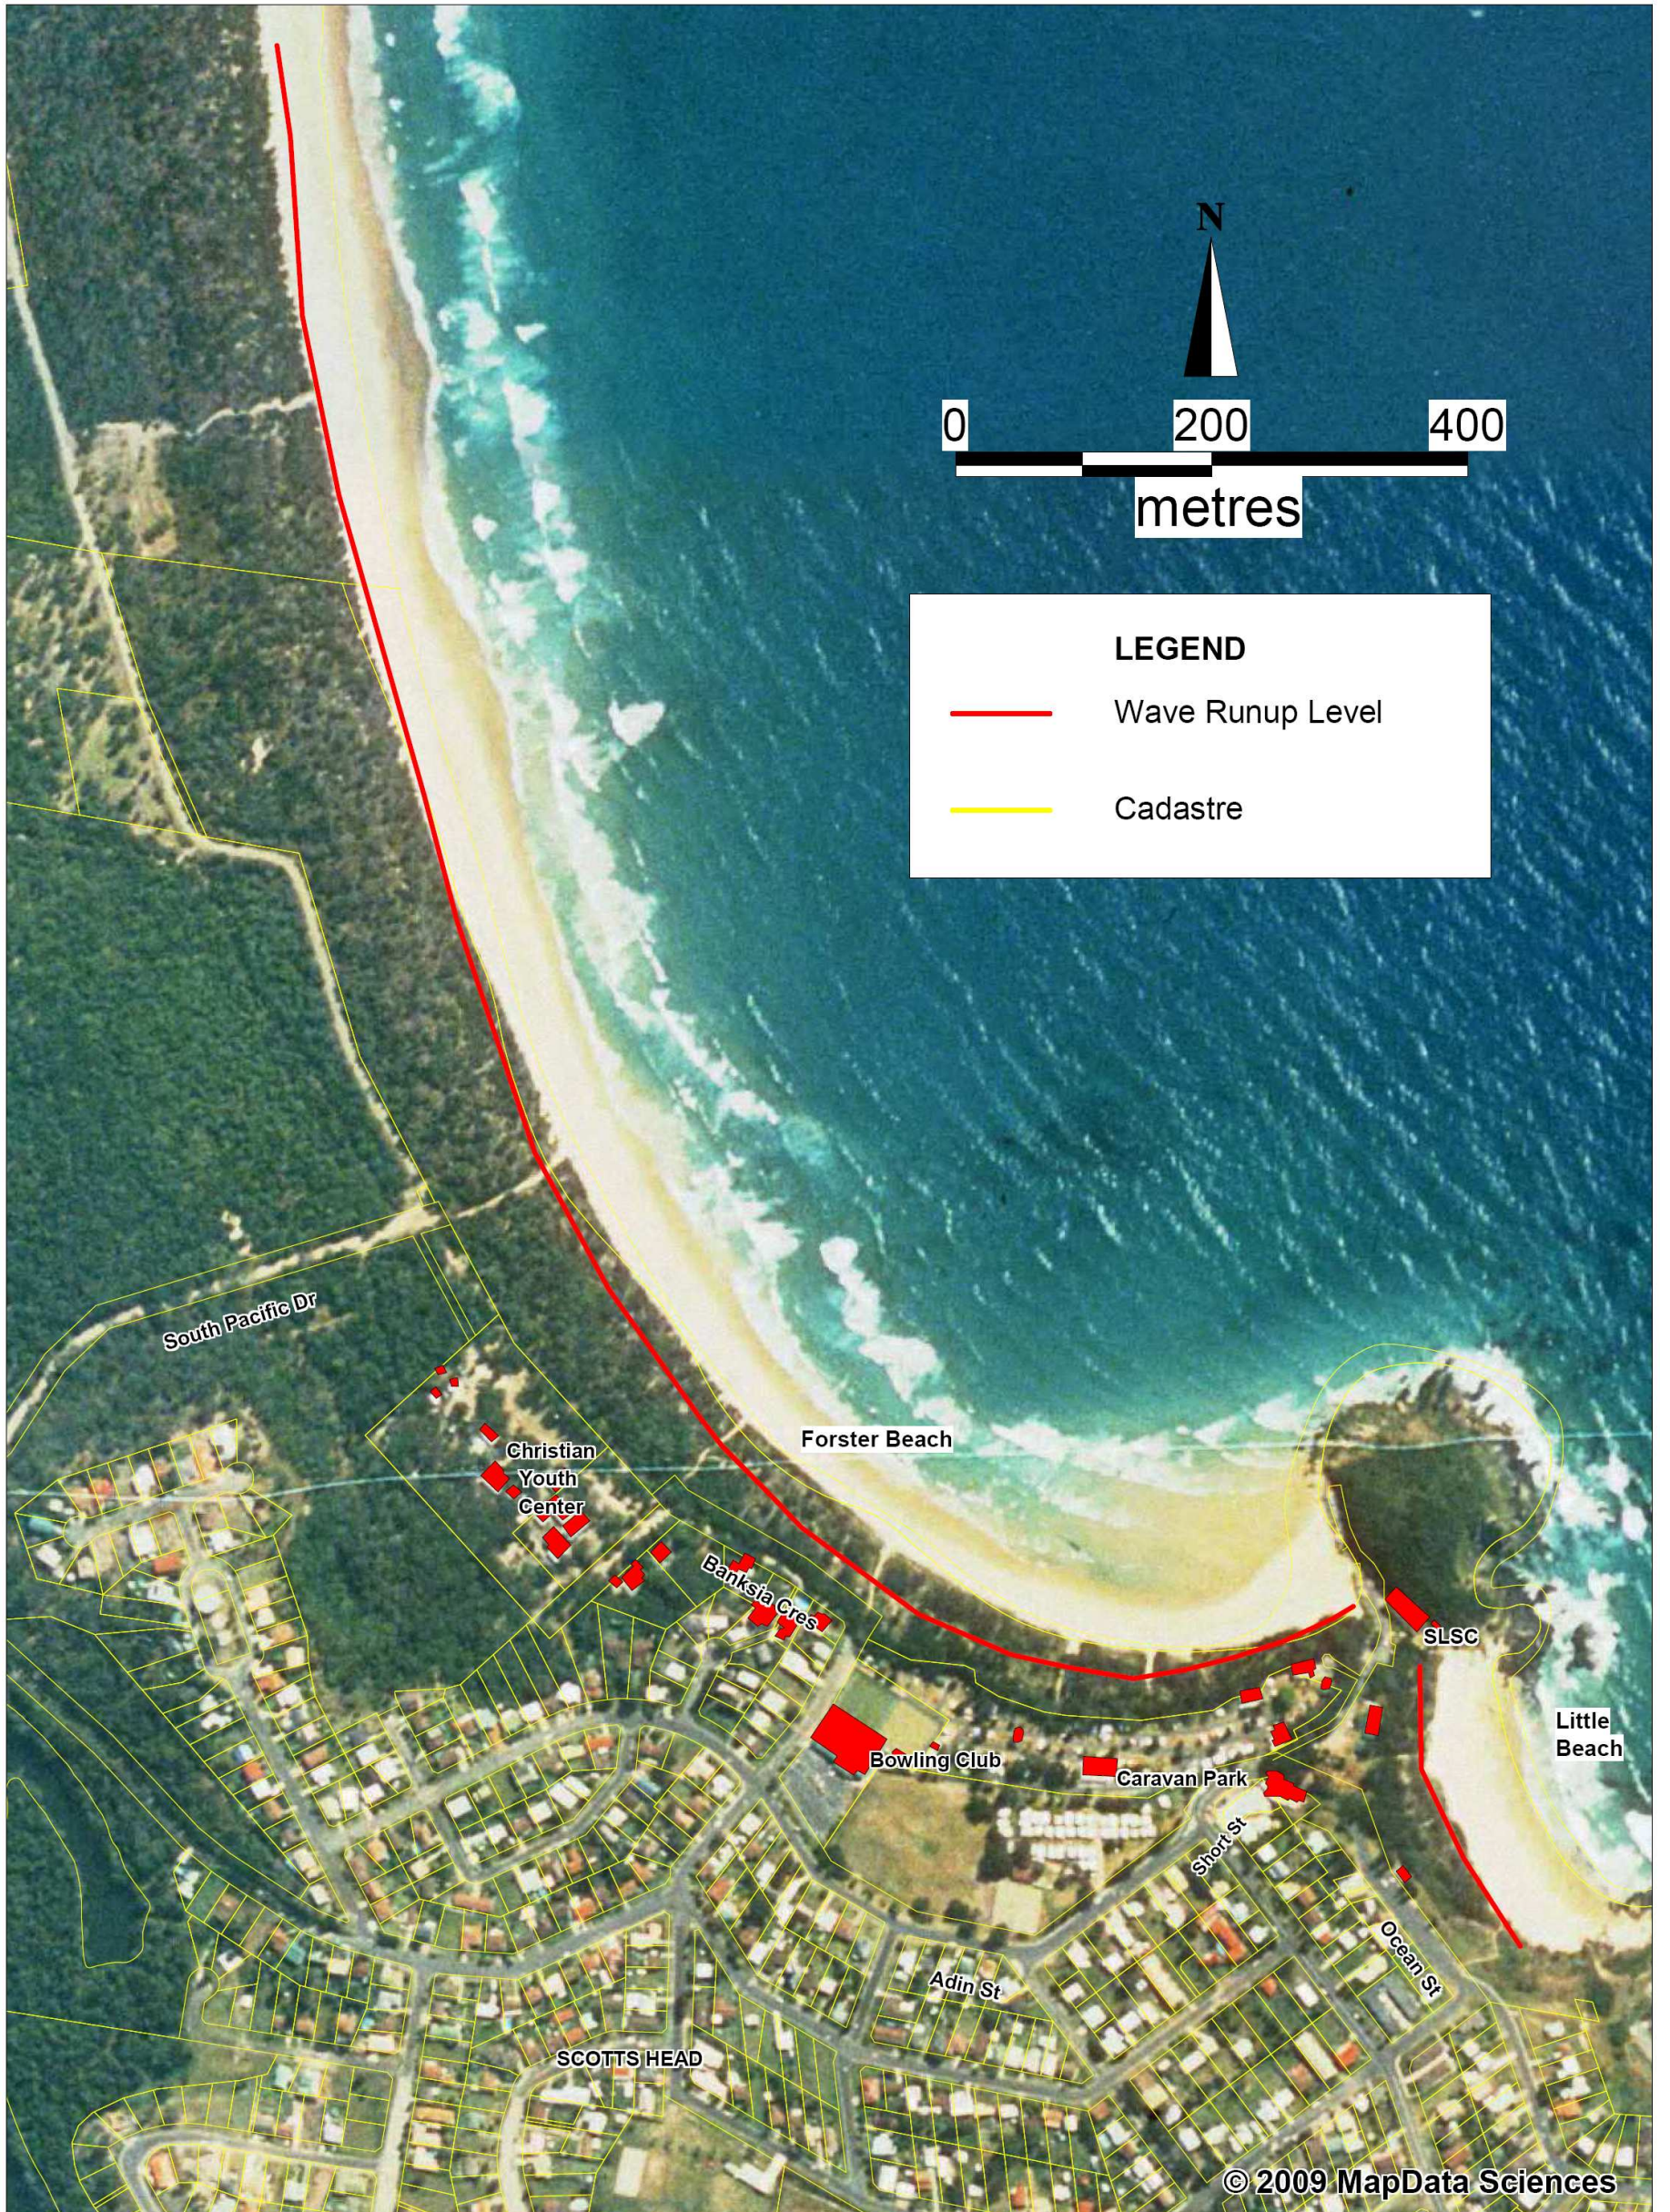
Figure 4.3 – 100 year ARI Wave Runup level, Scotts Head

Table 4.3 gives the results for the wave runup assessment. The analysis indicated that due to the relatively high embankment, there are few areas at risk of coastal inundation due to wave runup. The only area that would most likely experience inundation due to wave runup would be the SLSC located between Little and Forster Beach as the building is not protected by any dune and the retaining wall on the side of the SLSC fronting Little Beach would certainly be overtopped if a 5m high run up occurs. Wave inundation may also impact the carpark adjacent to the surf club, which may also affect the adjacent caravan park.

Figure 4.3 shows the expected limit of maximum wave runup for the 0.1% AEP storm event.

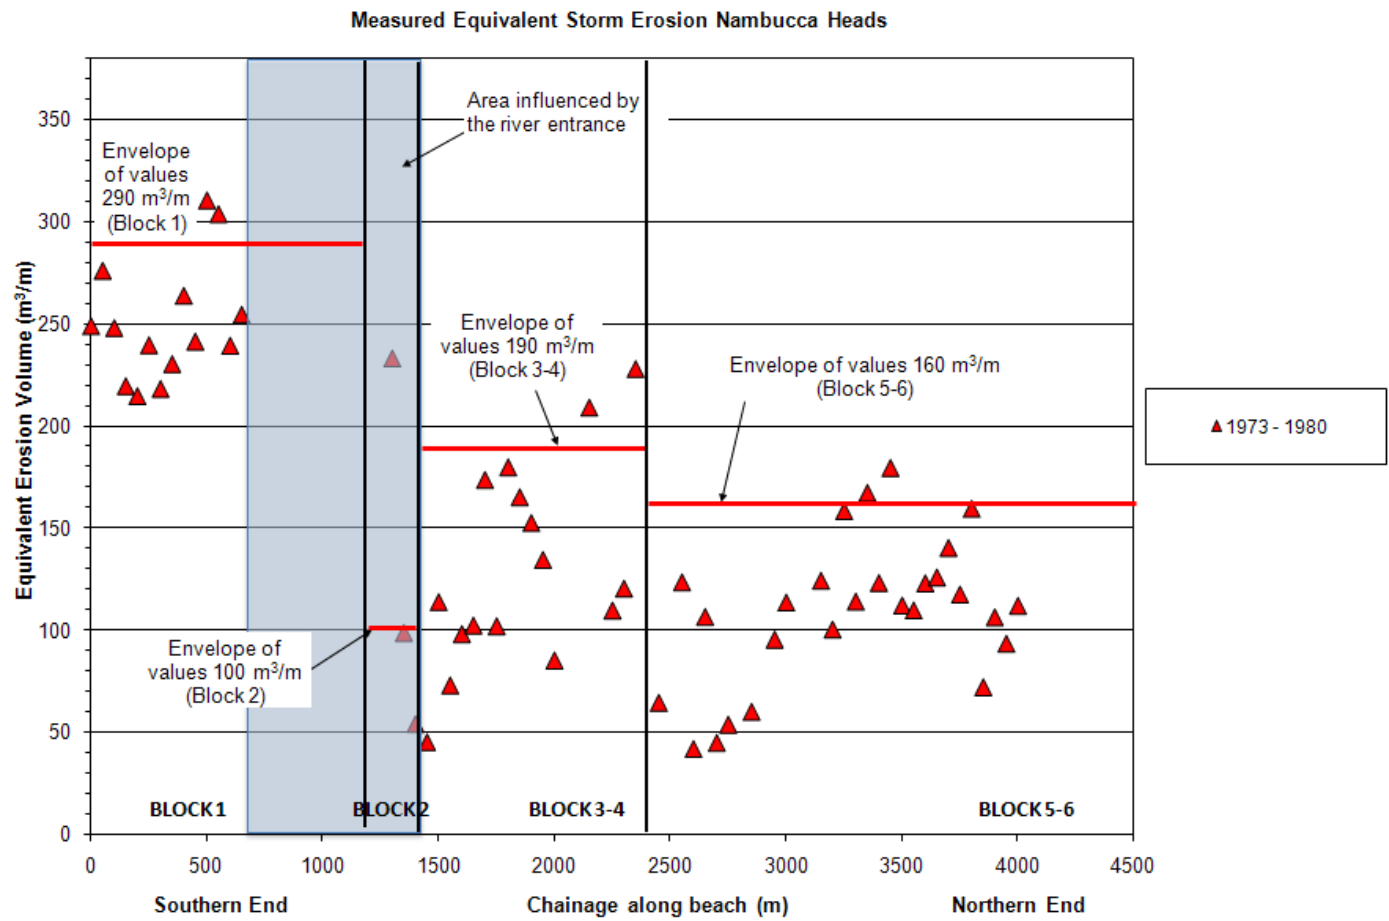
Figure 4.4 – Measured equivalent storm erosion, Nambucca Heads 1973 - 1980

The lack of sufficient data immediately before and after storm events meant that it was not possible to perform a statistical analysis and assign a design encounter probability to the recommended storm erosion demand value. However, it is considered that a storm that would lead to the design storm erosion demand would have a very low risk of being exceeded over the next 50 years. The estimated storm erosion demand from the 1974 storms for various locations along the beach at Nambucca Heads is plotted in Figure 4.4.

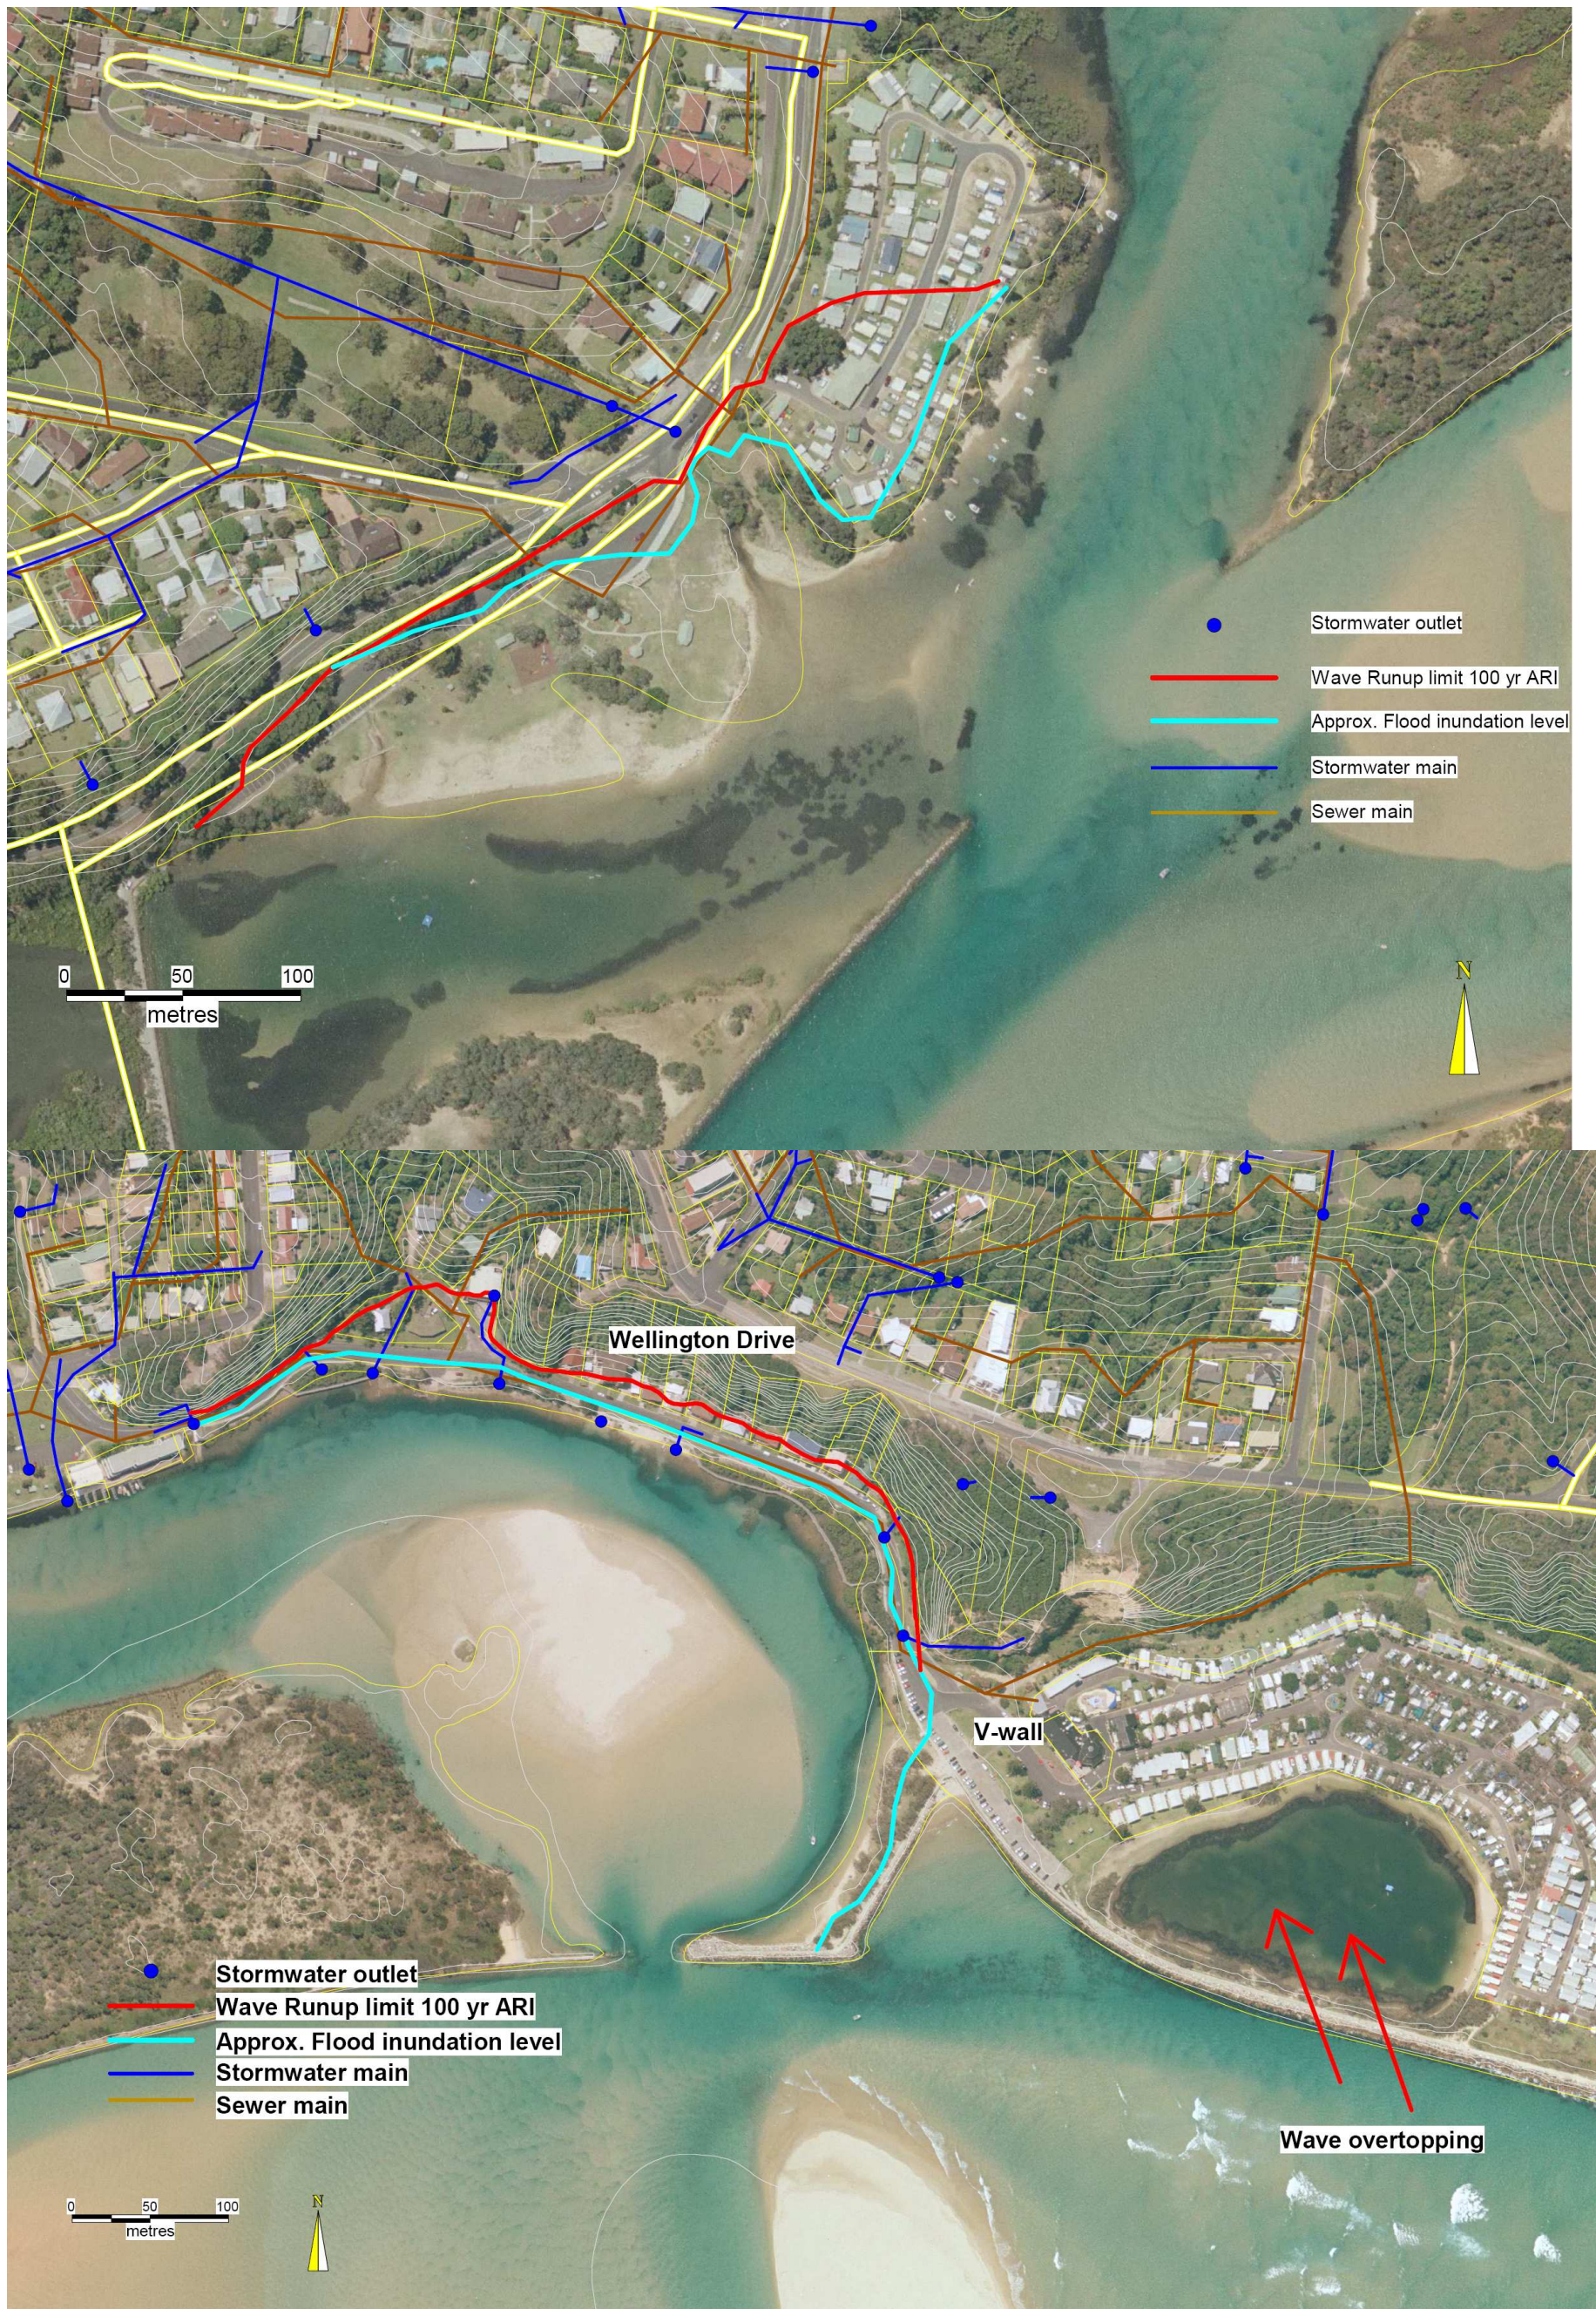
Figure 4.7 – Wave Runup limits, Top – Bellwood Park, Bottom, Wellington Drive, Nambucca Heads

Wave runup levels could reach an additional 1 m above the nearshore water level, based on the nearshore slope and wave height at Wellington Drive and Bellwood Park. This would inundate the roadway of Wellington Drive, and low-lying parts of Riverside Drive. Wave runup levels would likely increase by 2100 as a result of sea level rise due to climate change. The extent of any future increase cannot be quantified at this time, due to future morphological changes in the lower estuary affecting future runup levels.

Figures 4.6 and 4.7 indicate the areas subject to wave runup inundation both for the beaches and lower estuary areas.

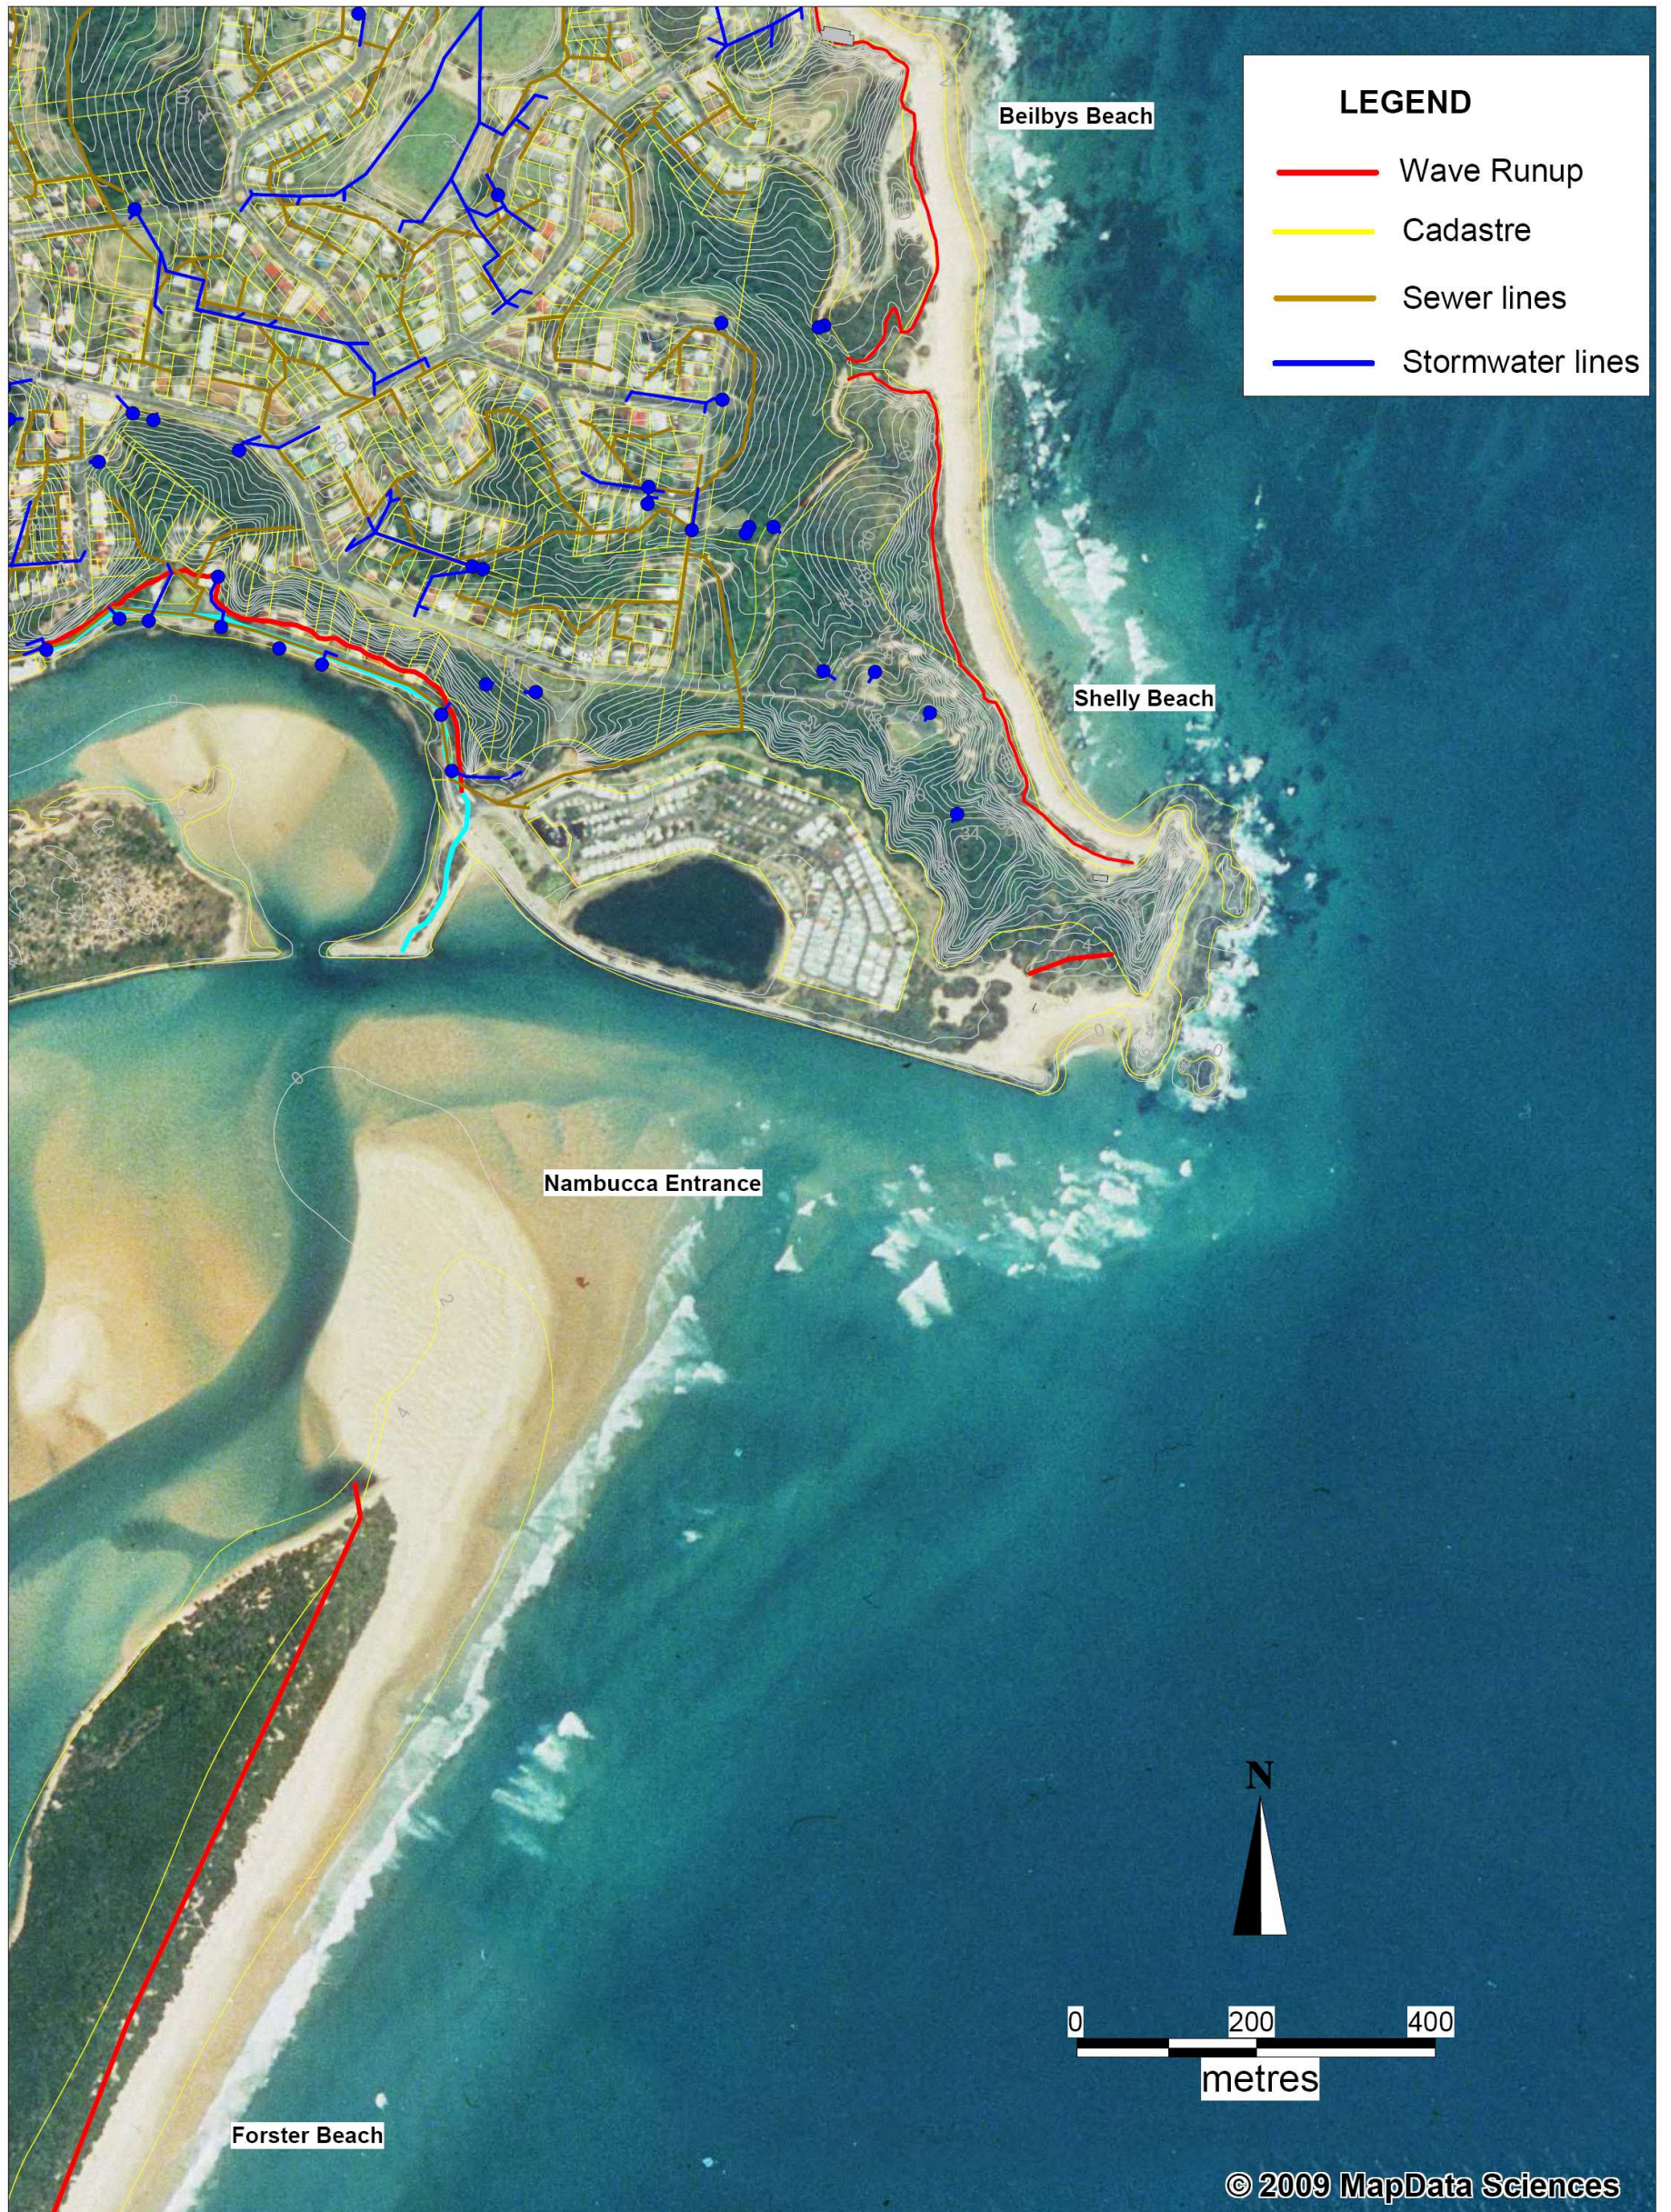
Figure 4.7a – Wave Runup limits, Nambucca entrance, Shelly Beach and Beilbys Beach, Nambucca Heads

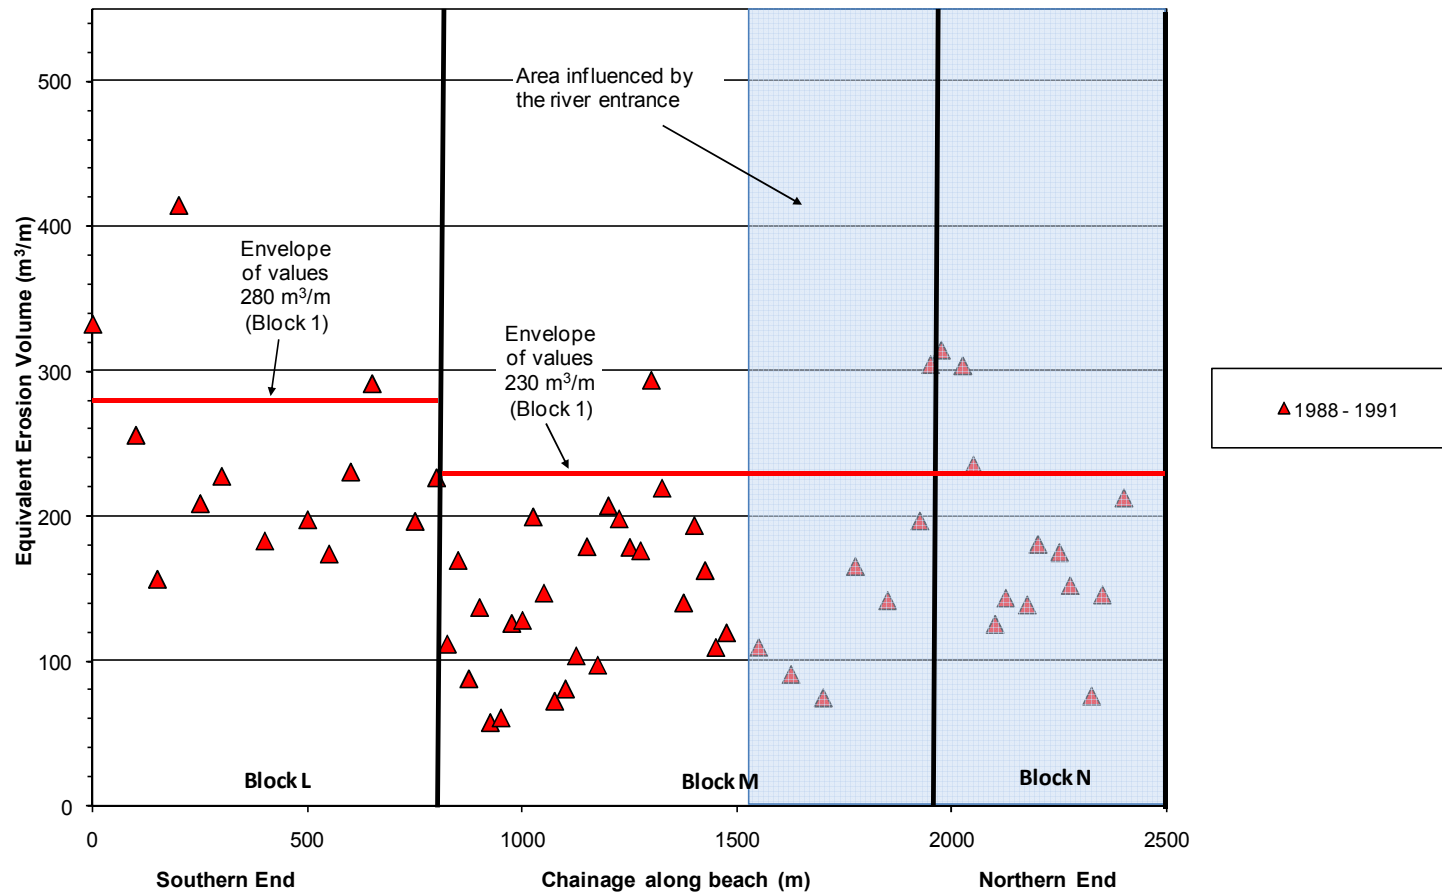
Figure 4.8 – Valla Beach measured equivalent storm erosion 1988 - 1991

Equivalent storm erosion volumes were obtained from the analysis of the beachfront areas along the entire Valla Beach coastline. Analysis of the photogrammetric data between 1988 and 1991 showed that most of the erosion values range from 150 to 290 m³/m for Block L and from 50 to 230 m³/m for Blocks M and N. Some higher values were noted but were checked and found to be outliers, due to inconsistencies in the photogrammetric data. Maximum storm erosion demand values of **280 m³/m for Block L** (equivalent to a loss of 25 m of dune), **230 m³/m for Blocks M and N** (equivalent to a loss of 33 m of dune) and **250 m³/m for Block O** (equivalent to a loss of 42 m of dune) were therefore adopted for the 1990 storms at Valla Beach. The values are close to the typical values of 200 – 250 m³/m adopted for open coast beaches elsewhere along the NSW coast where the beaches consist of unconsolidated sands. However, it should be noted that erosion along some parts of the coastline will be limited as the dunes are backed by rocky cliffs and bluffs.

The lack of sufficient data immediately before and after storm events meant that it was not possible to perform a statistical analysis and assign a design encounter probability to the recommended storm erosion demand value. However, it is considered that a storm that would lead to the design storm erosion demand would have a very low risk of being exceeded over the next 50 years, given that the measured storm erosion demand was based on the combined effects of three storm events and a Tropical Cyclone in 1990. The estimated storm erosion demand from the 1990 storms for various locations along the beach at Valla Beach is plotted in Figure 4.8.
