An aquatic | Nambucca River and Deep Creek ecosystem check for the CATCHMENT REPORT CARD 2018

About Ecohealth

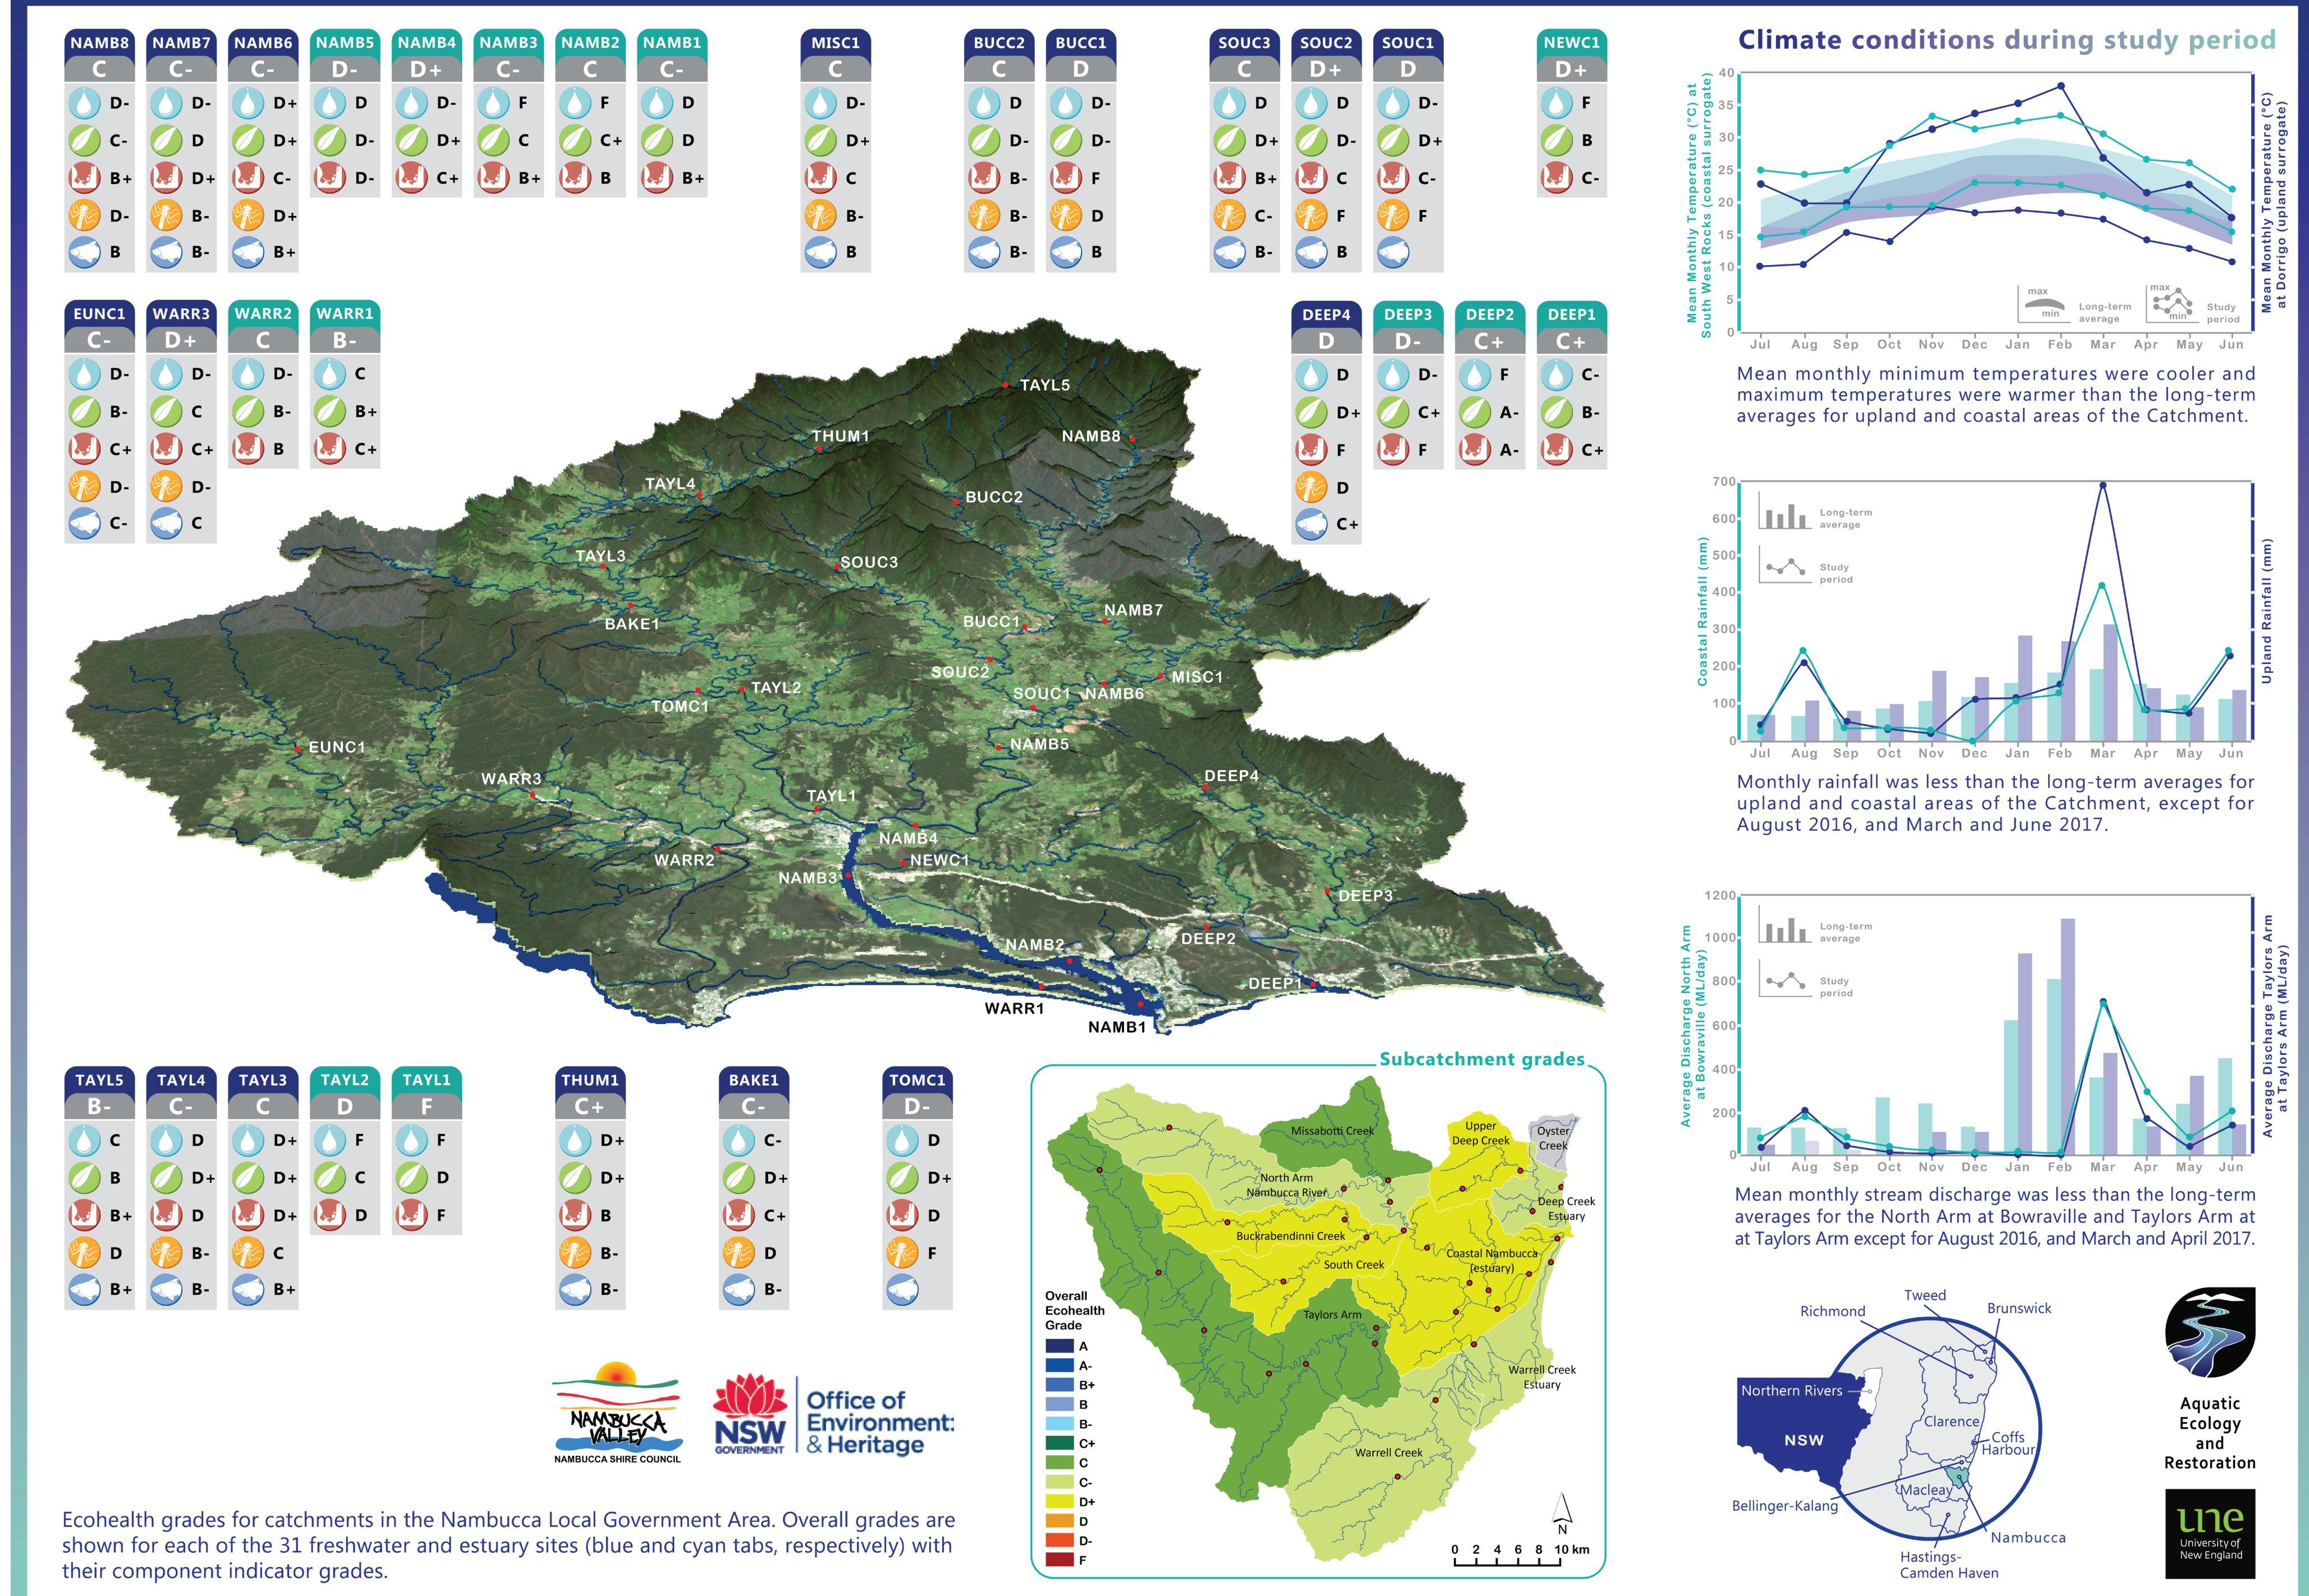
A total of 31 sites in 14 waterways was used to calculate an overall moderate condition of C- for the Nambucca and Deep Creek catchments (see map below).

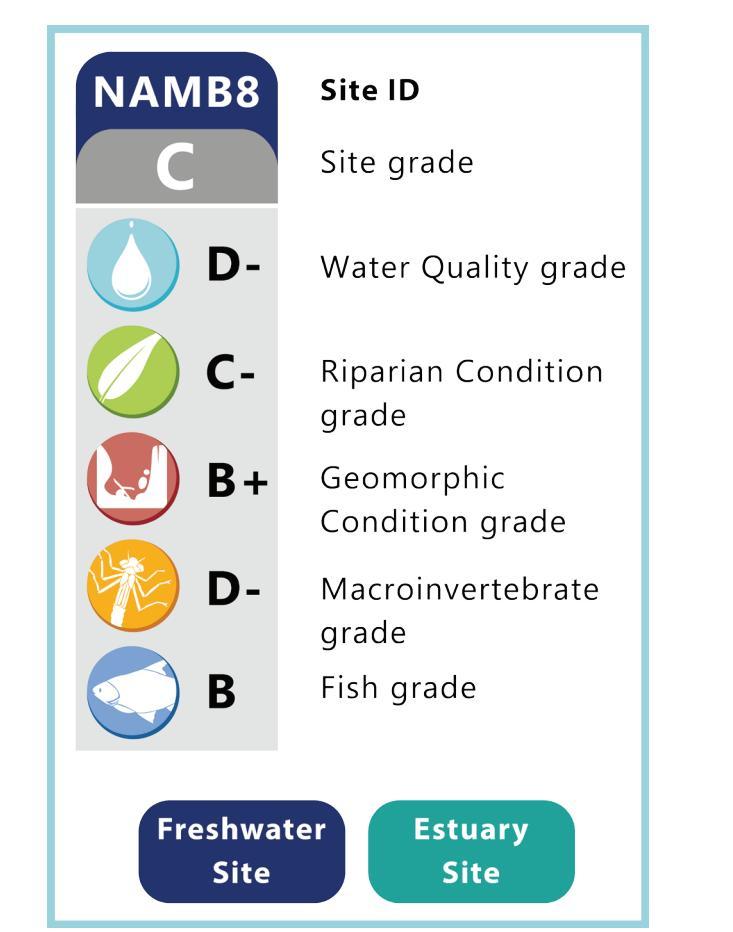
The diagram to the right shows the Ecohealth grading system, where a grade is given for water quality, riparian condition, geomorphic condition, aquatic macroinvertebrates and freshwater fish. Based on the average of these grades, an overall grade is awarded to the site. Overall grades are then also awarded for each river system, subcatchment, and for all freshwater and estuarine sites.
